Bunker Hill Rd Culvert (Bear Swamp Brook, TOA) - Pictures before work to protect downstream headwall from erosion and scour. Photos taken by Wetlands Agent 03.11.2024.

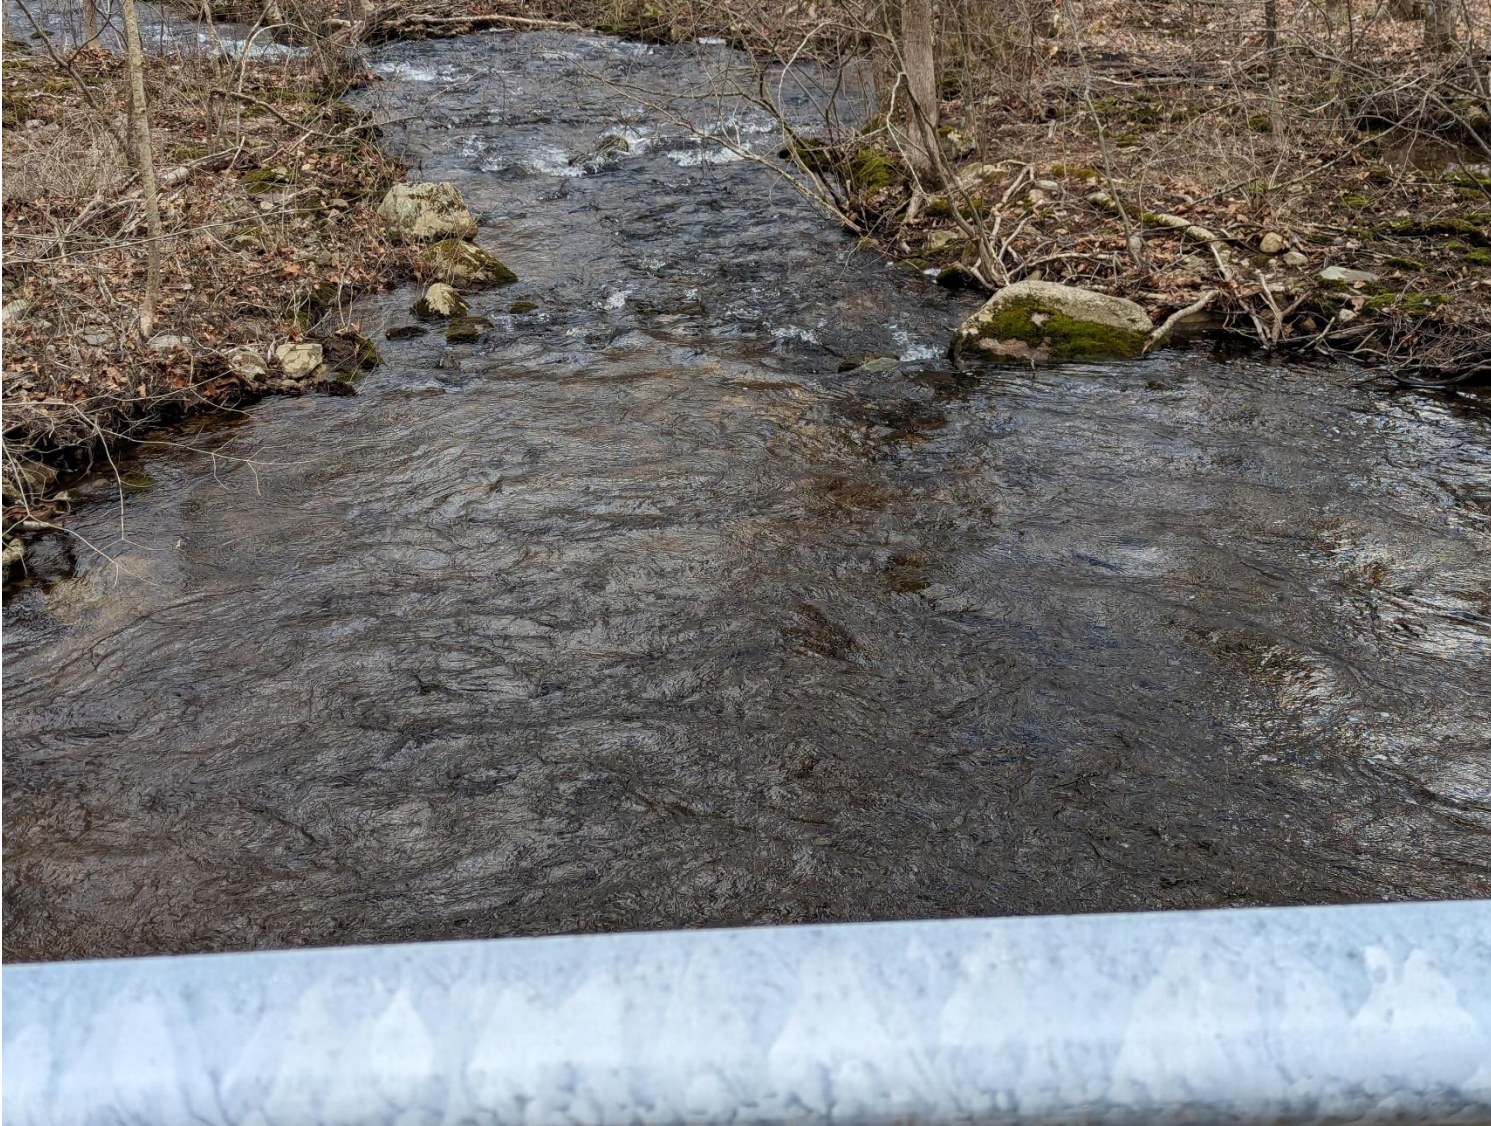
*1- View of brook flowing downstream from crossing.*

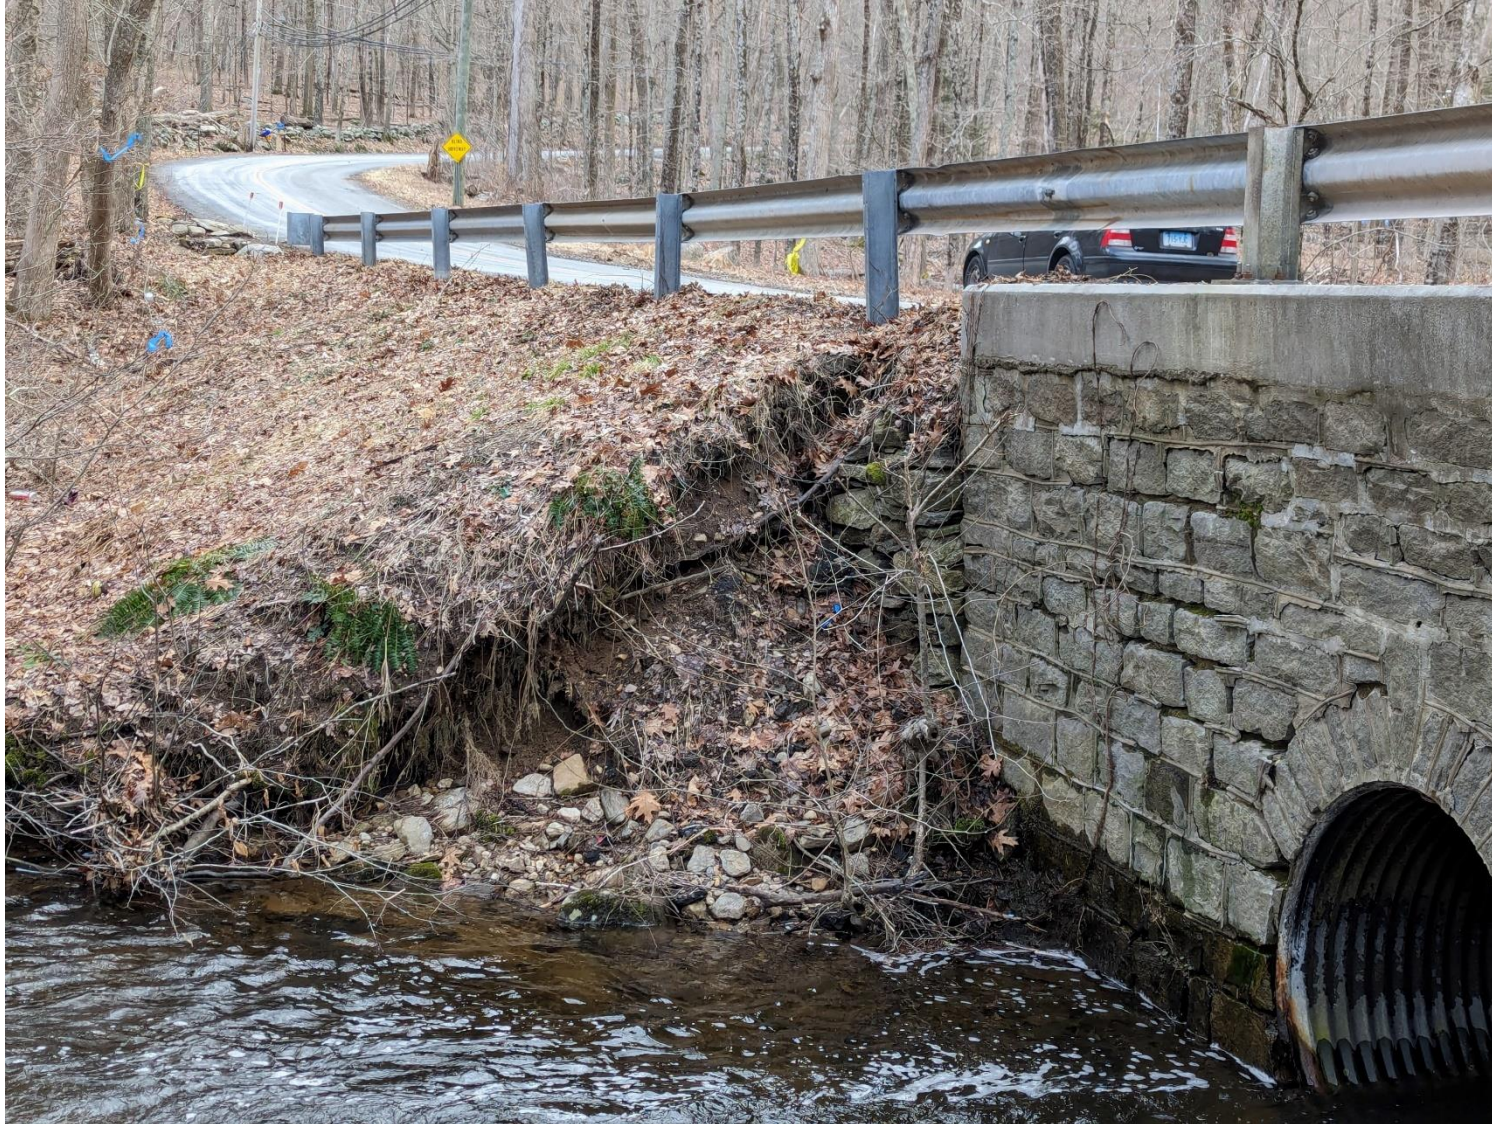
2 - View of downstream side of headwall--erosion is clearly visible.

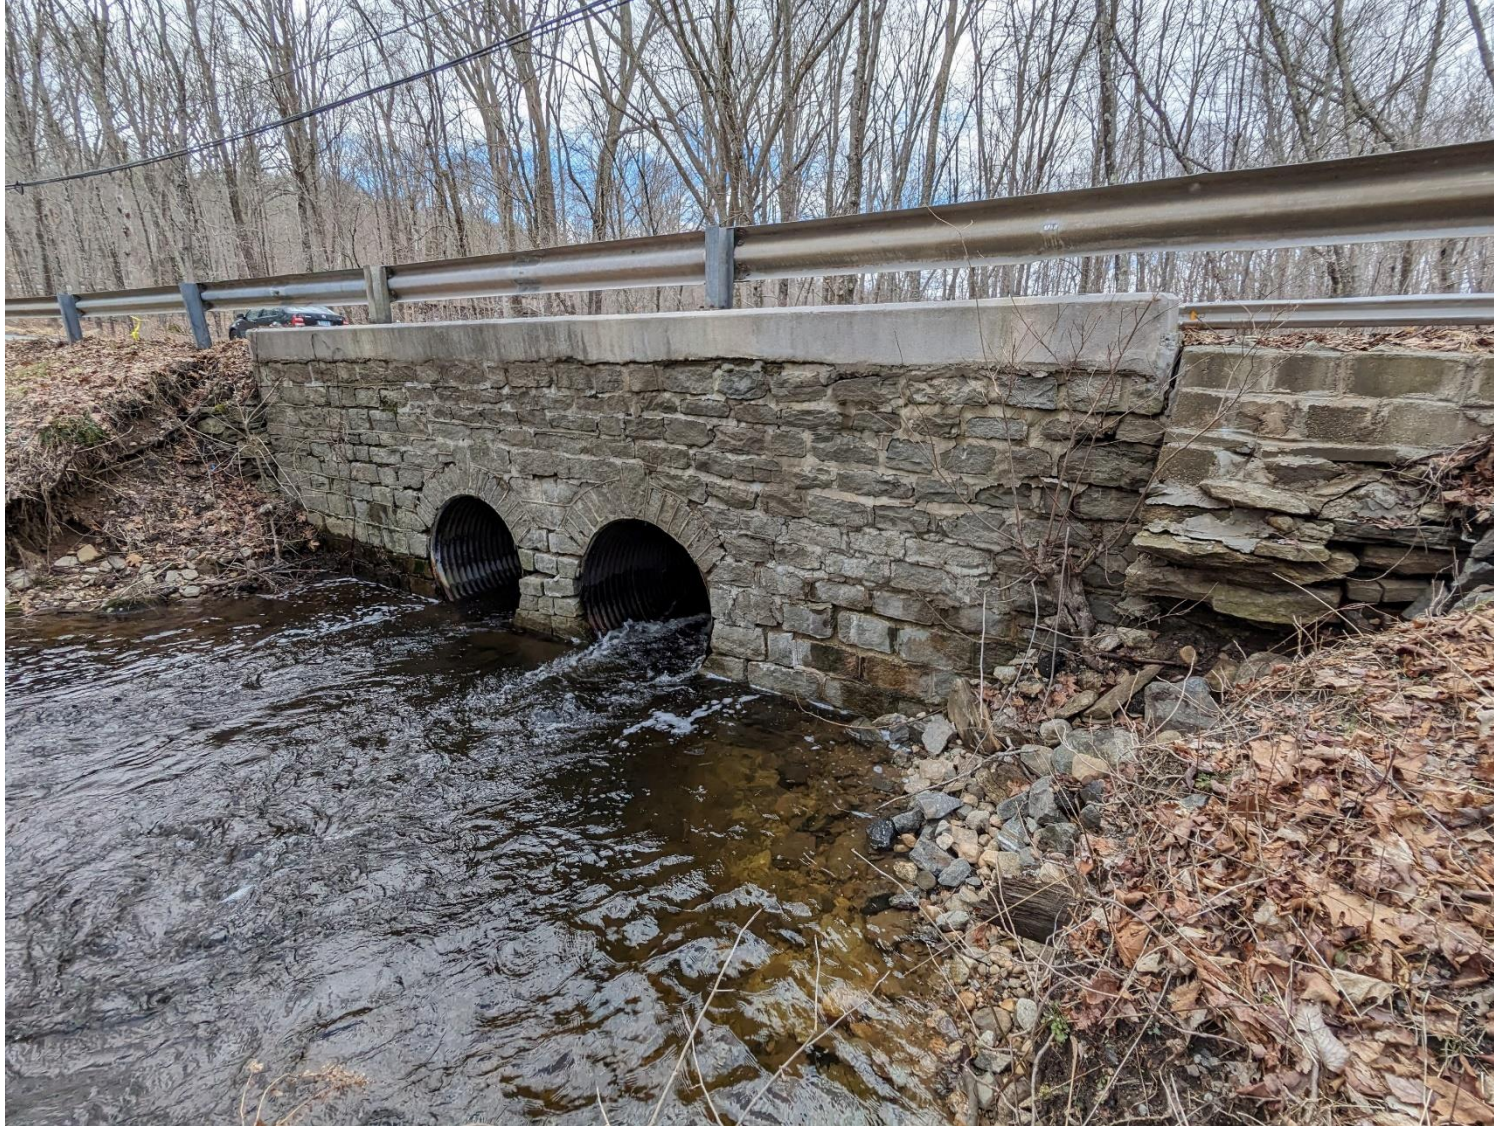
*3 - View of downstream side of crossing, where work will take place. Erosion is clearly visible on the sides of the headwall.*

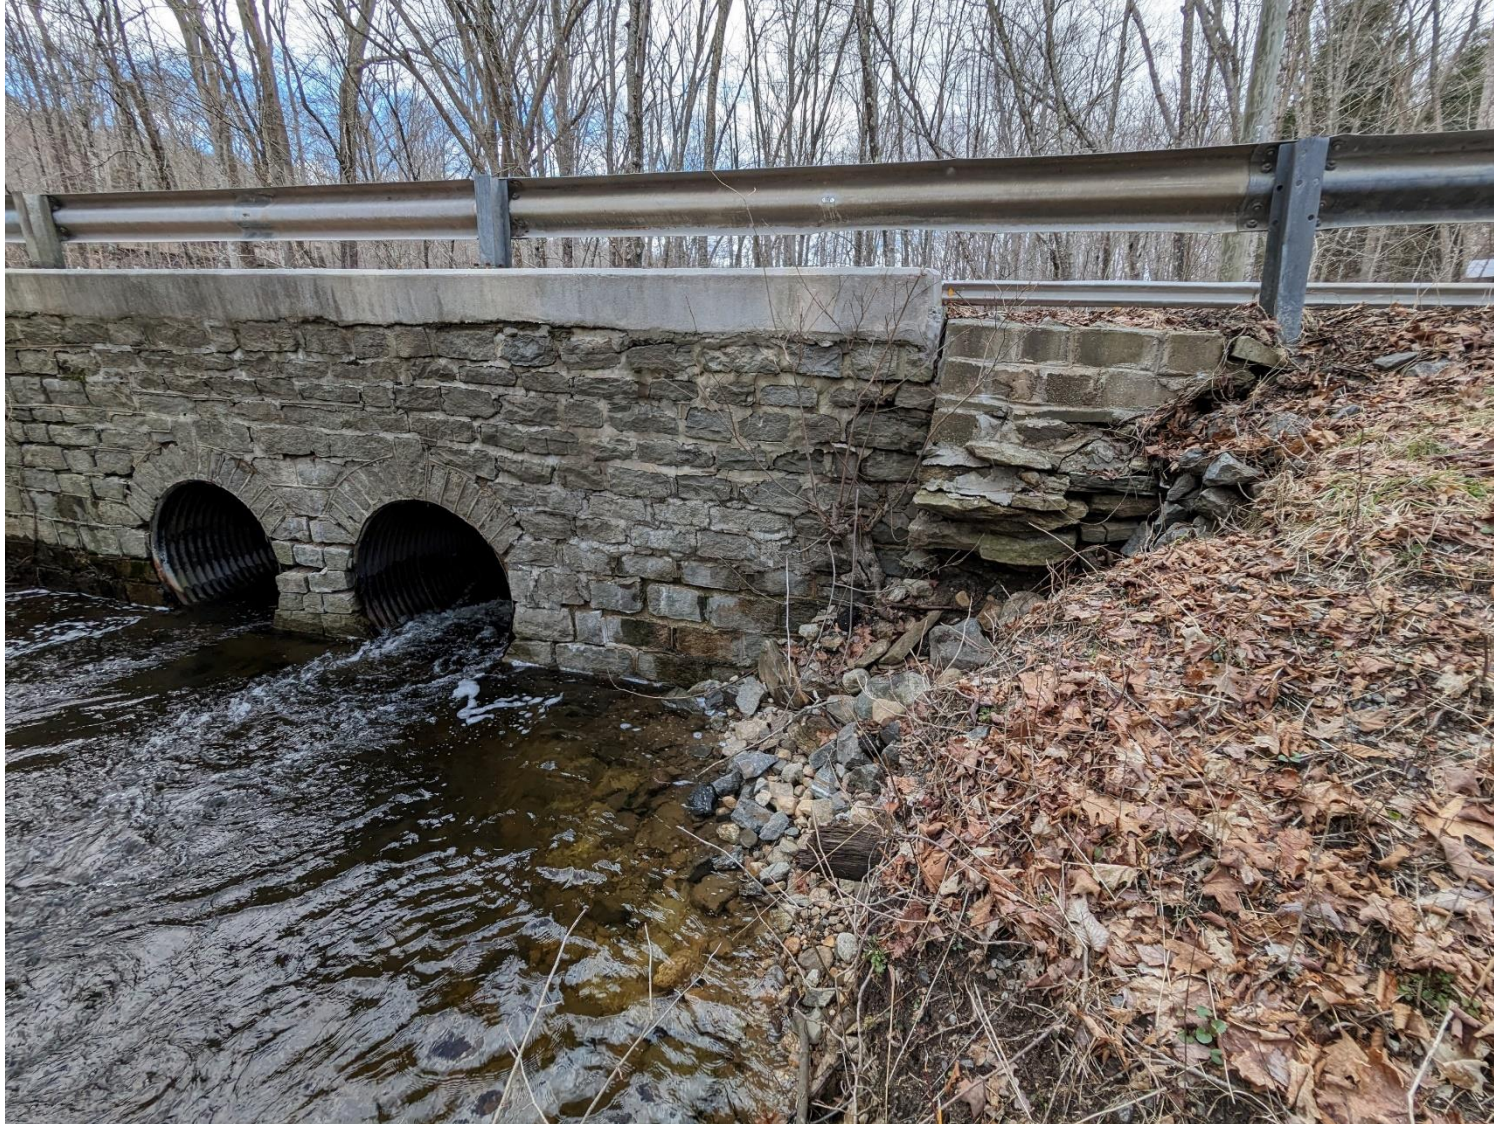
4 - View of downstream side of crossing

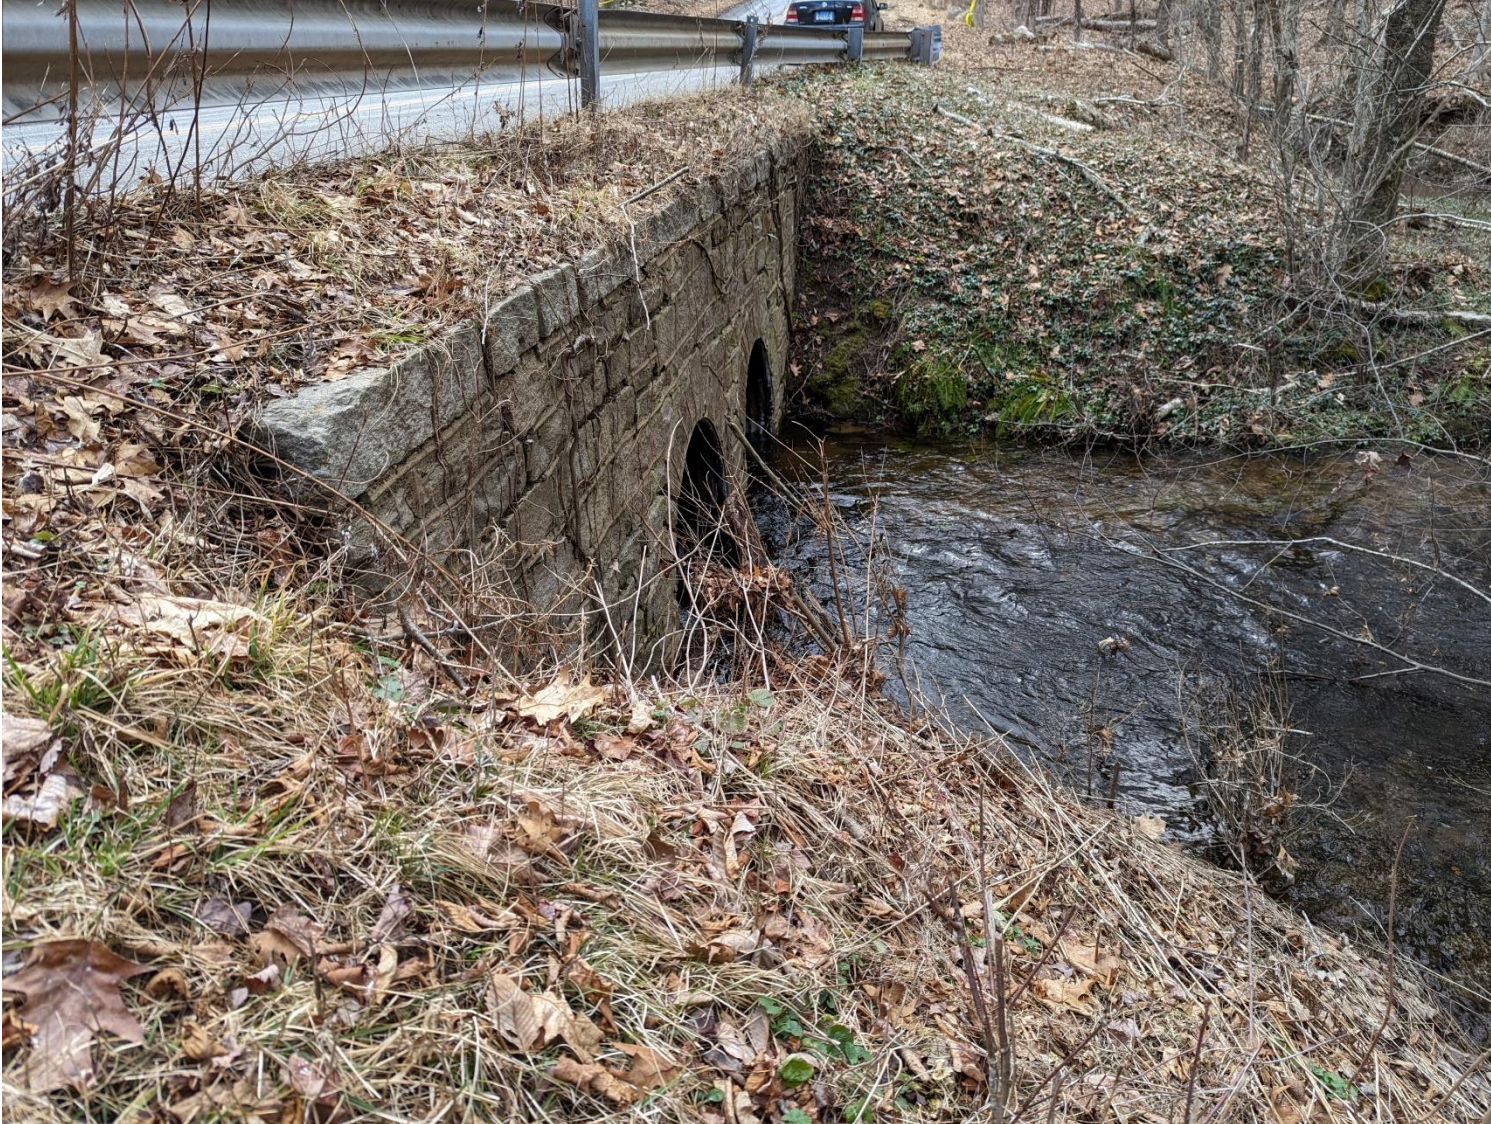
5 - View of upstream side of crossing.

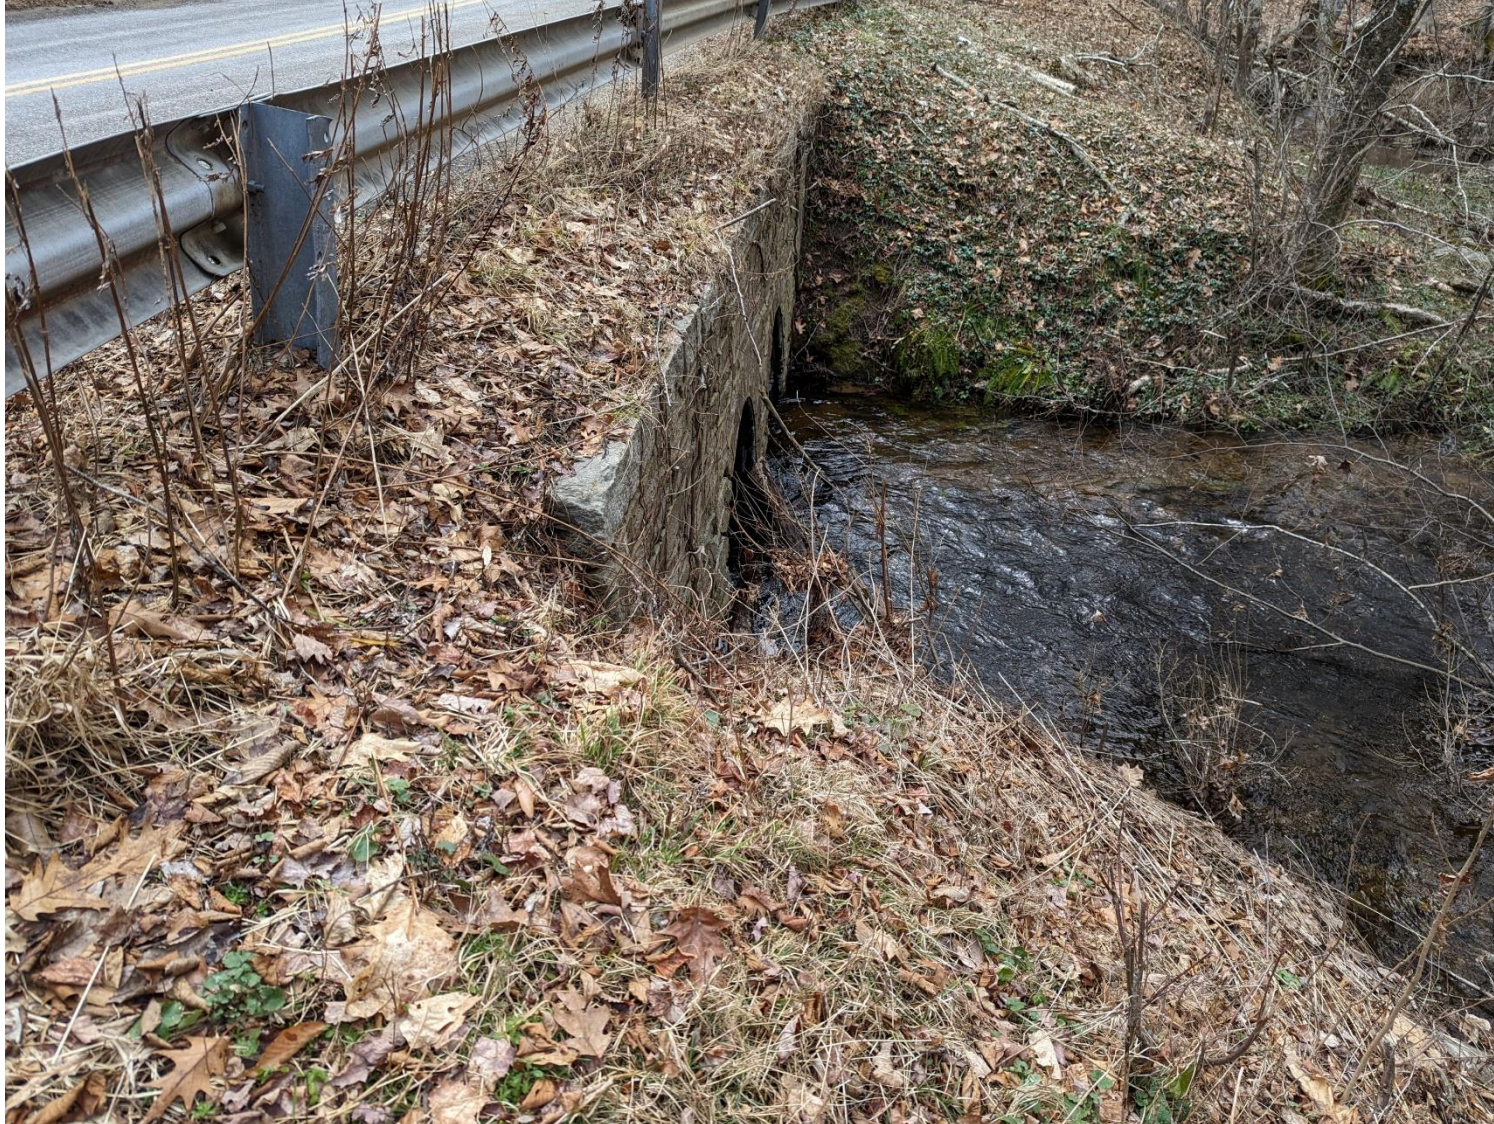
6 - View of upstream side of crossing

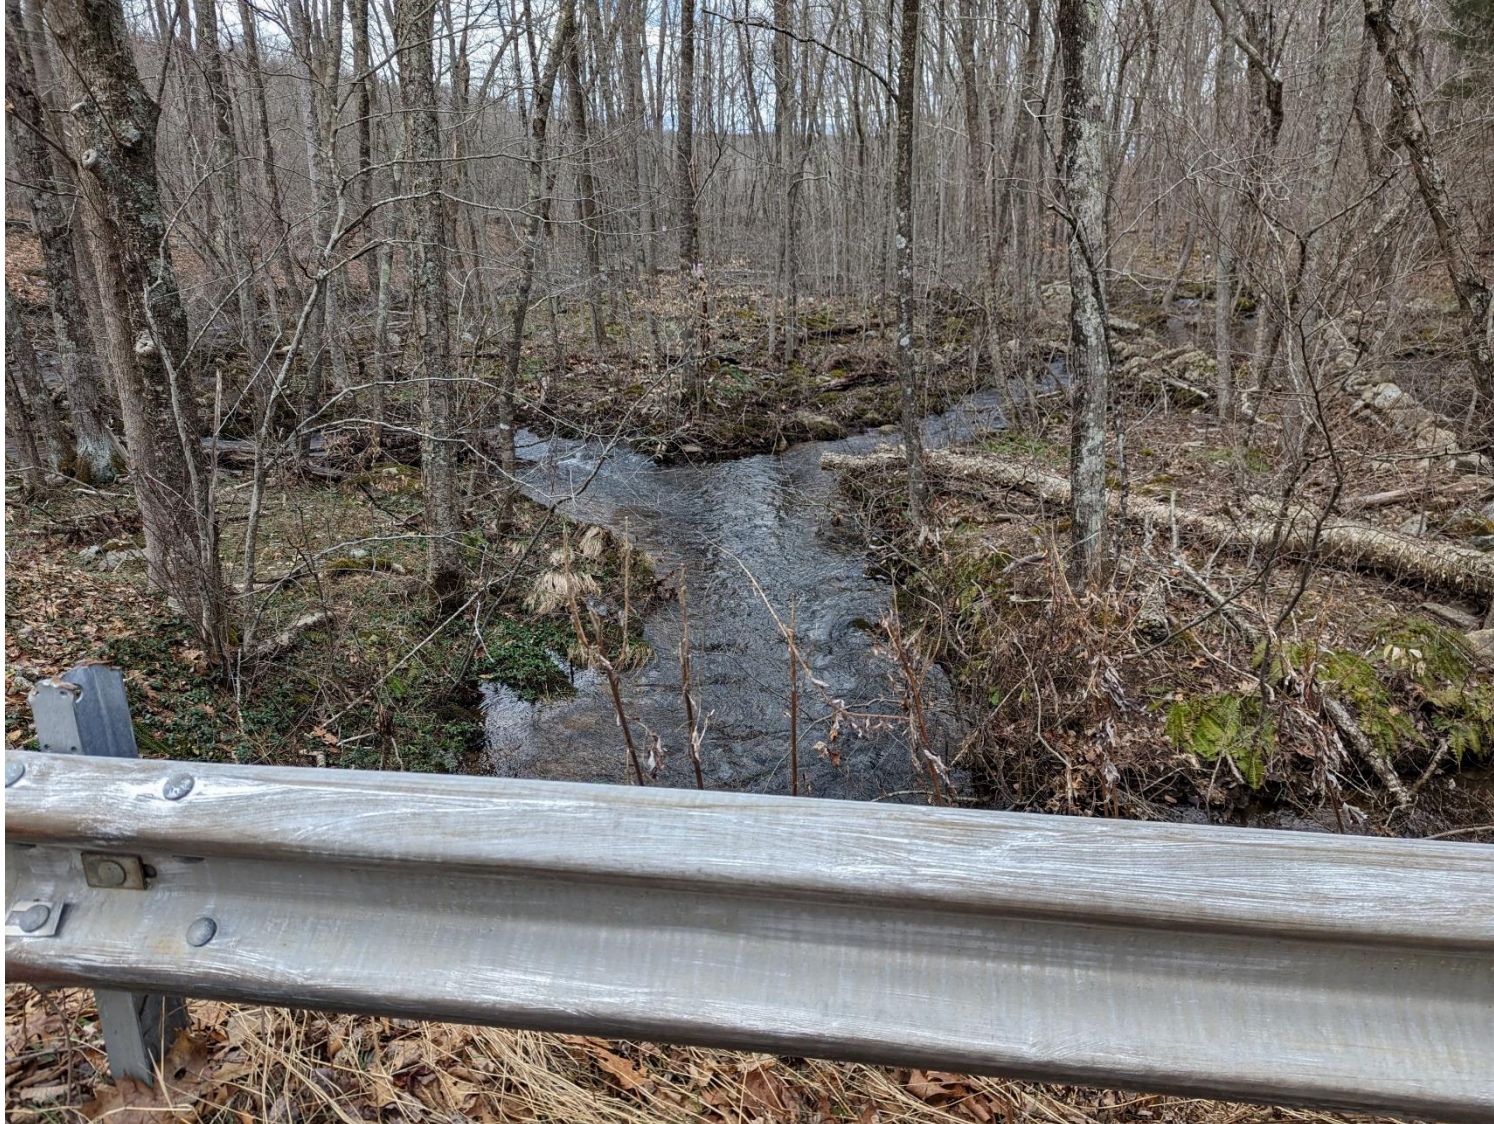
7 - View of upstream side of crossing

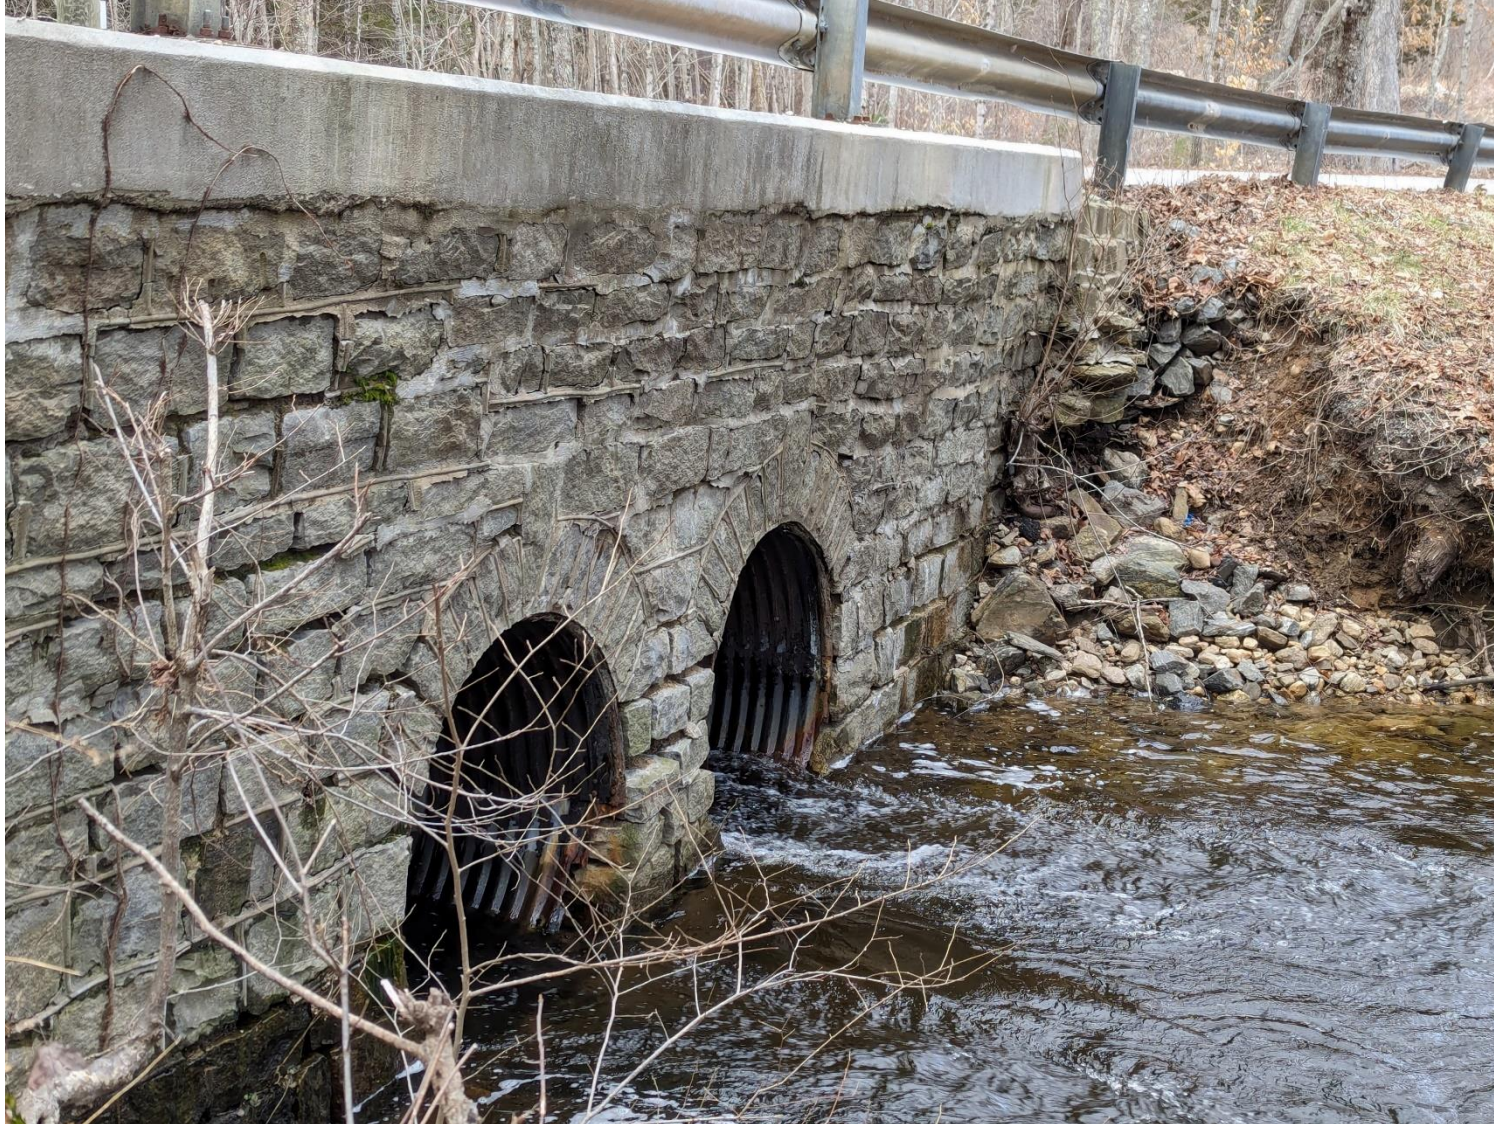
8 - View of downstream side of crossing.
