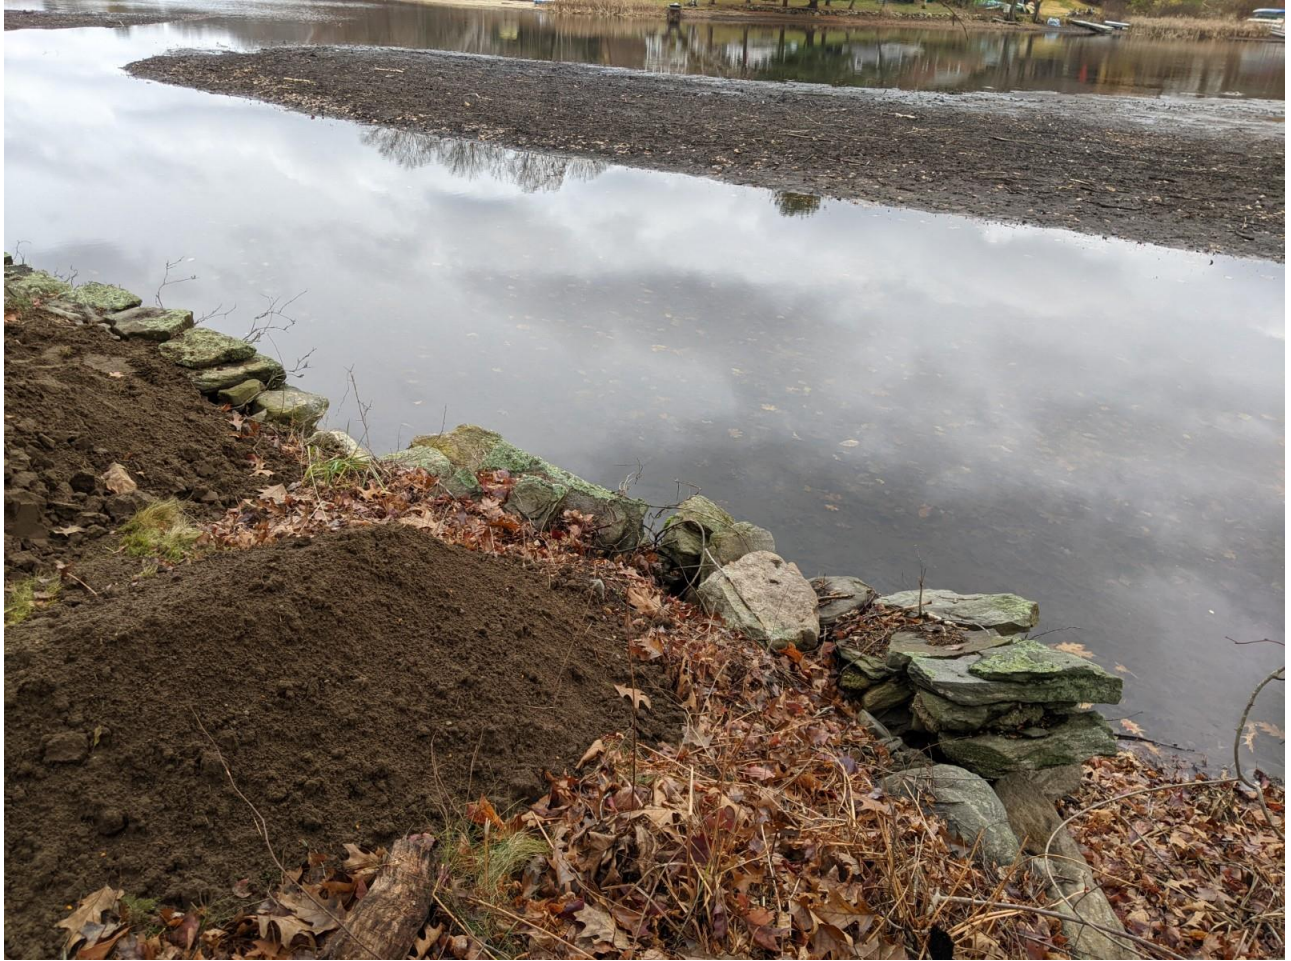
*1- Looking at the southern corner of the lake wall. This area is proposed to be restacked.*

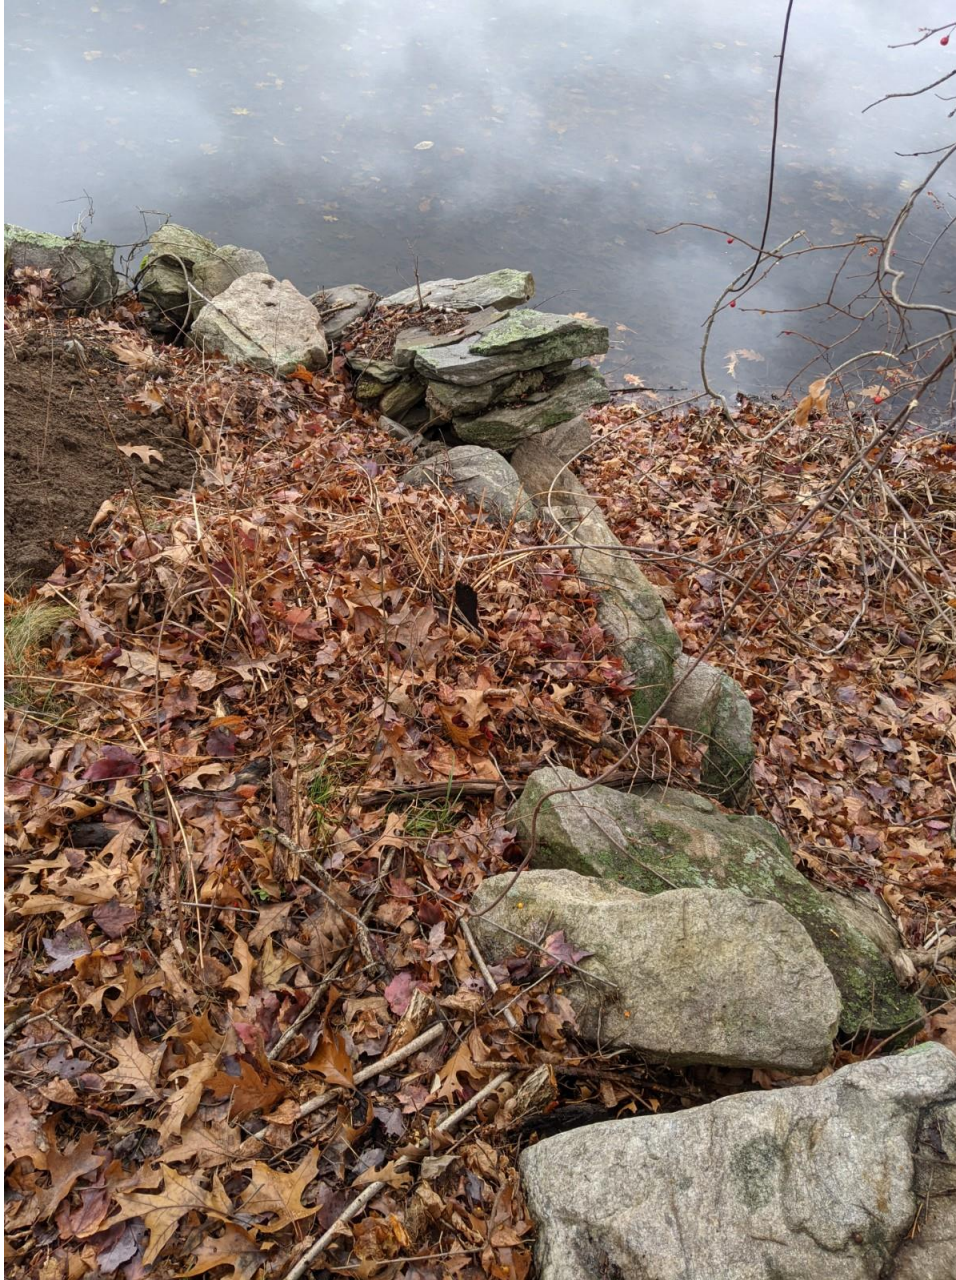
*2- A view of the southern corner of the wall where it turns west into the property and away from the lakeshore. This area is proposed to be restacked.*

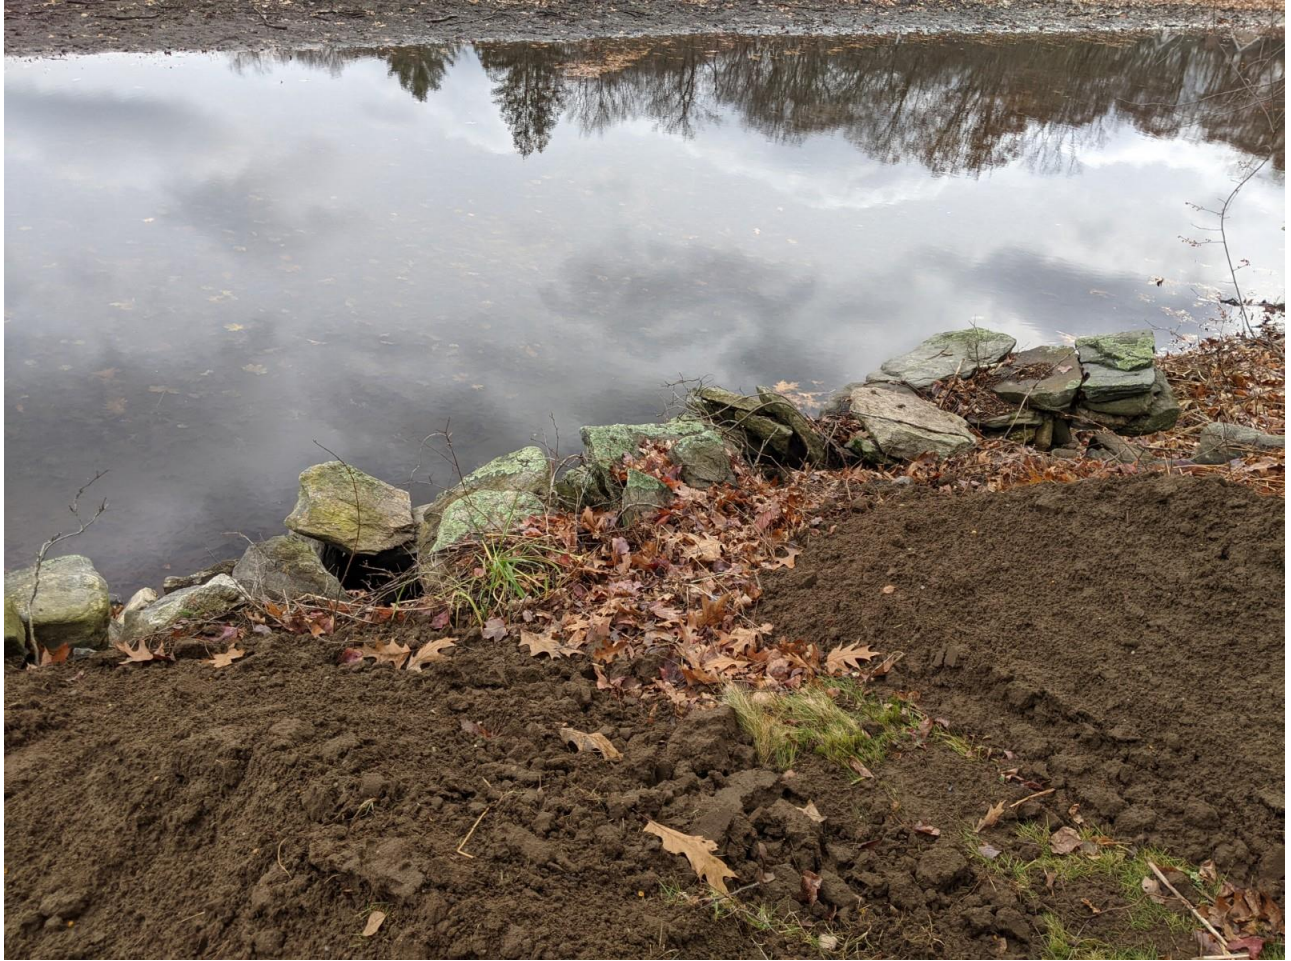
*3- Looking down at the southern corner of the lake wall. This end is proposed to be restacked.*

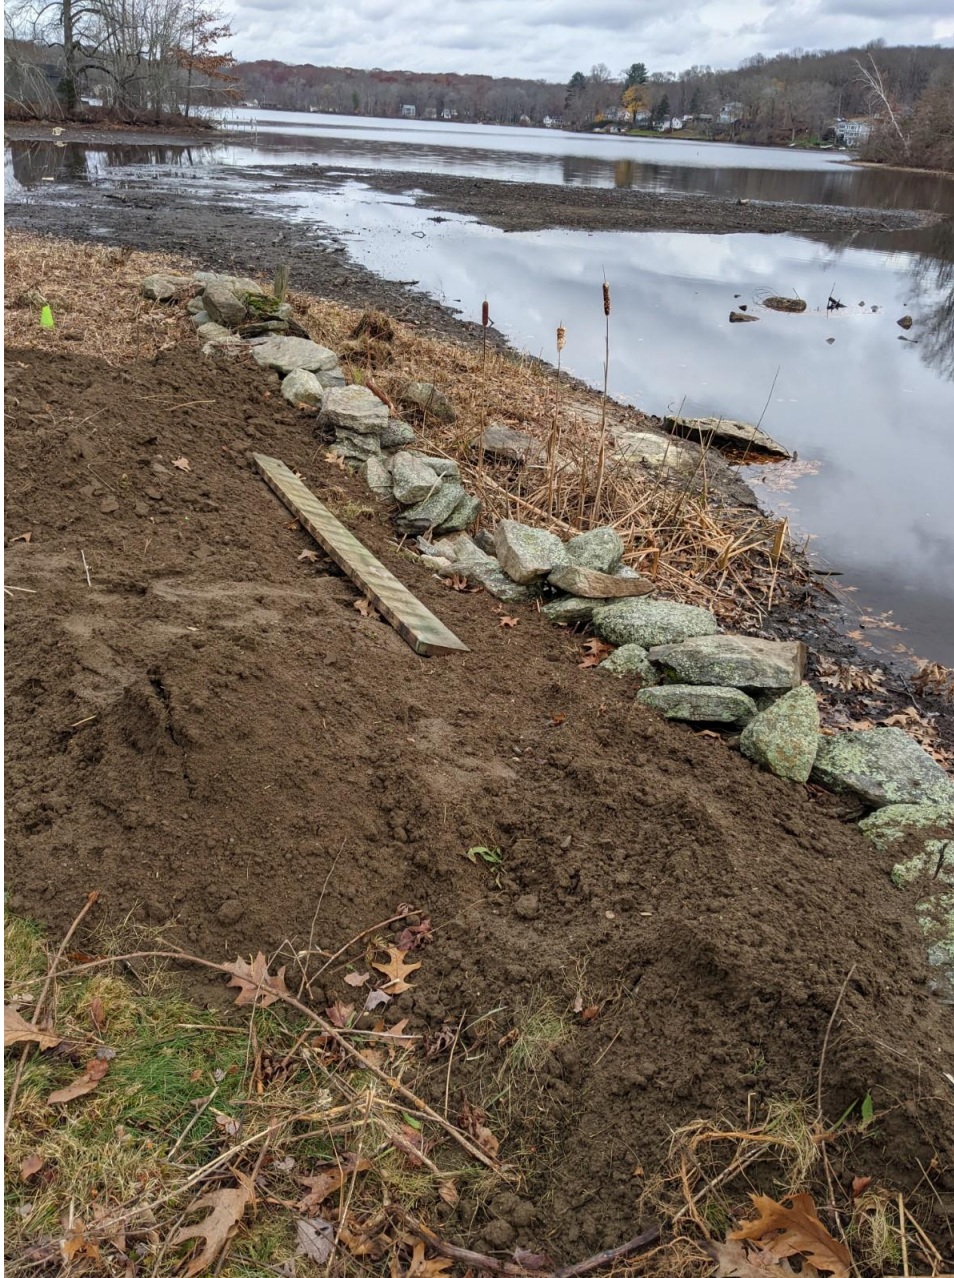
4- A view of the north section of the wall-- one of the areas proposed to be restacked.

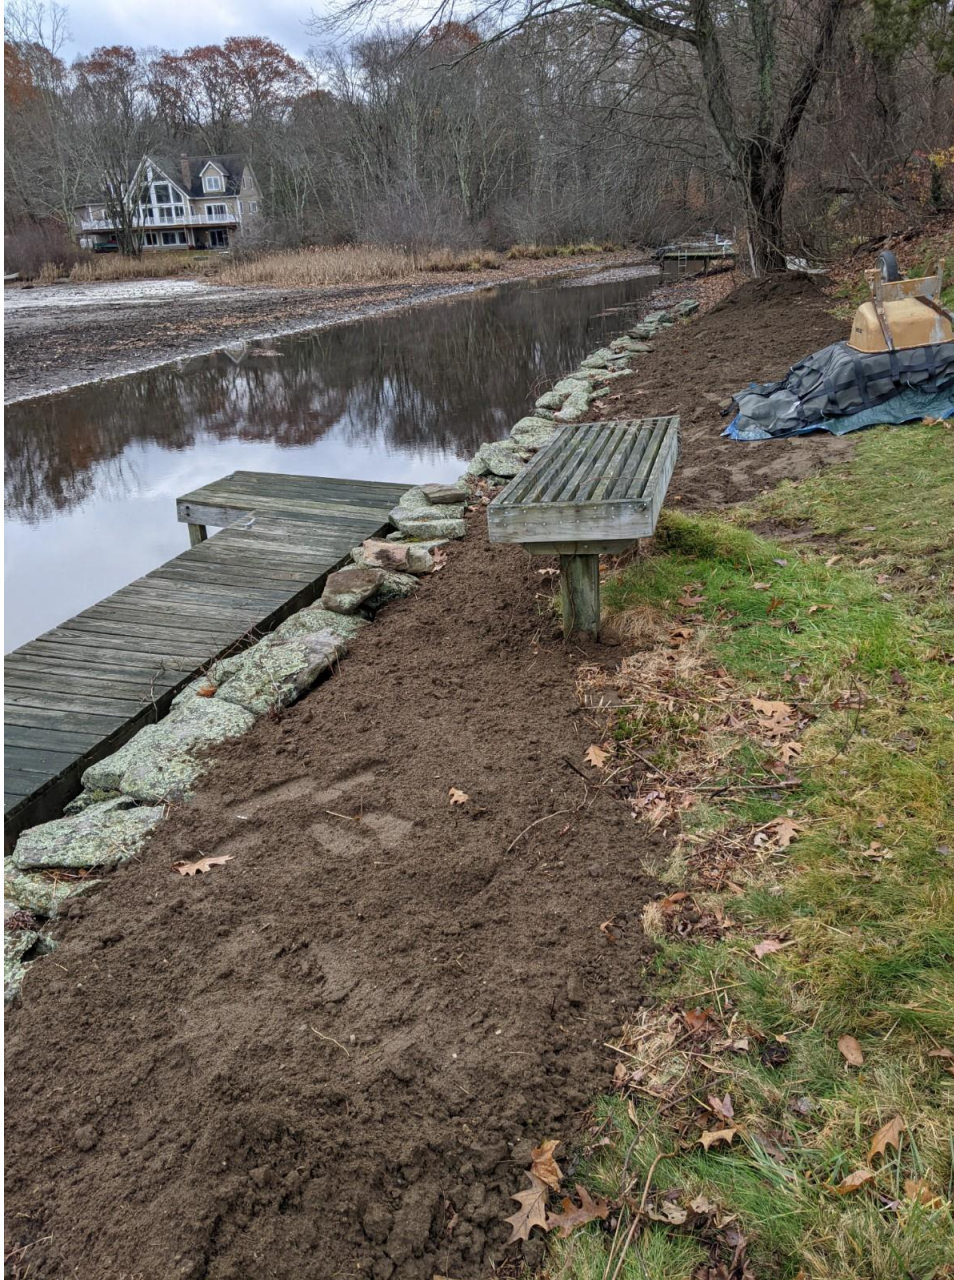
*5- View of the center area of the lake wall. This area is proposed to be re-pointed with mortar, but does not need to be restacked.*

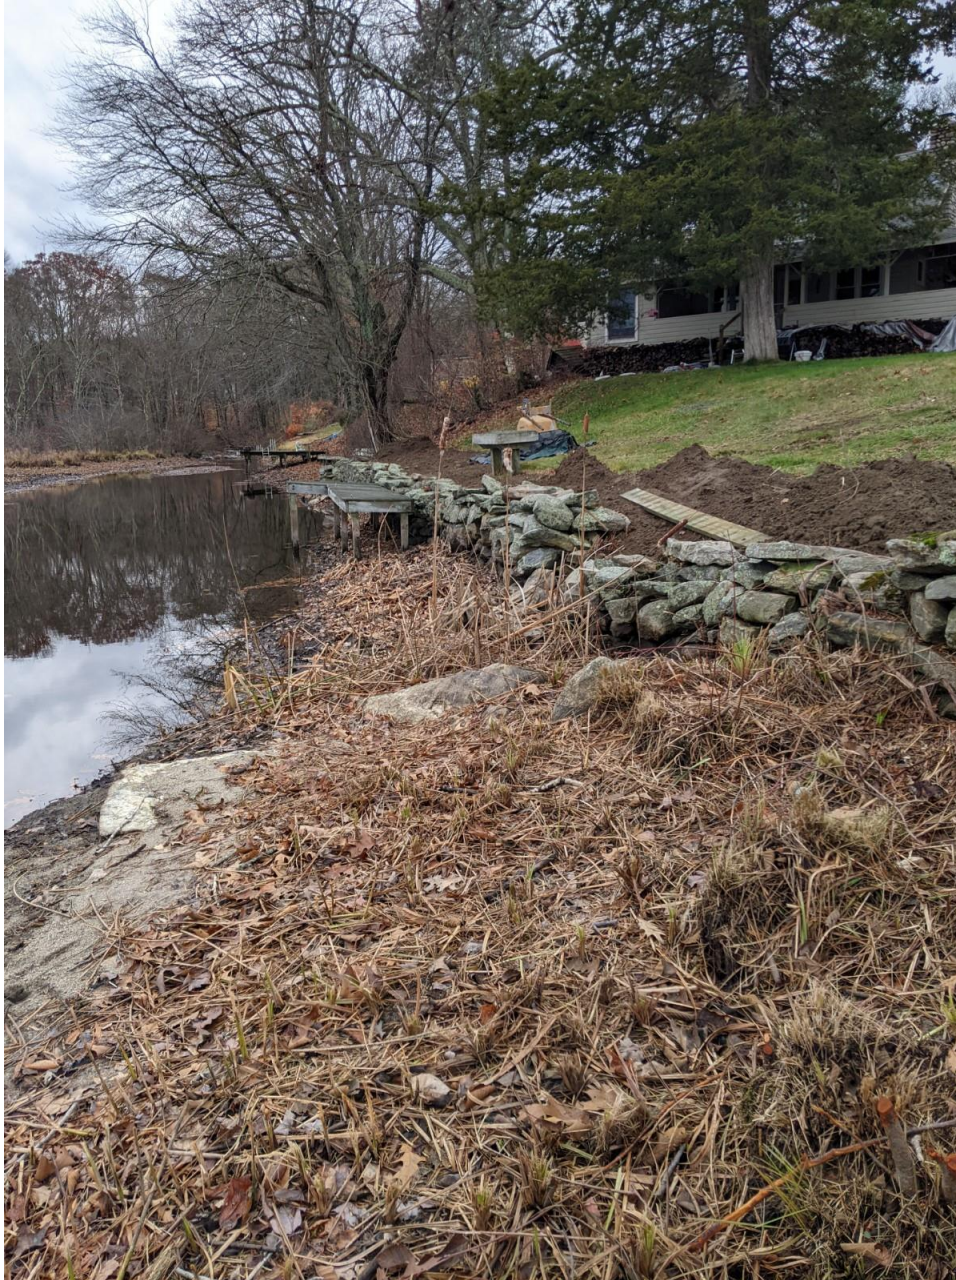
*6- View of wall from the shoreline at the north end of property.*

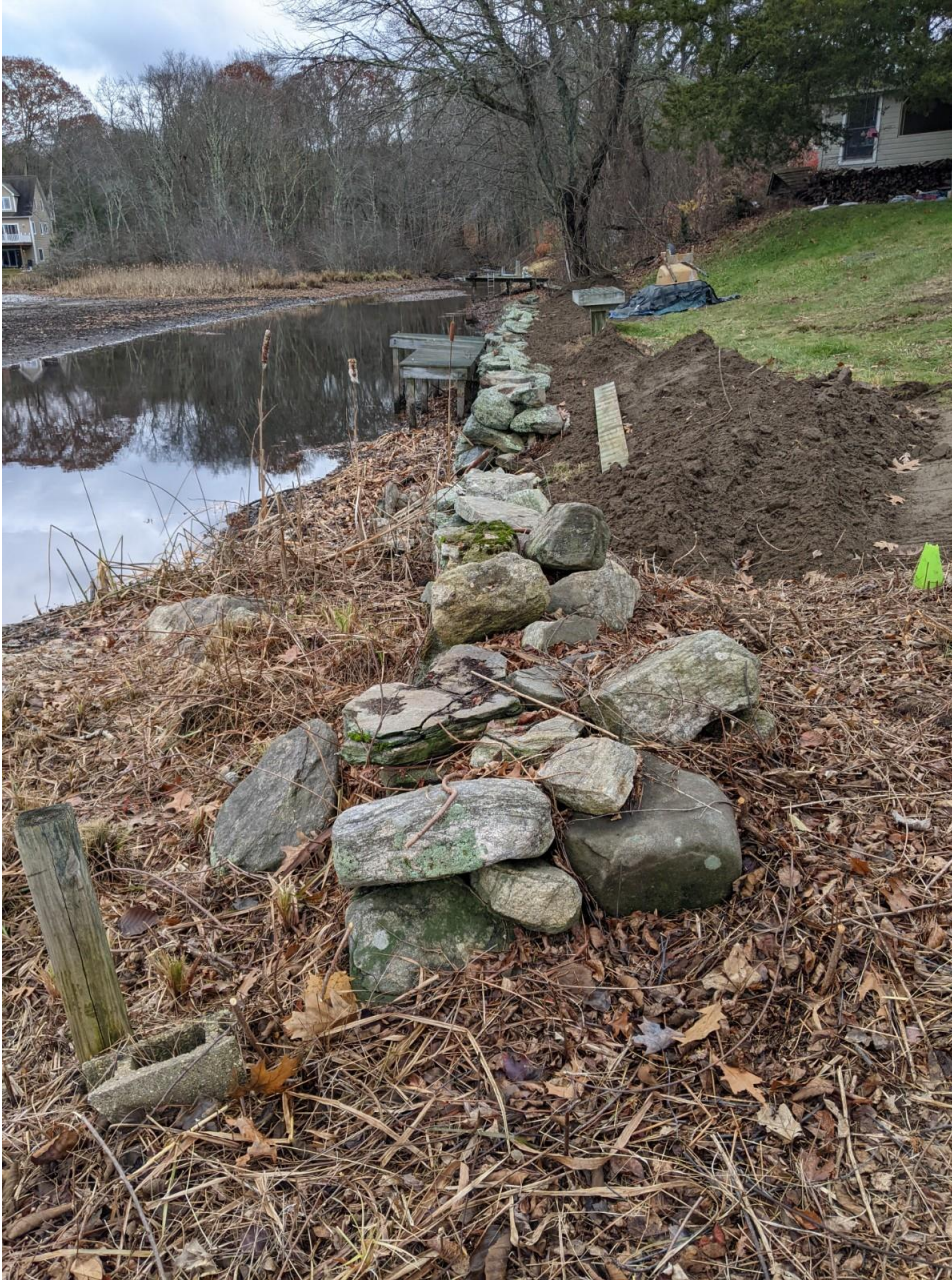
7- Looking along wall from the north end of the property. The crumbled wall in the foreground is proposed to be restacked.

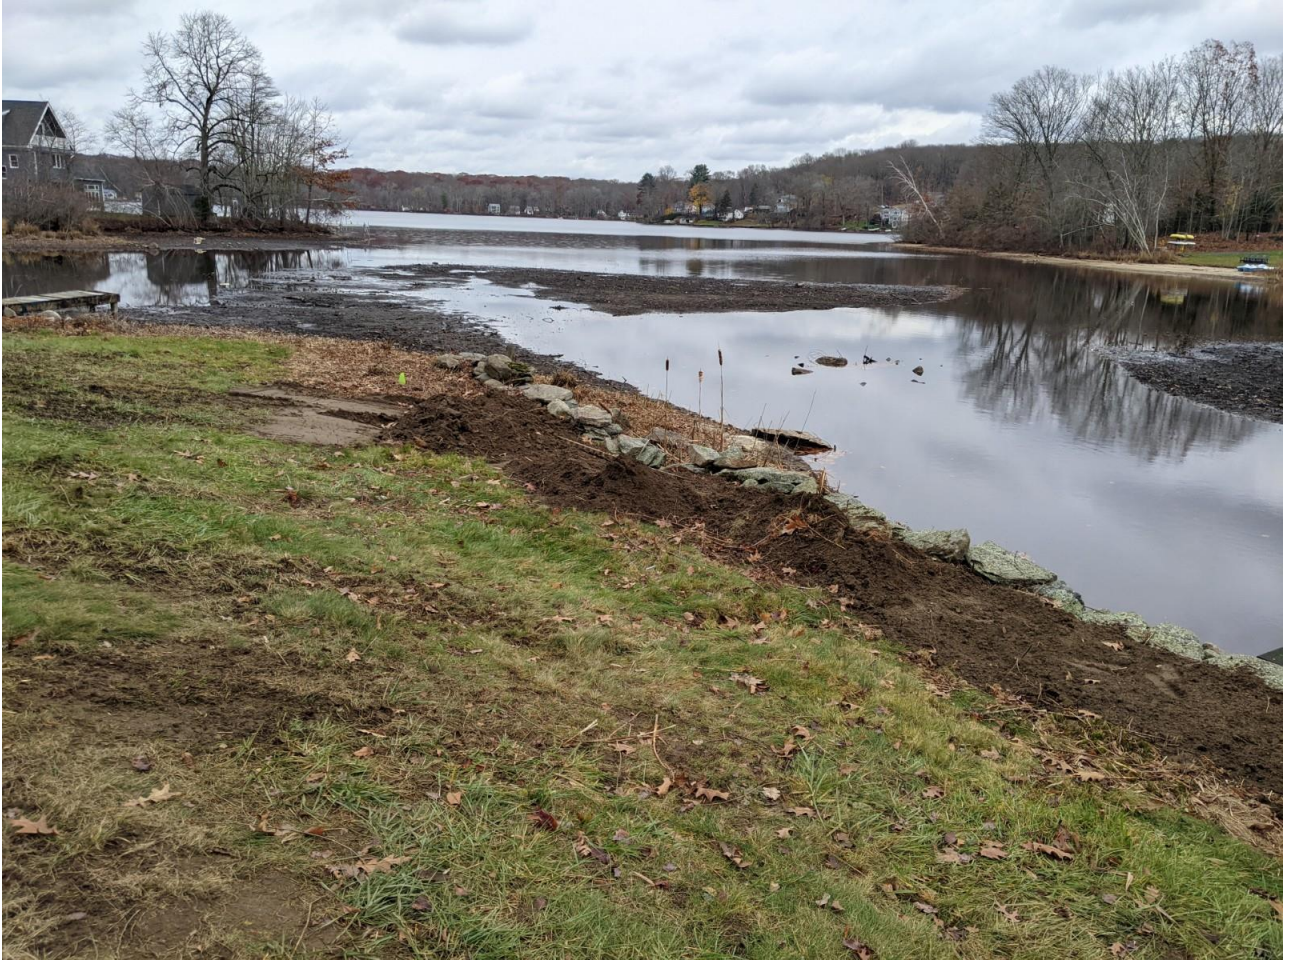
*8- View of wall, looking northeast from lawn of 1 Lakeside Dr.*
