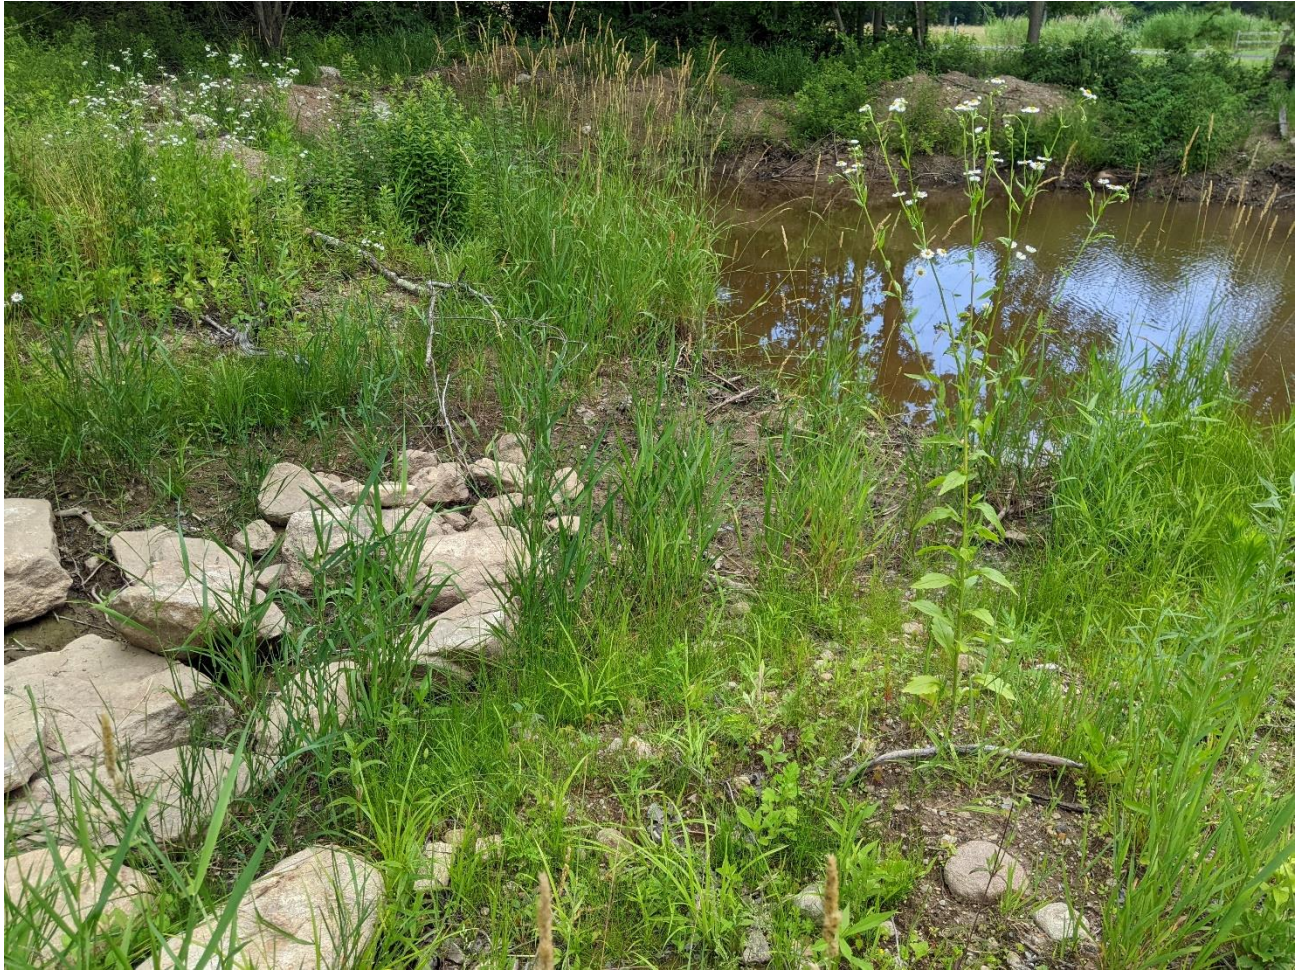
*1 View of pond outlet in foreground. Pond inlet is in background, obscured by vegetation. Driveway of Hurst Farm is visible in upper right of photo.*

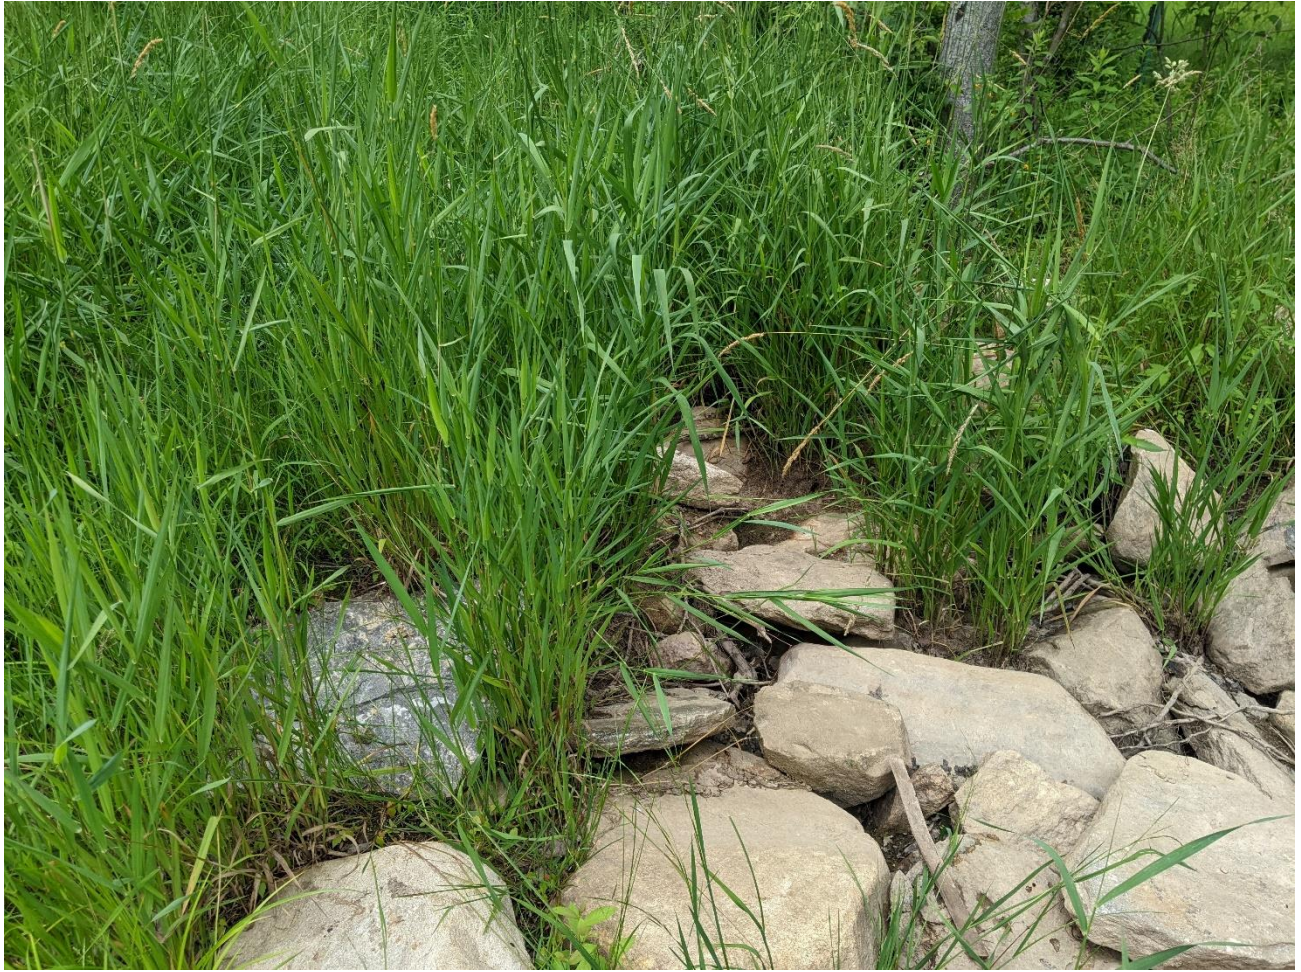
*2- View of existing stream channel near pond outlet. Channel is heavily silted and is obstructed by vegetation.*

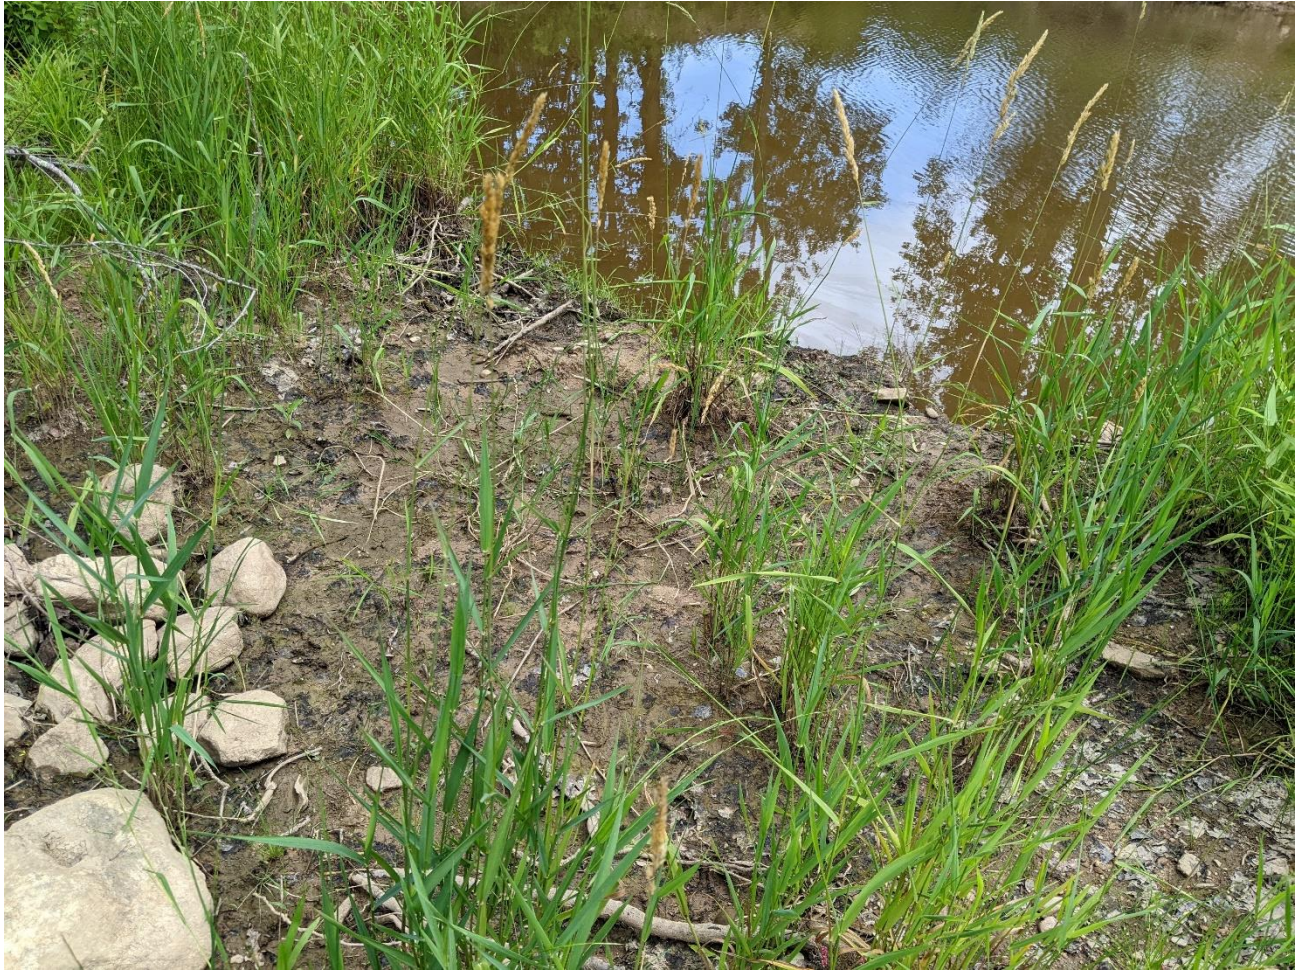
*3- View of area near pond outlet, on northern side of pond near 768 East St.*

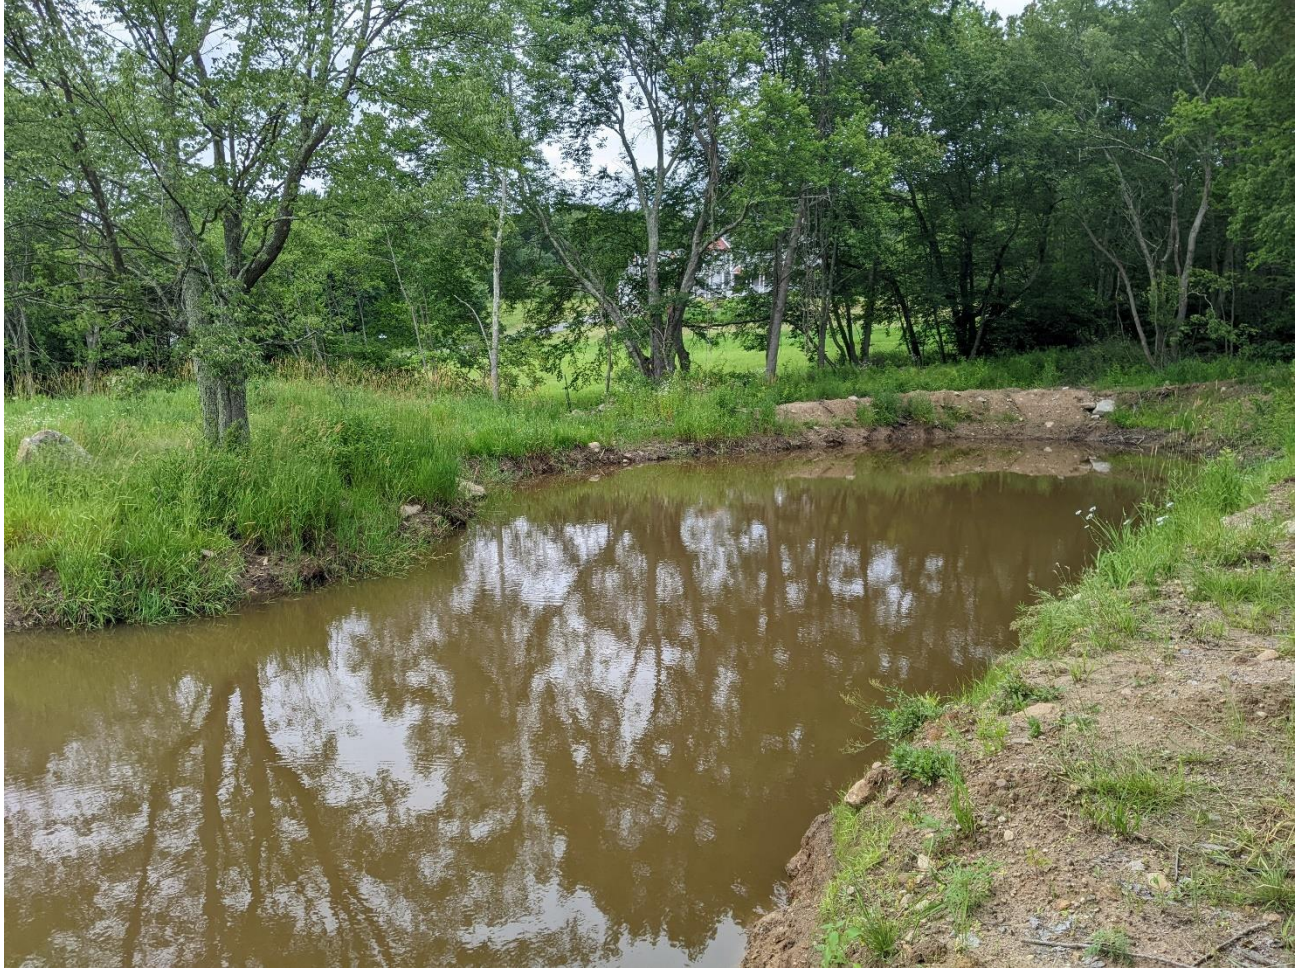
*4- View of pond, looking north toward 768 East St. Hurst Farm driveway is to the right. Pond inlet is near the center right of the photo (not visible), and pond outlet is to the center left, behind the tree.*

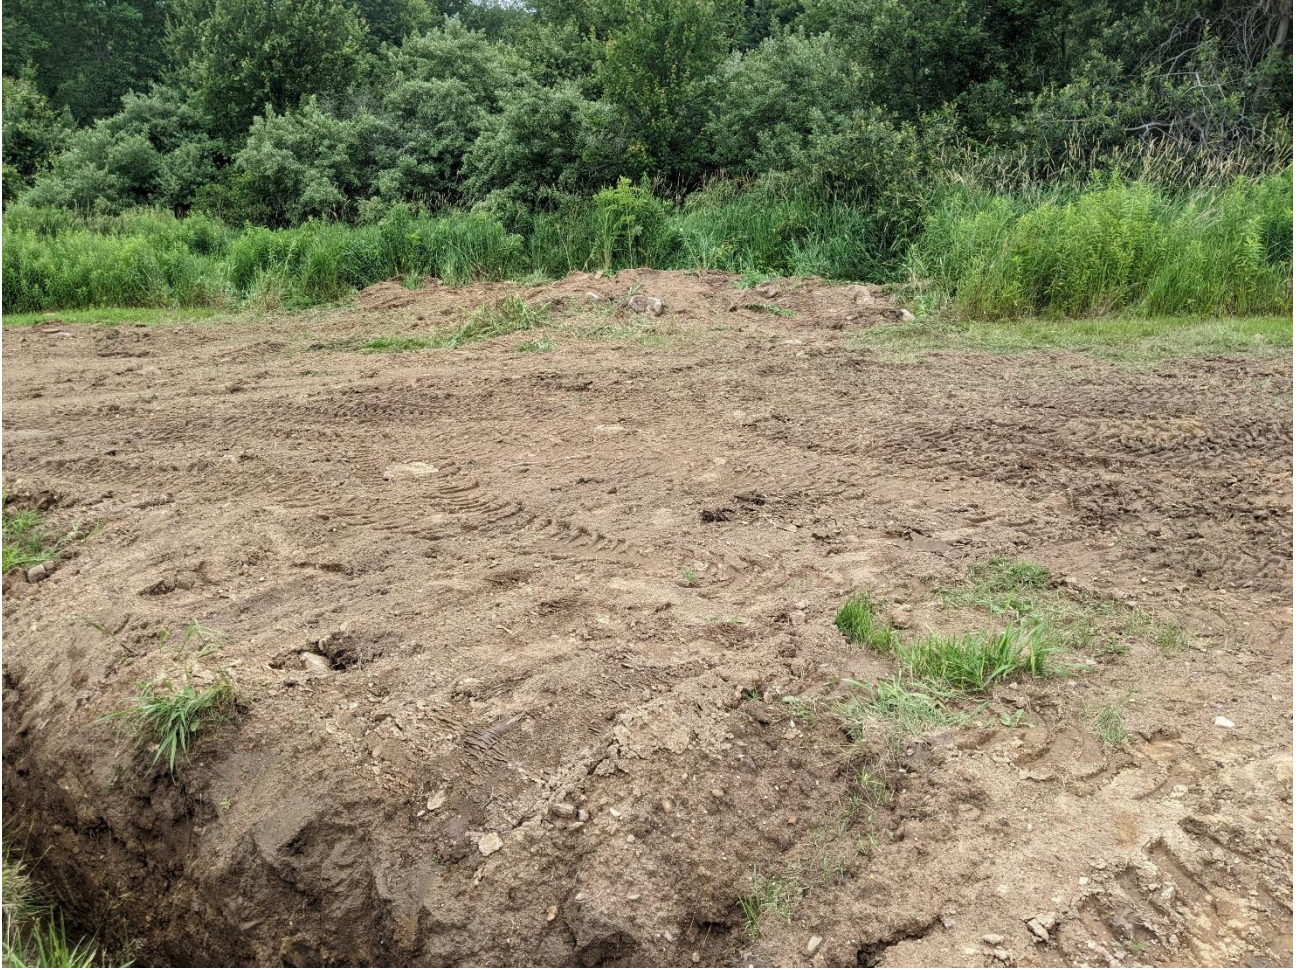
*5- View of graded area near lower portion of stream. I am standing near excavated area, looking northeast toward 768 East St.*

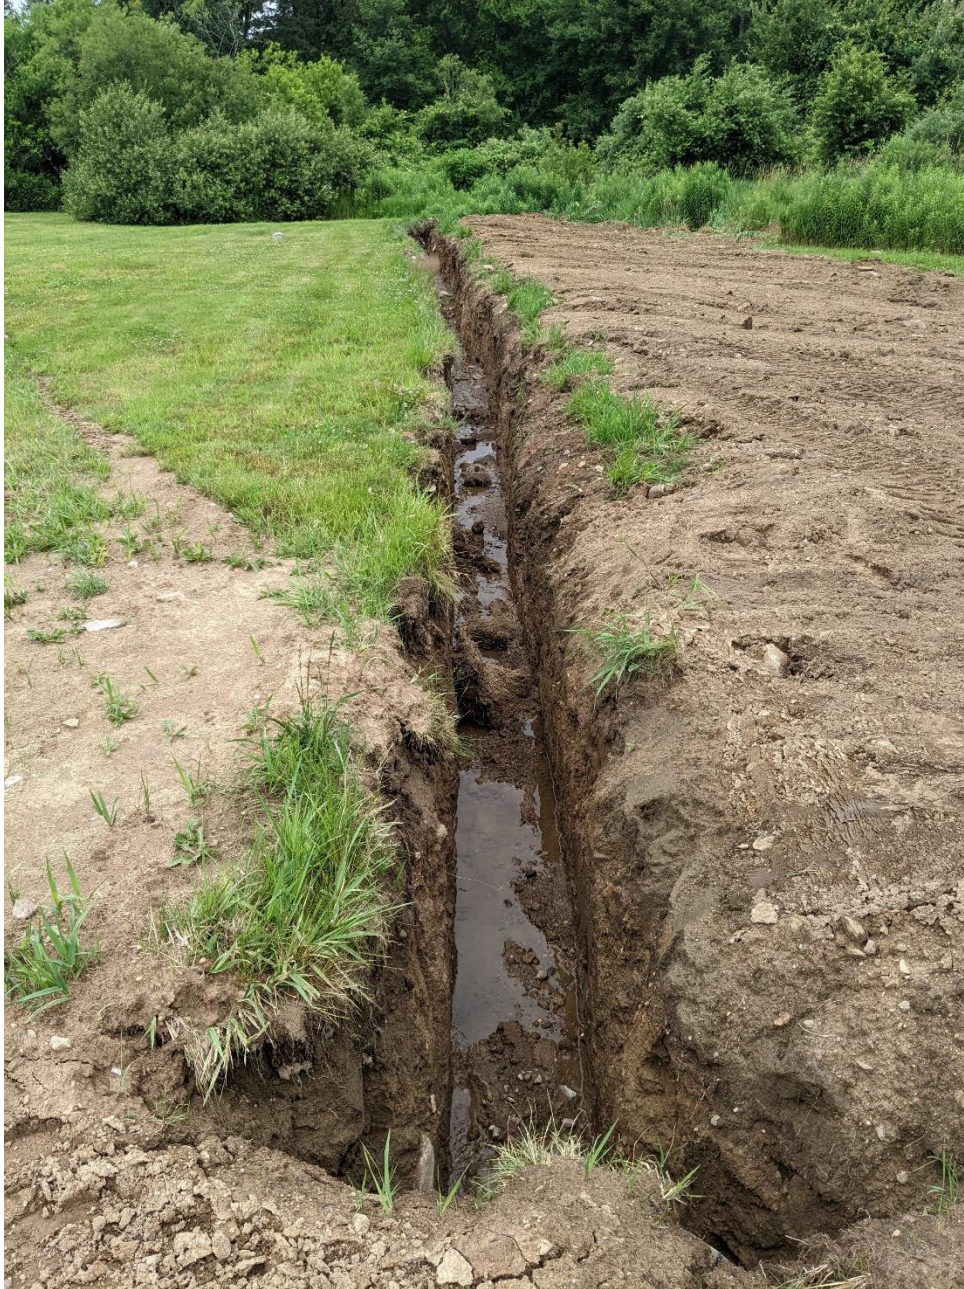
*6- View of excavated diversion created by homeowner looking northwest toward 780 East St.. This section flows into the existing intermittent stream which crosses the 768 East St. driveway. This area will be filled and restored according to the plan submitted to the commission.*

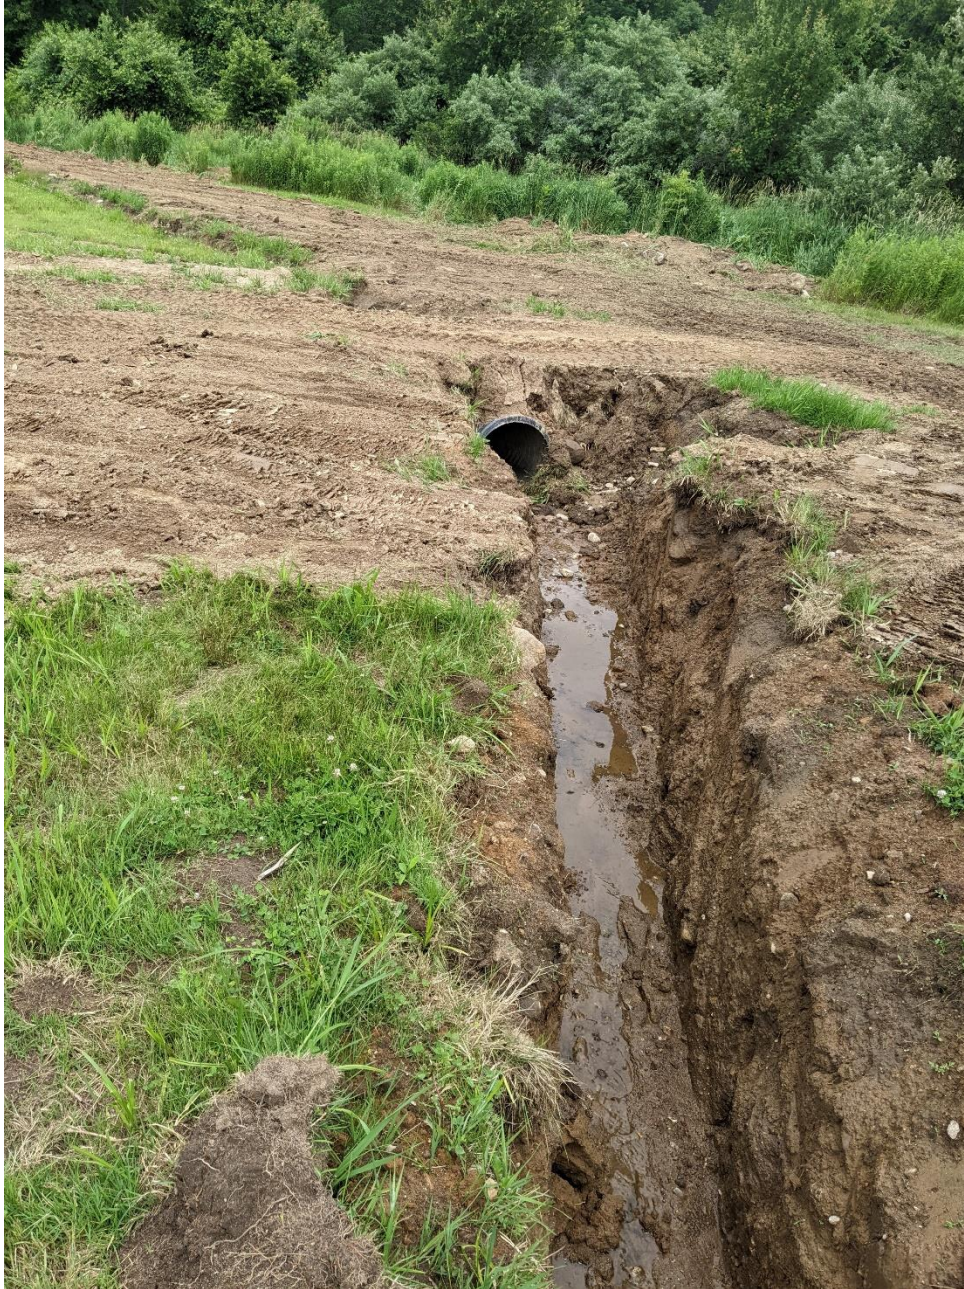
*7- View of excavated diversion created by homeowner, looking northwest toward 780 East St. The area in the foreground will remain but will be sloped and graded, with rocks placed in the new streambed to prevent erosion and slow water velocity. The proposed stream will connect this section to the existing stream near the culvert crossing in the photo. This culvert will be relocated upstream closer to the pond, and the remaining area downstream of the culvert will be filled and restored.*

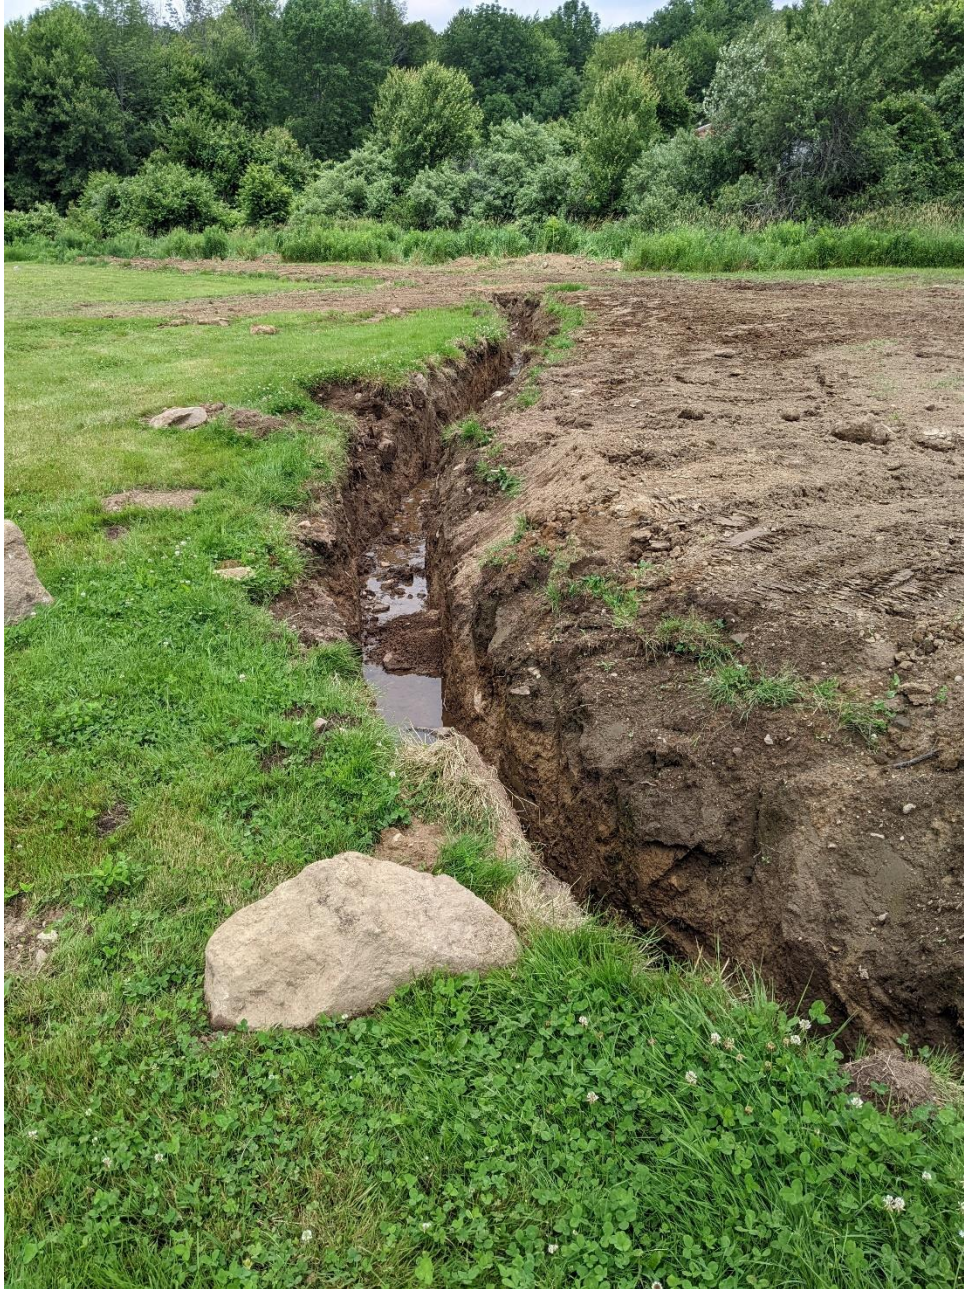
*8- View of diversion excavated by homeowner. This section will remain, but will be sloped and stabilized to limit erosion potential. Culvert crossing in center of photo will be closer to foreground to provide access for yard and pond maintenance. Area in top left of photo will be filled and restored.*

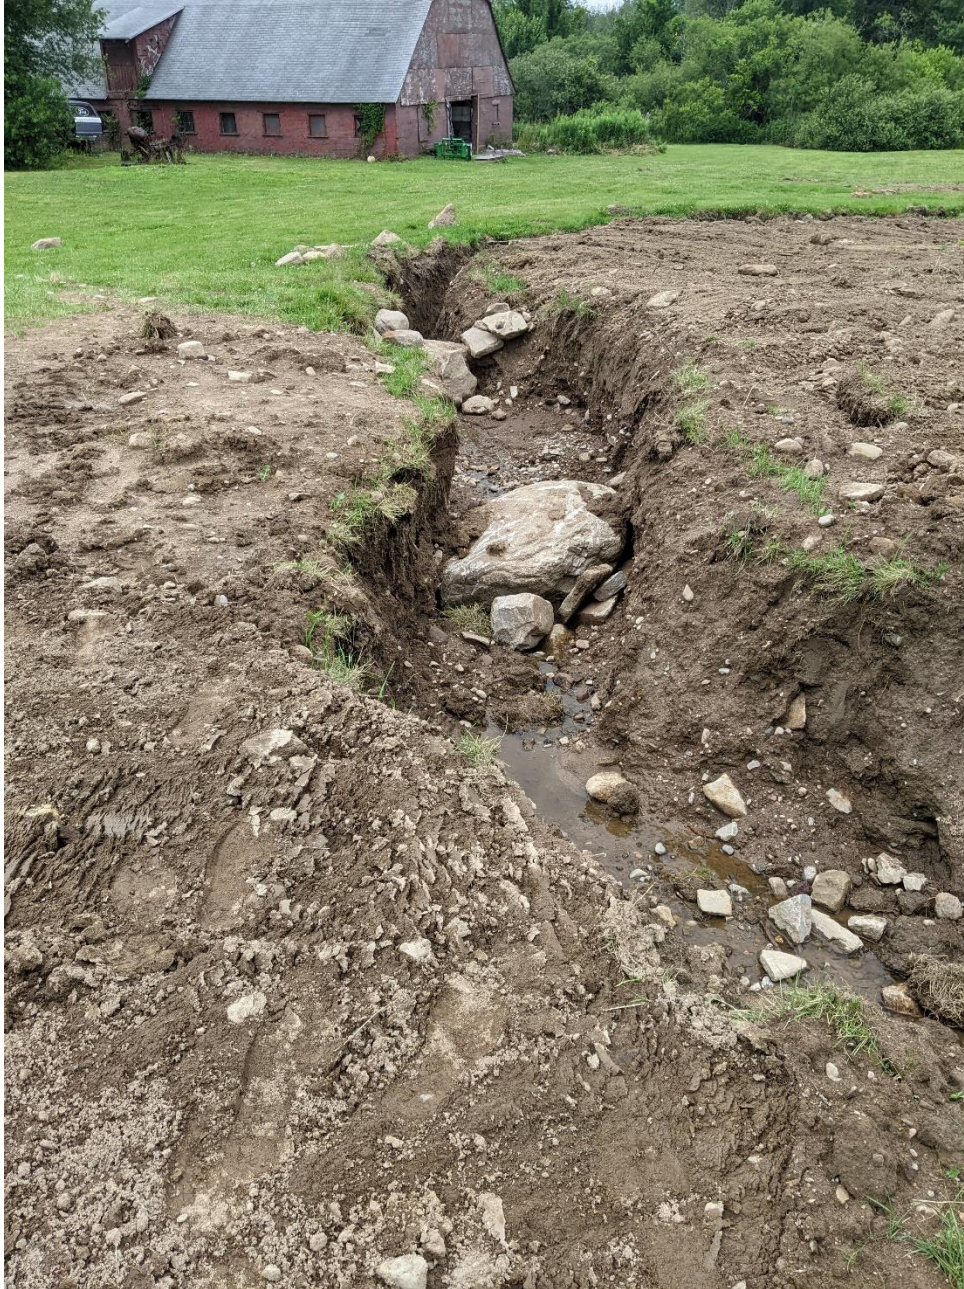
9- View of diversion excavated by homeowner. This section is proposed to remain in place, with grading and erosion control measures put in place. Proposed pond outlet near western end of pond is behind me.

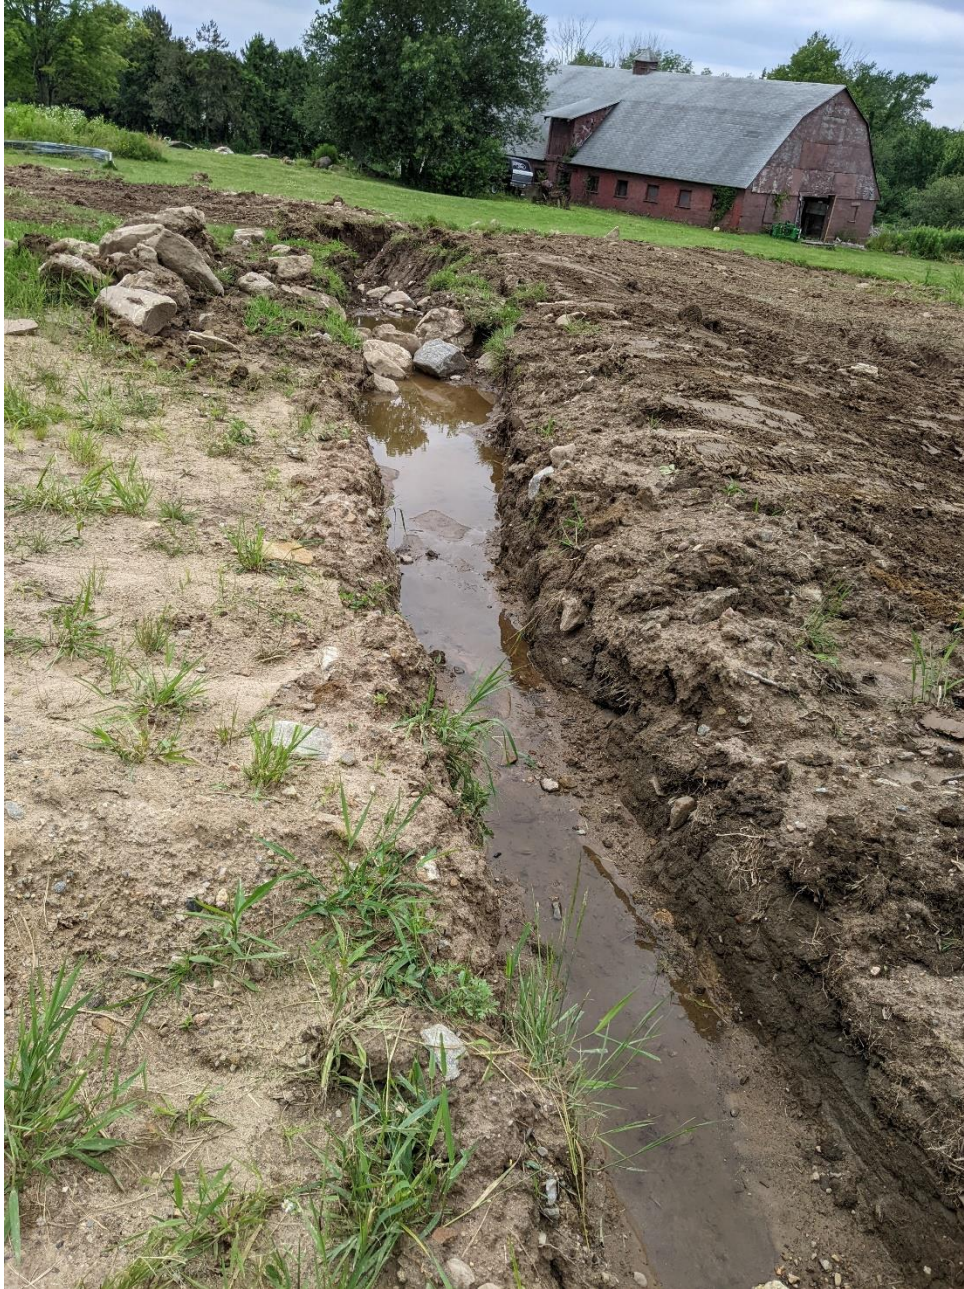
*10- View of diversion excavated by homeowner, further downstream than photo #9. This section is proposed to remain in place, with grading and erosion control measures put in place. Proposed pond outlet near western end of pond is behind me.*

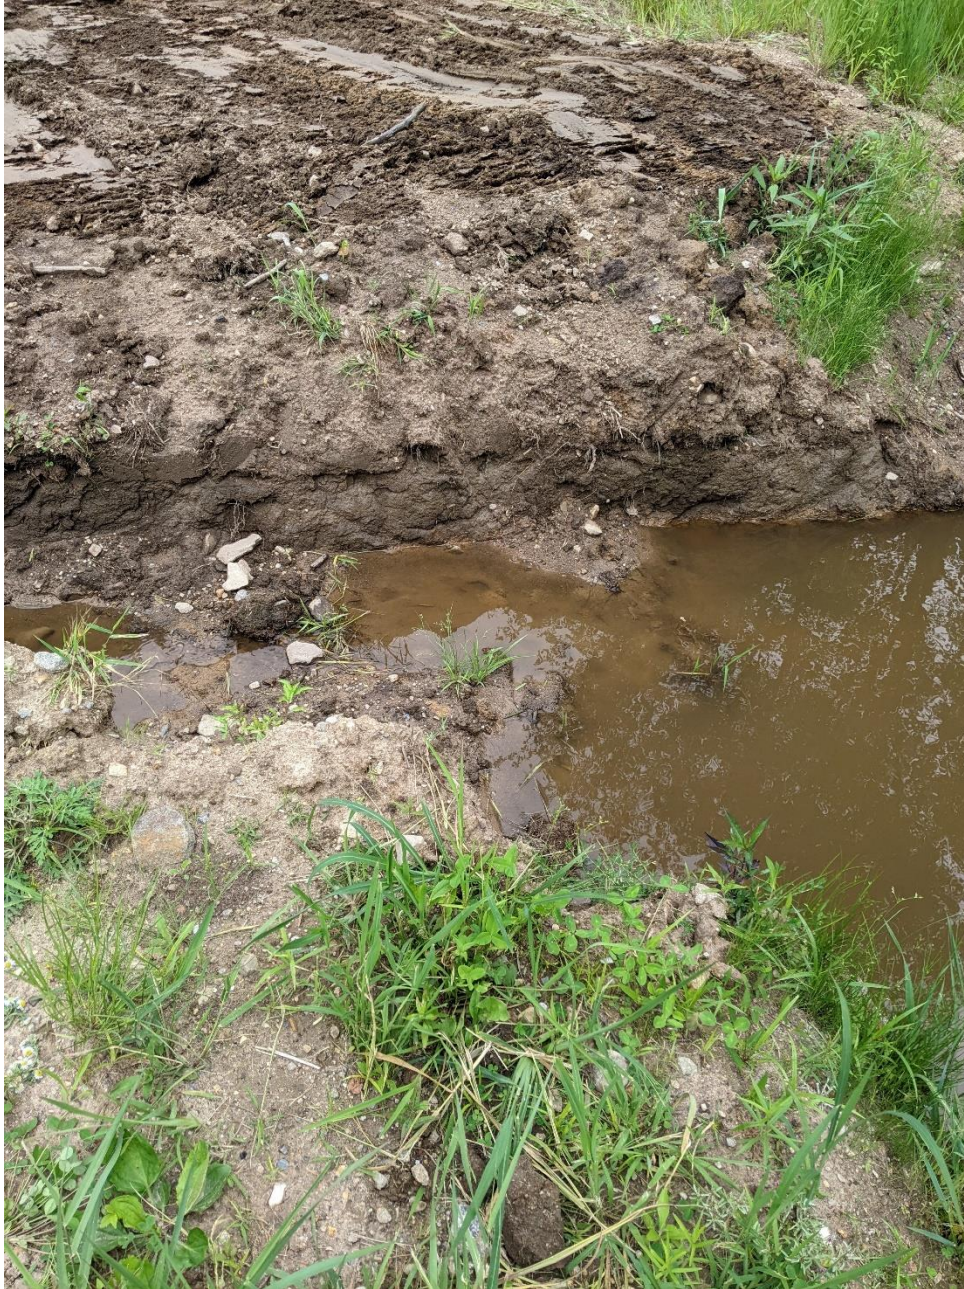
*11- View of pond outlet that was created by homeowner. This outlet is proposed to remain, but will be stabilized with rock and graded for erosion control.*

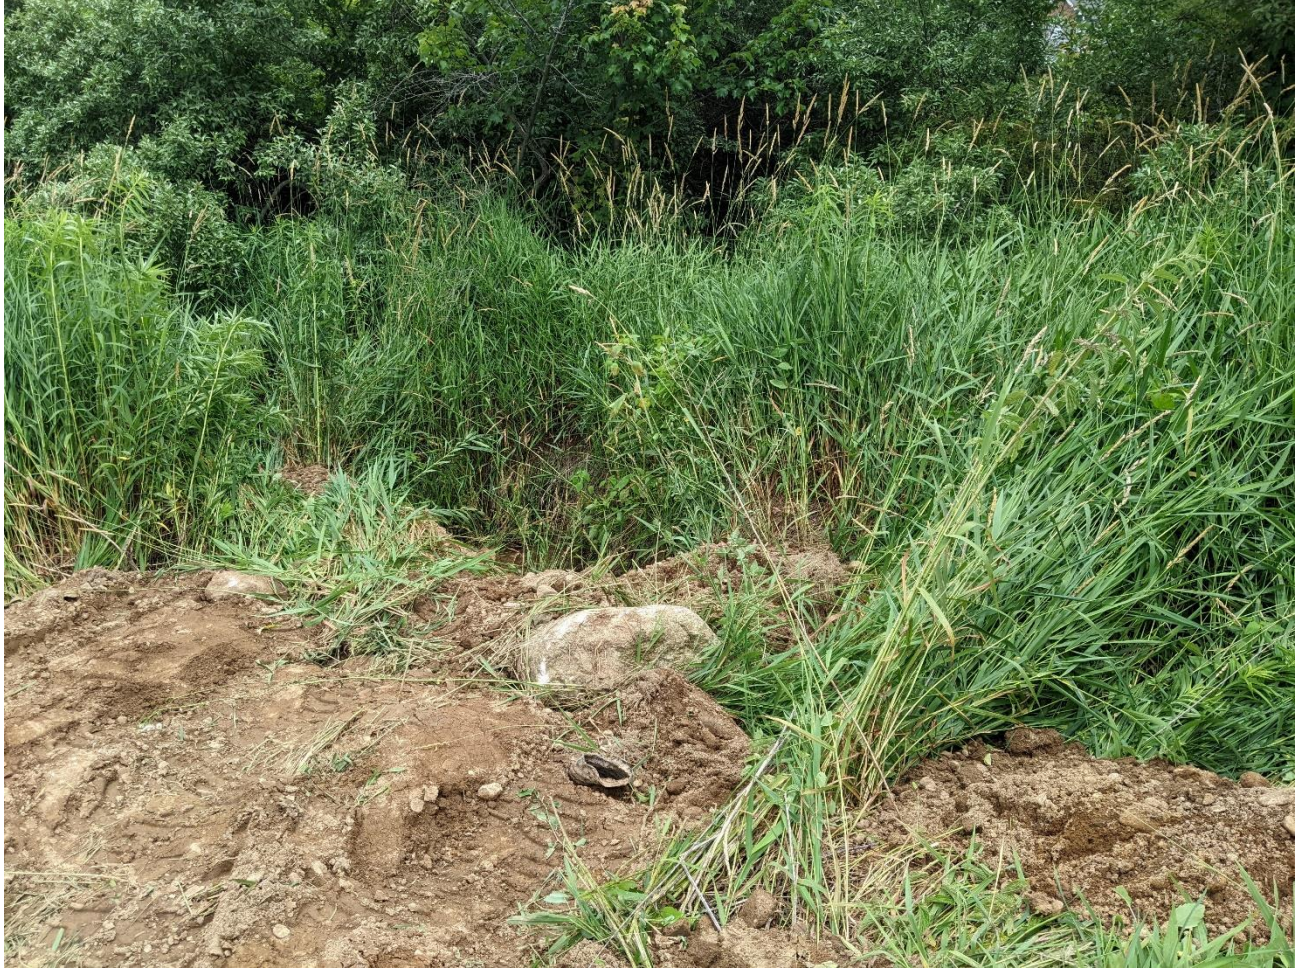
*12- View of area of existing stream channel where proposed stream will rejoin this existing channel. Seasonal vegetation will be removed so existing channel can be cleaned and maintained, and native trees will be planted in area to provide shade and to limit growth of invasives and primary vegetation which will limit flow through the stream..*

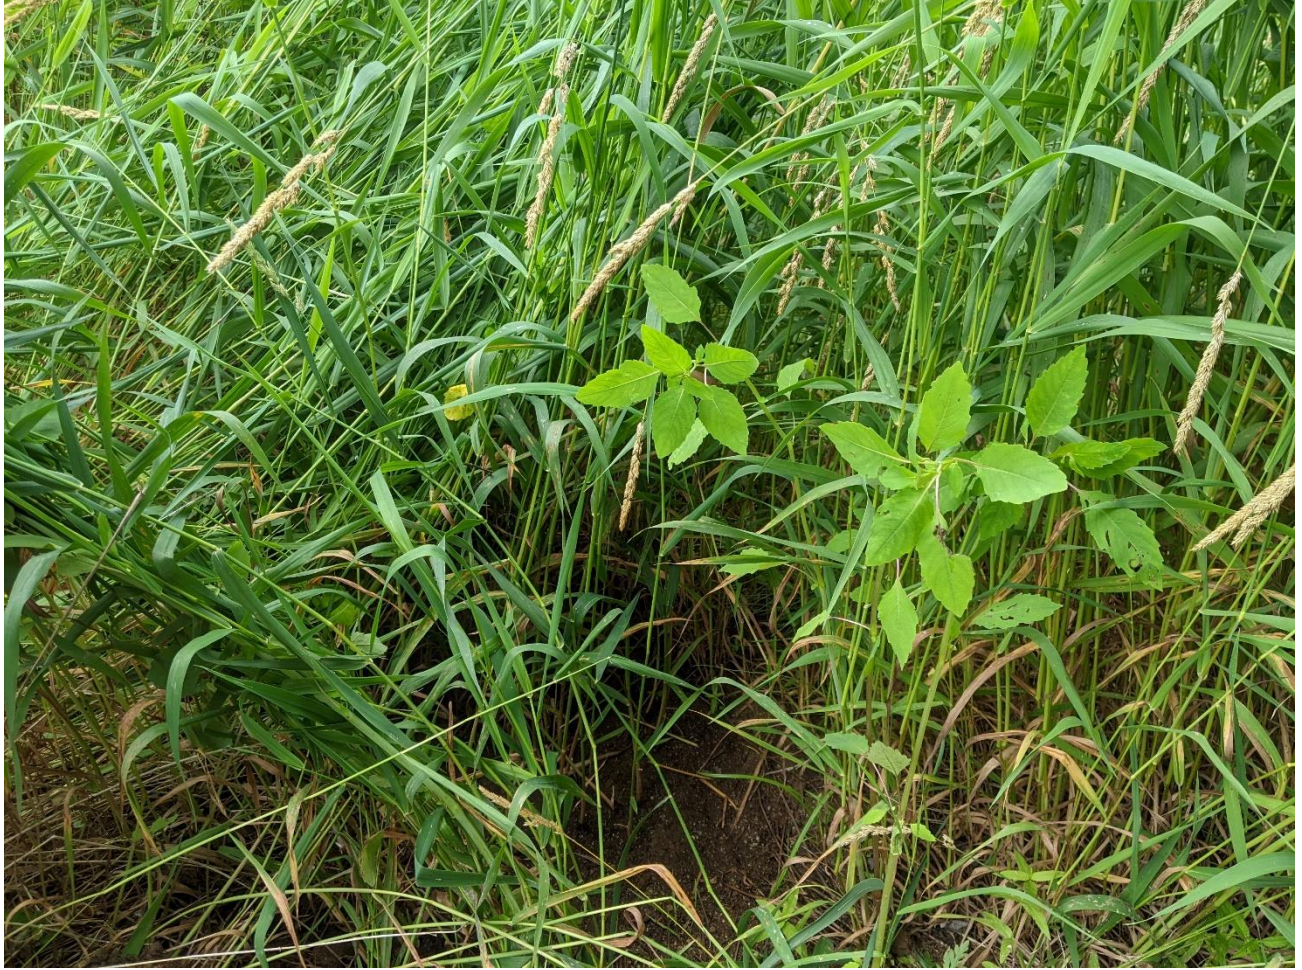
*13- View of existing stream channel that is overgrown with vegetation and is filled with sediment.*

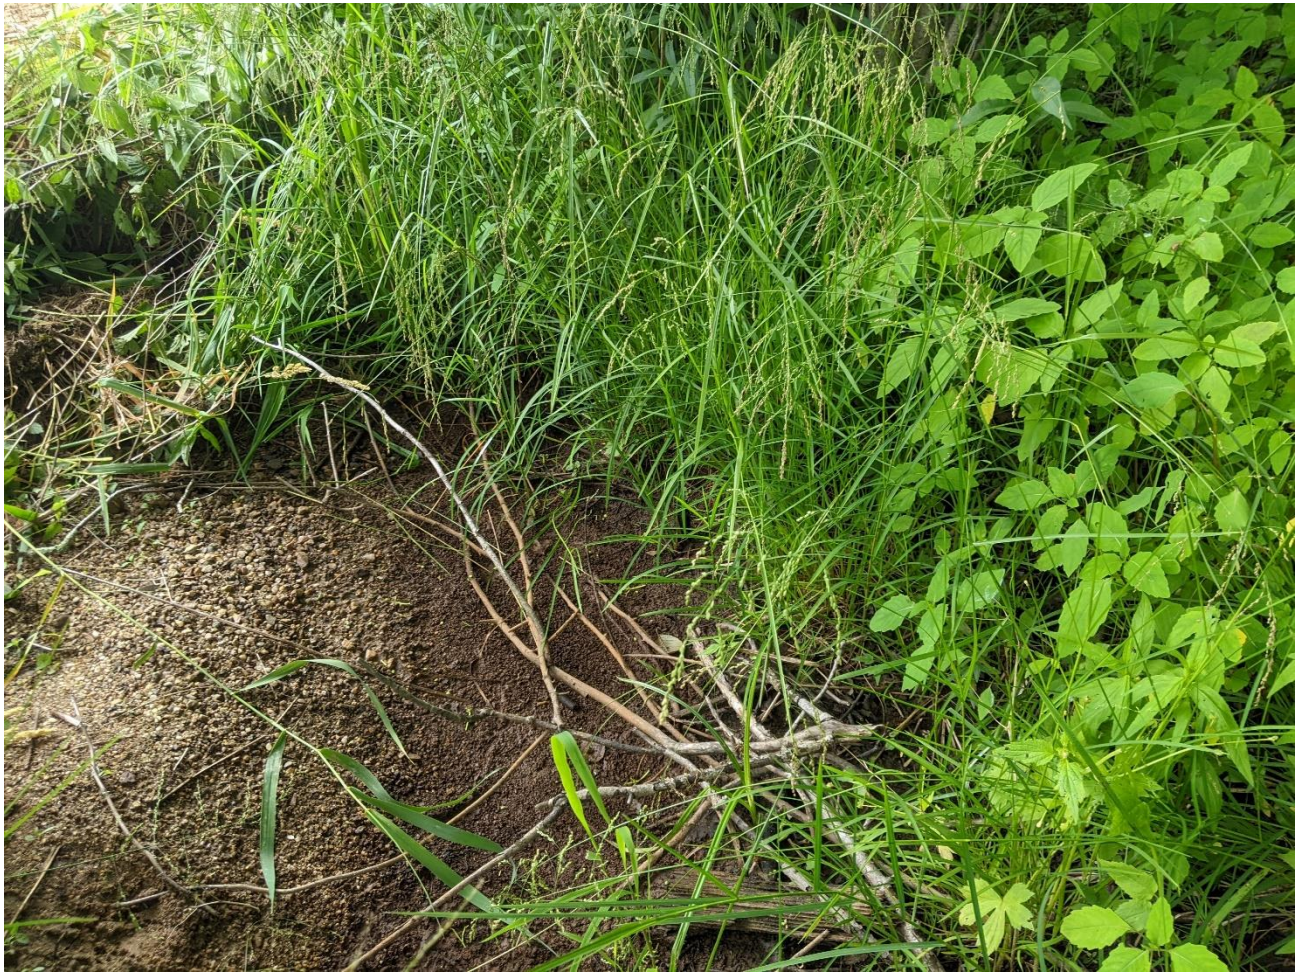
14- View of sediment in existing stream channel.

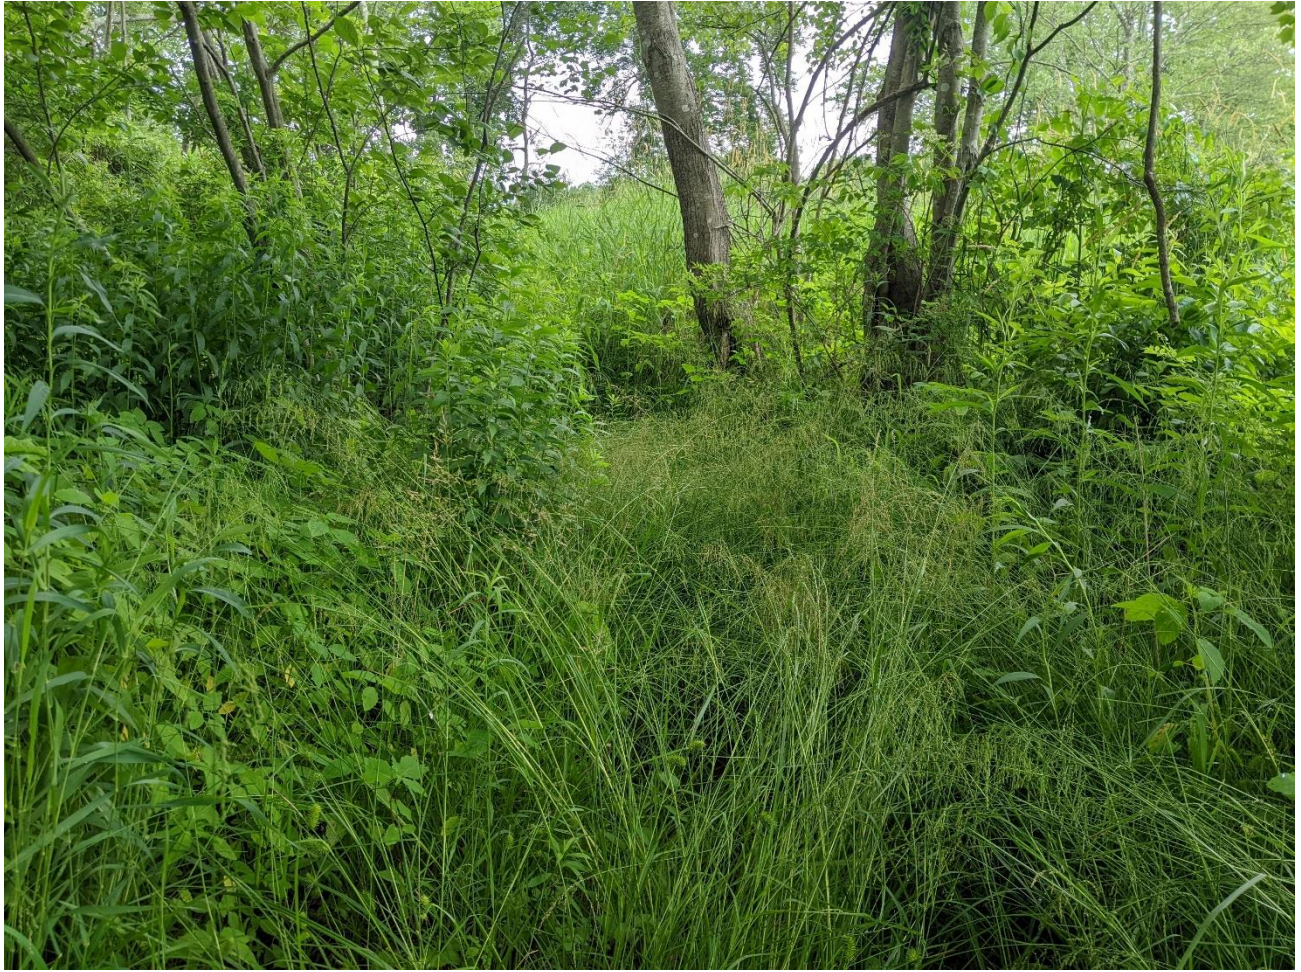
*15- View of existing stream channel, looking upstream and southeast toward pond outlet.*

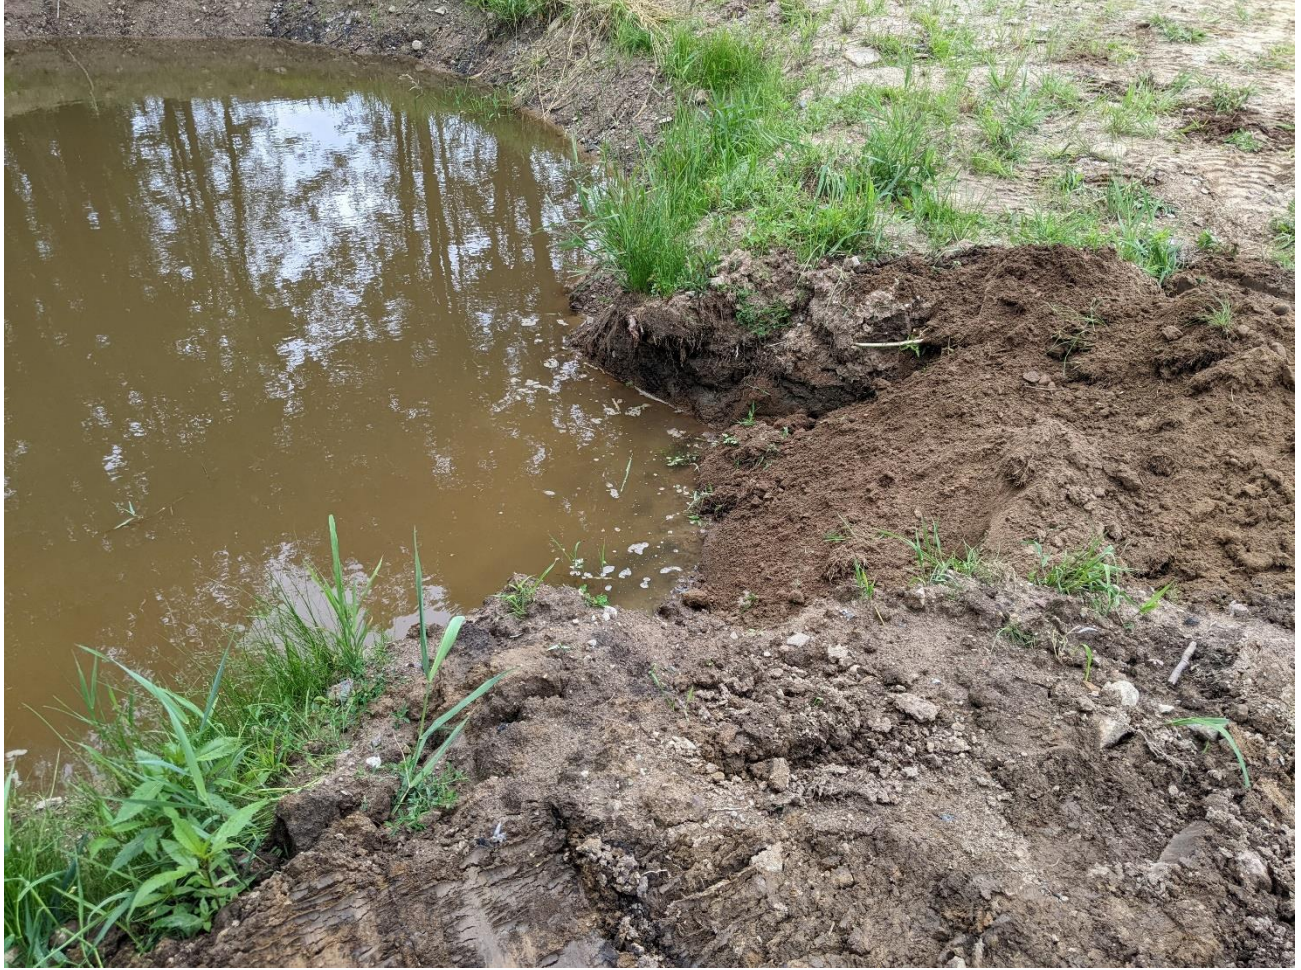
*16- View of new pond outlet created by owner. This was taken during placement of of rocks and fill to create a dam and to redirect the water into the existing stream until a permit application can be reviewed by the commission.*

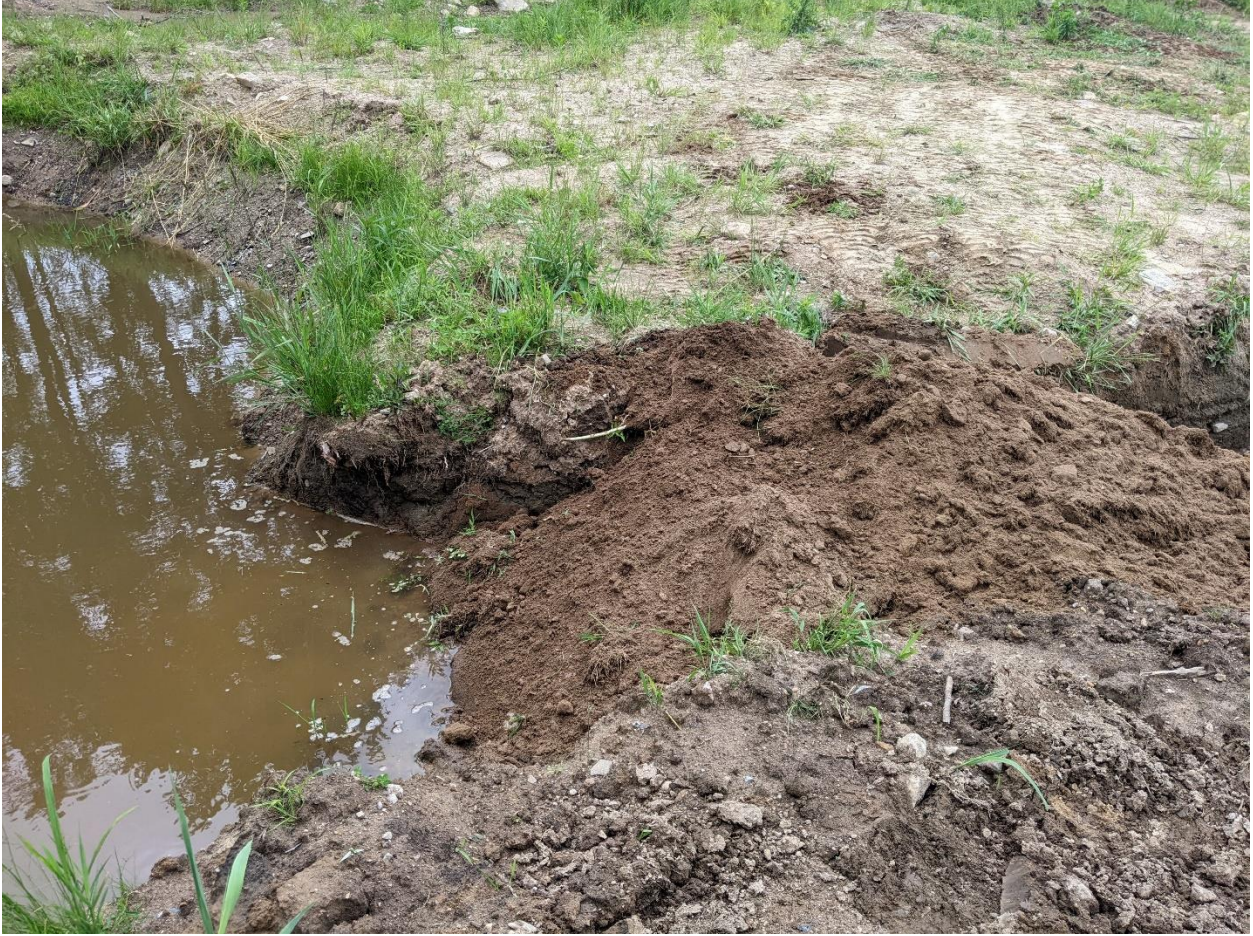
*17- Another photo of dam created in the southwestern outlet of the pond (created by homeowner). This dam will remain in place until downstream part of proposed stream is constructed and stabilized.*
