Andover Town Buildings and Properties 2020-21 CIP Report

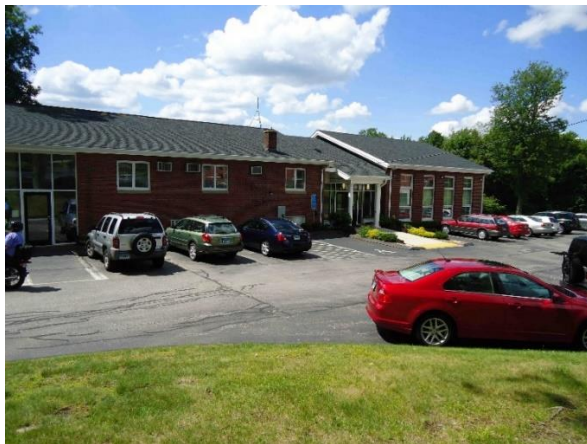
2. Andover Town Hall at 17 School Road

- Bike Rack installed at main entrance in the summer of 2019.
- Gutter on front entrance needs to be reset, as it was installed out of level and functions poorly.

- After extended power outage from Storm in August of 2020, electrical work will need to be done to the Town Hall based on deficiency's found:
 - Main Service panel #2 is an old Stabloc, panel needs replacement. Server Room Plugs need to be on the back-up system. Administrator/s office Lighting needs to be backed up. Multiple plugs for AC units need work. We still need to try to address whole building backup including the Community Room.

Current Condition = 6

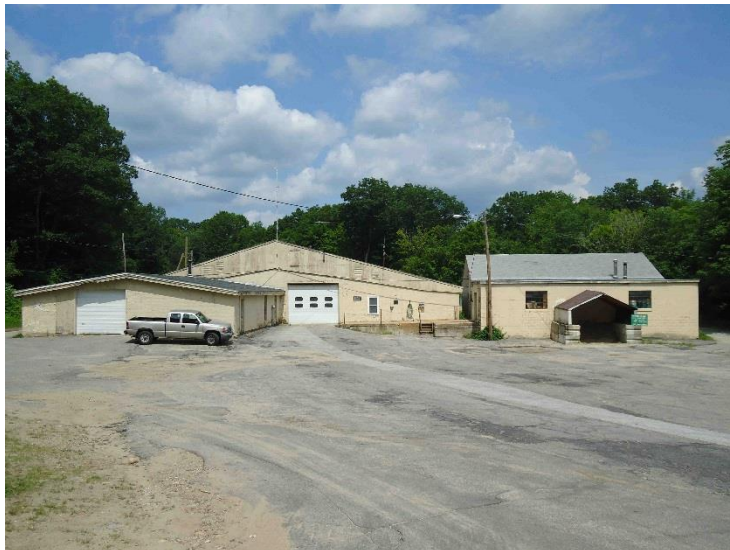
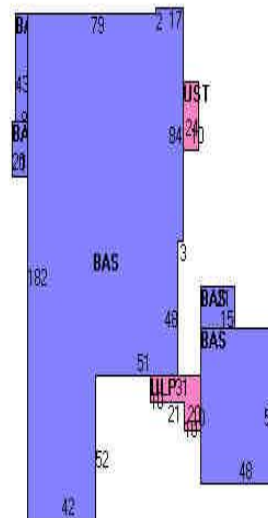
5. Andover Public Works Building at 12 Long Hill Road

- Cold Storage Building will still need the roof replaced/ part EPDM and part shingled in poor condition. CMU block of cold storage building needs repointing also.
- Consideration should be made for a Stand alone Steel Building to house the vehicles for the Andover Seniors if they get displaced from the current location. Building will need power connection to plug in vehicles during winter months.
- The paving in the driveway is in very poor condition, and should be repaved.

Current Condition = 5

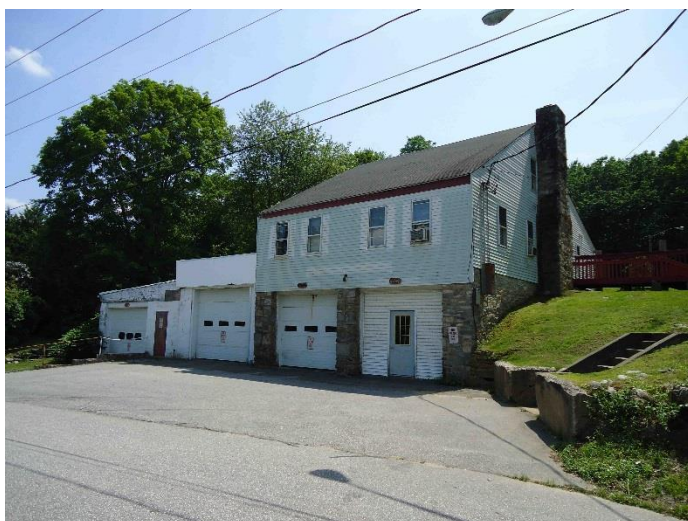
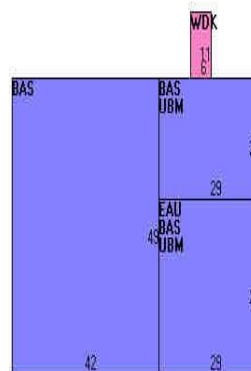
6. Andover Senior Center/Old Fire Station at 15 Center Street

- Building has reached the end of its life expectancy. Multiple roof leaks on the lower flat roofs. There is extensive mold in the basement and many people complain of respiratory distress using the upper meeting area. The building has a pest problem with both mice and bats. The basement is used for parking vehicles, but the Gypsum fire barrier between the garage and living area is not intact- this is a fire code violation

Current Condition = 1

- Costs to renovate, and perform mold remediation exceed the true value of the structure. At a minimum bringing it up to reasonable function would require:

- mold remediation,
 - foundation excavation and damp proofing,
 - add proper footing drains,
 - Install up-grade curtain drain.
 - All drains led to the stormwater system- requires a cut across Center Street

- Replacement of gutter and downspouts and tied into drain system
 - Replacement of the Flat EPDM roof
 - Replace the insulation between basement and first floor

- Reinstall Drywall on basement ceiling (firecode) use paperless drywall
 - Add Supplemental dehumidification to basement
- The functions of the current building should be transferred to other town buildings and the costs for demolition included in 2021 CIP budget.

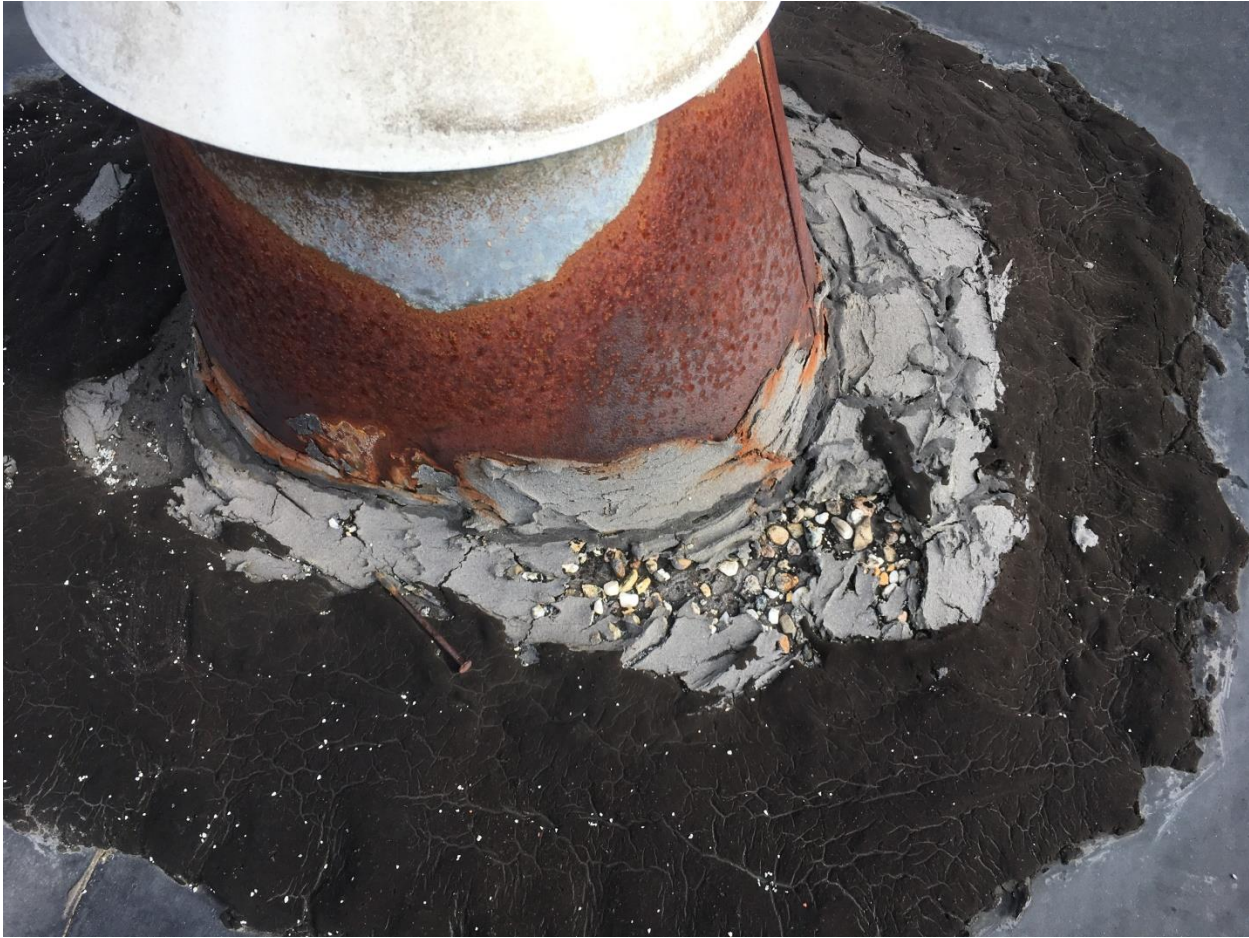
Flashing on EPDM (flat) roof is failing should be repaired to prevent leaks.

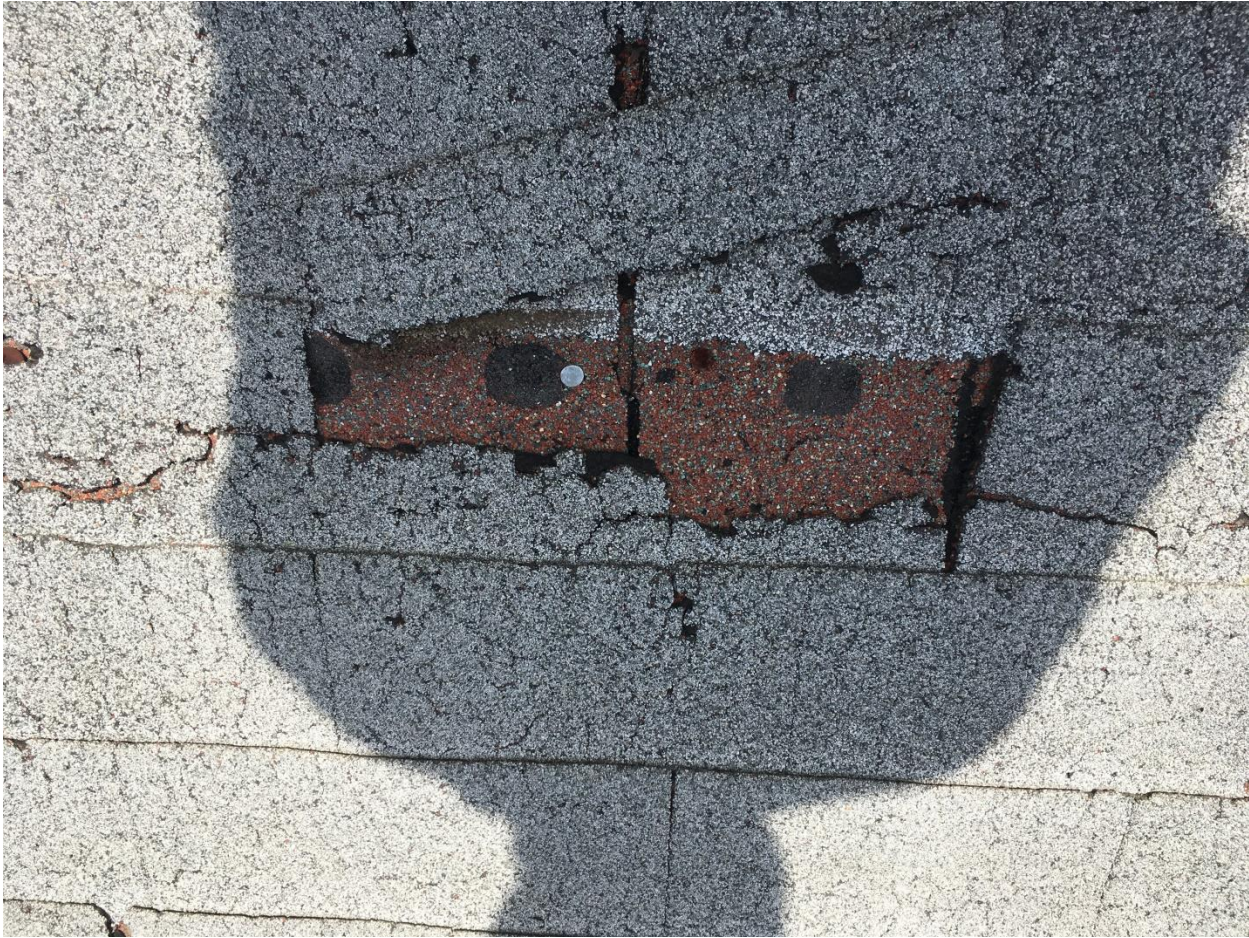
Building #2 peaked roof has 2 layers of shingles, both are failing can be patched temporarily 2-3 years

- a. Replace epdm (rubber) roof and peaked roof on building 2. Replace peaked roof with new shingles
- b. Run electrical power to building #2 from public works building
- c. Consider a Solar Array if a suitable contract can be signed Because municipalities are allowed to net meter

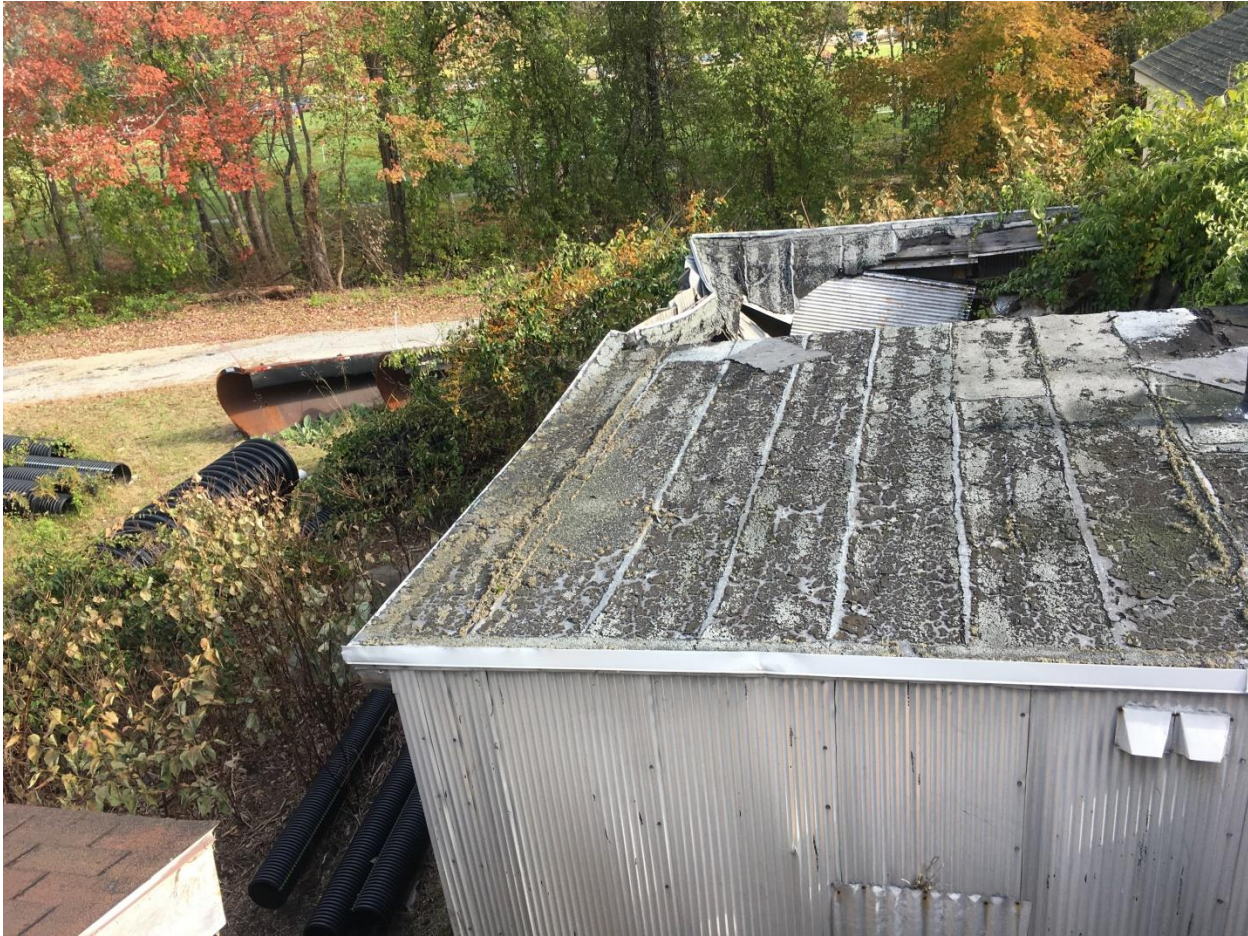
This is a flat roofed structure attached to building 2 (rear of building) Roof and part of the wall has collapsed due to water damage. This part is not salvageable and should be torn down.
