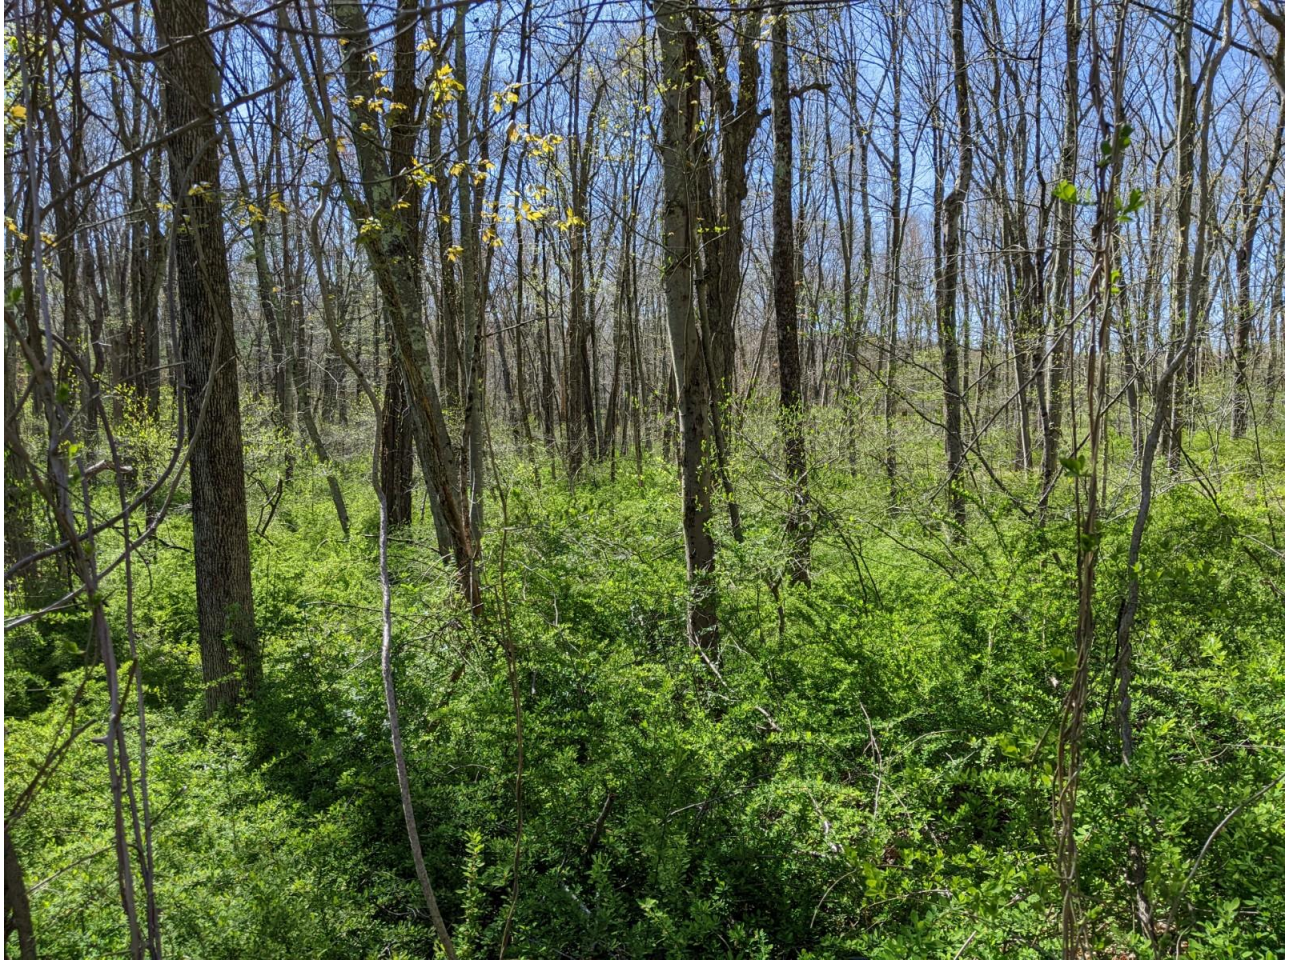
*1- View of area of proposed timber harvest that is southeast of the gas line corridor. One stream crossing will be constructed in this area, which consists of relatively low-sloped and level terrain. Stream location is difficult to see due to the invasive Barberry plants.*

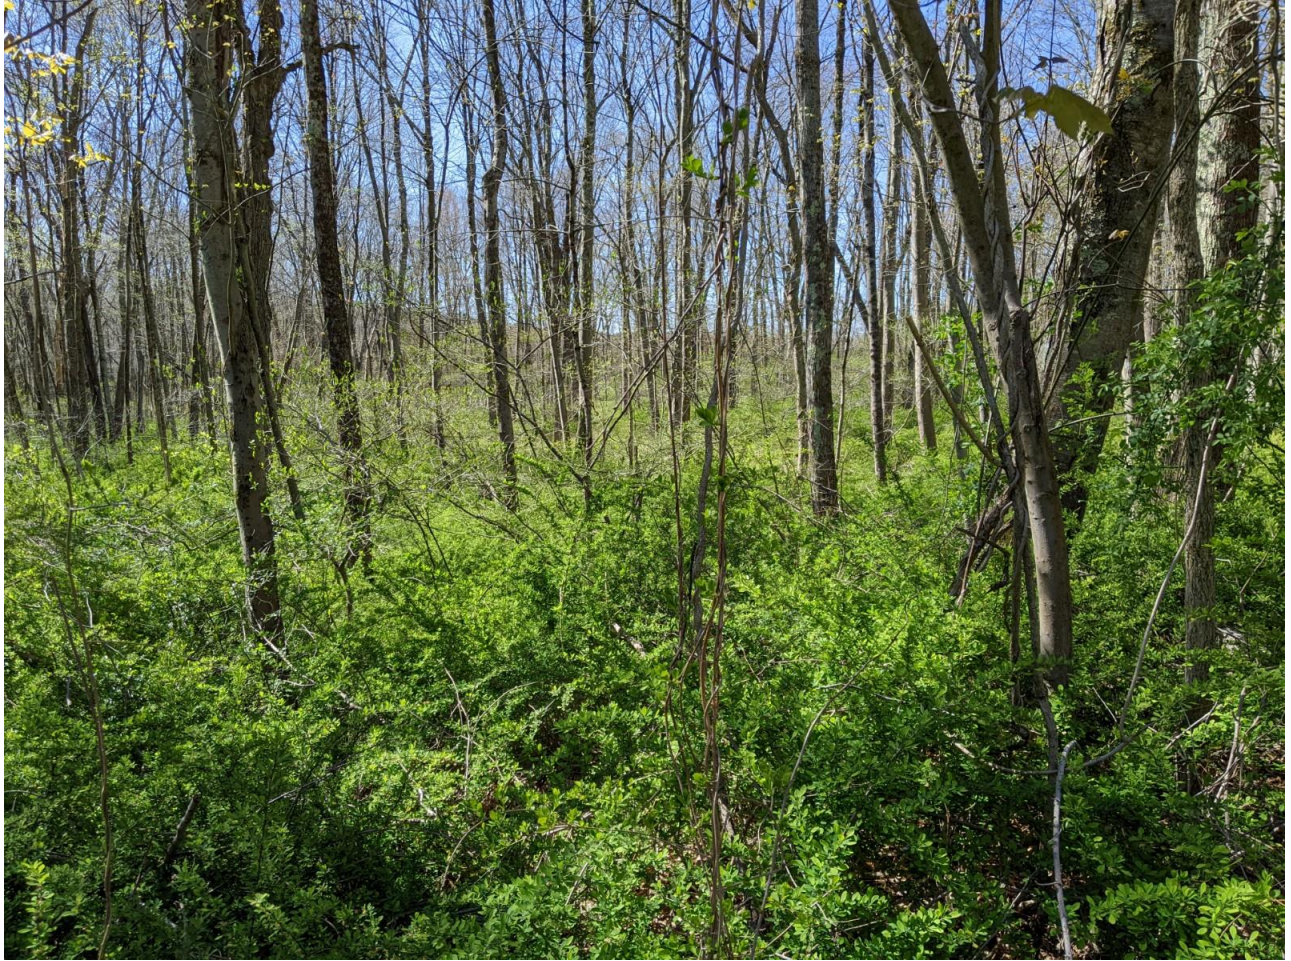
*2- Another view of area of proposed timber harvest that is southeast of the gas line corridor. One stream crossing will be constructed in this area, which is on relatively low-sloped terrain. Stream location is difficult to see due to the invasive Barberry plants.*

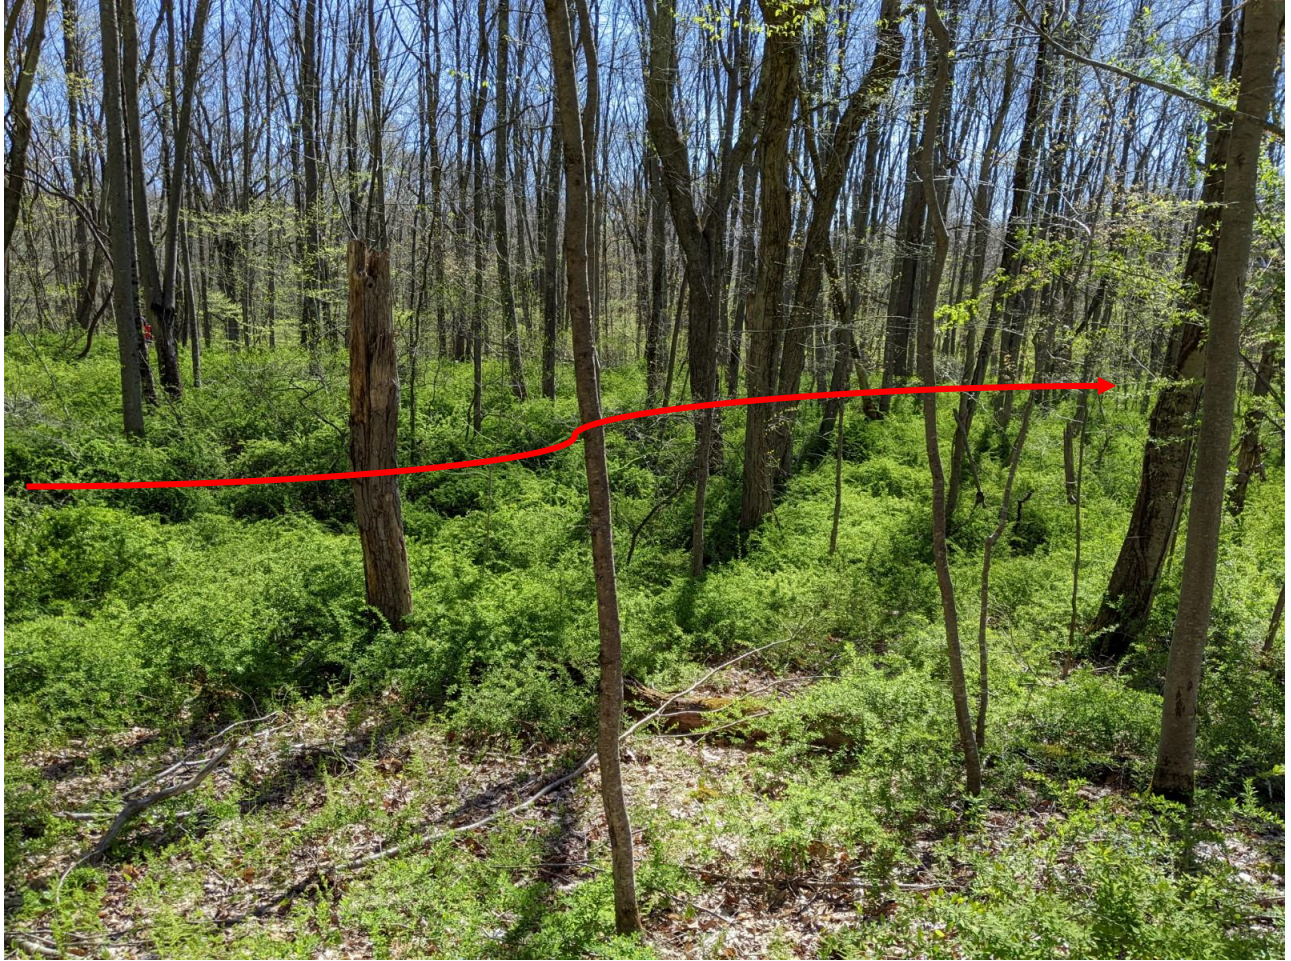
3- View of watercourse near (downstream of) the proposed northwest crossing location. The red line denotes the approximate location of the watercourse, which is difficult to see due to the invasive Barberry plants

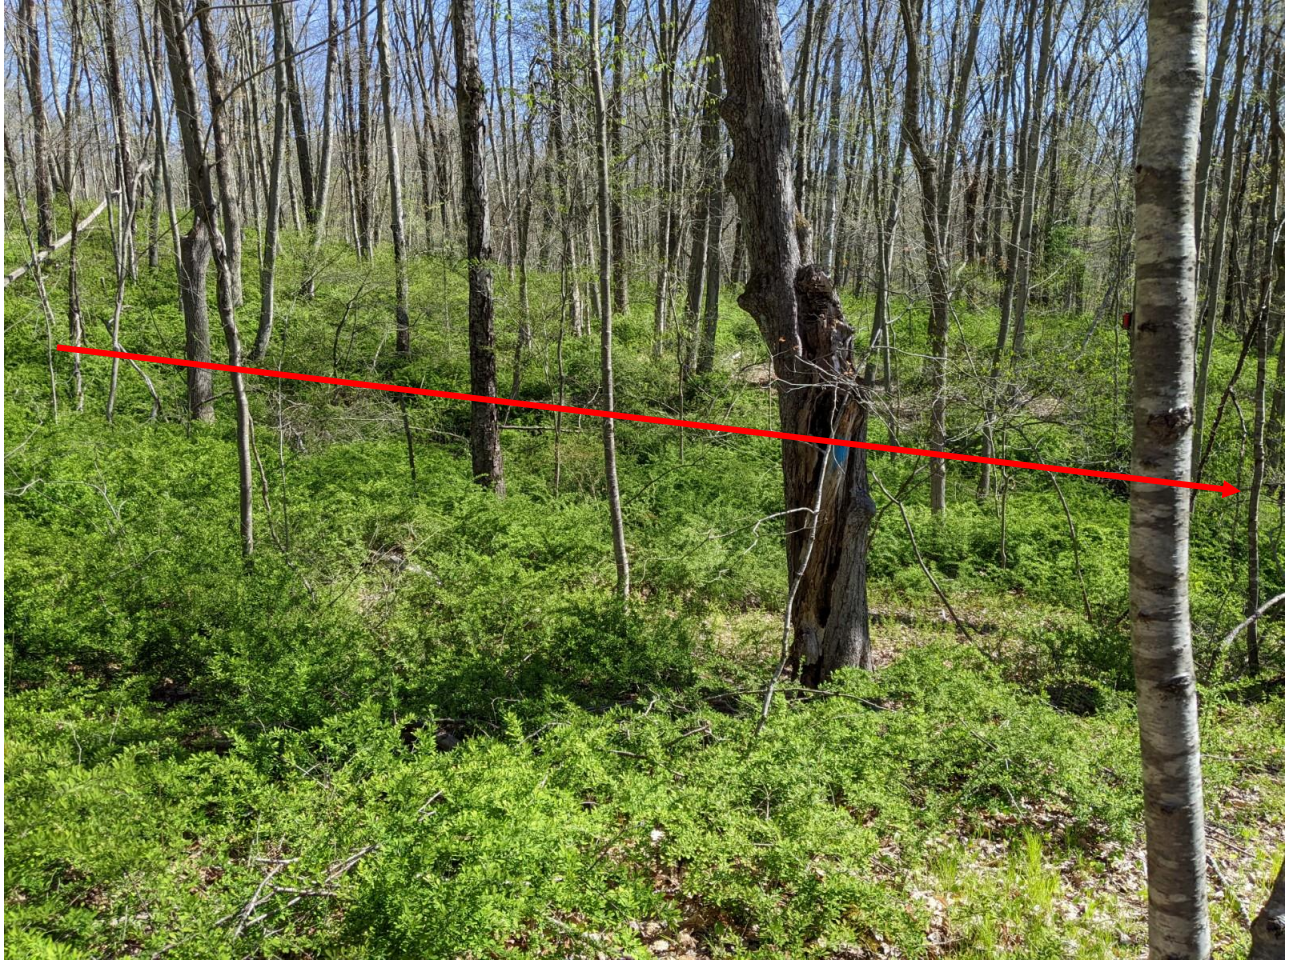
4- View of watercourse near proposed northwest crossing location. The red line denotes the approximate location of the watercourse, which is difficult to see due to the invasive Barberry plants

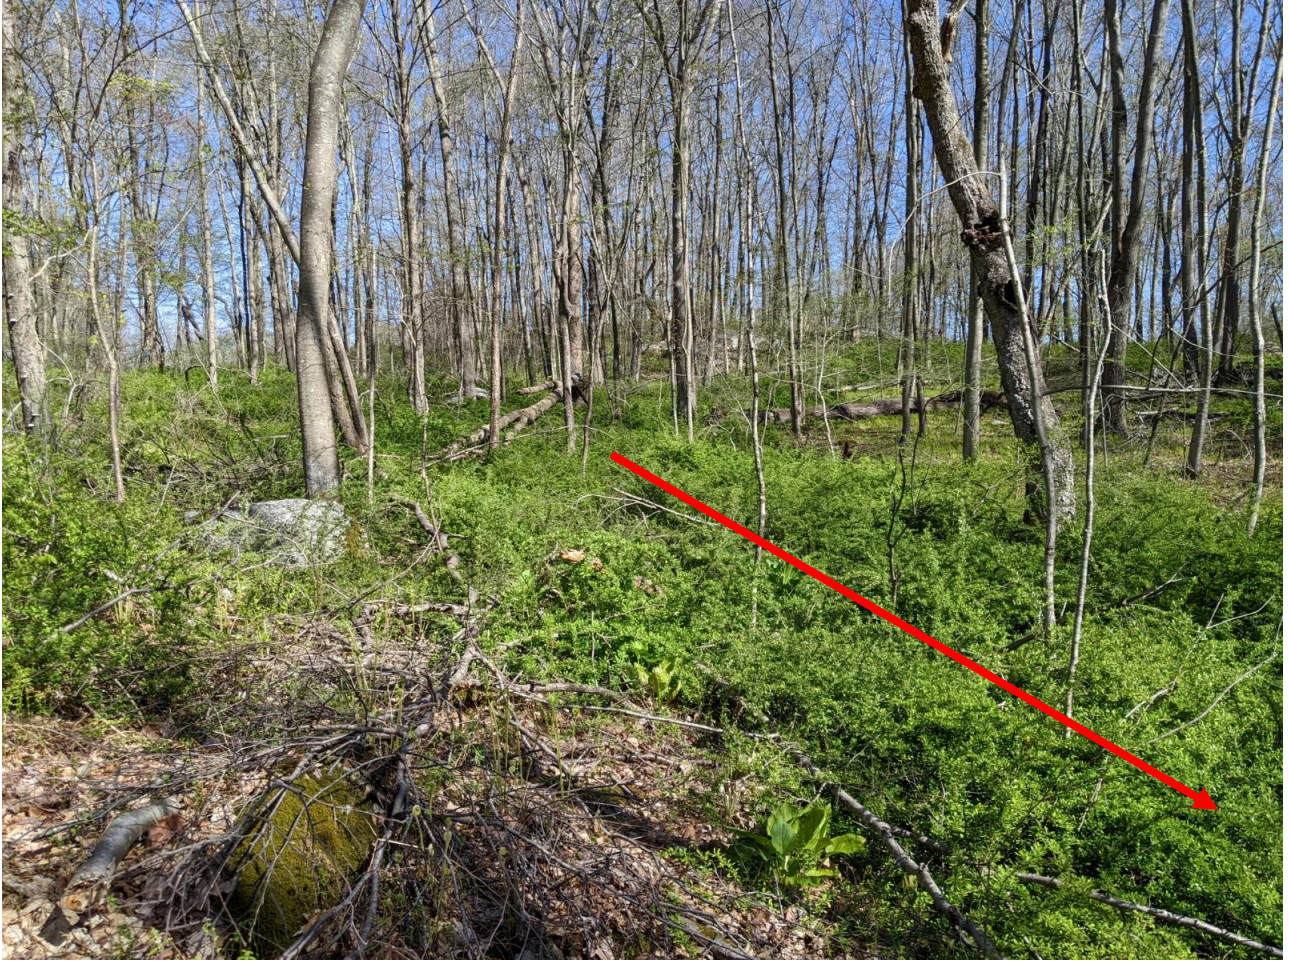
5- View of watercourse near proposed northwest crossing location. The red line denotes the approximate location of the watercourse, which is difficult to see due to the invasive Barberry plants

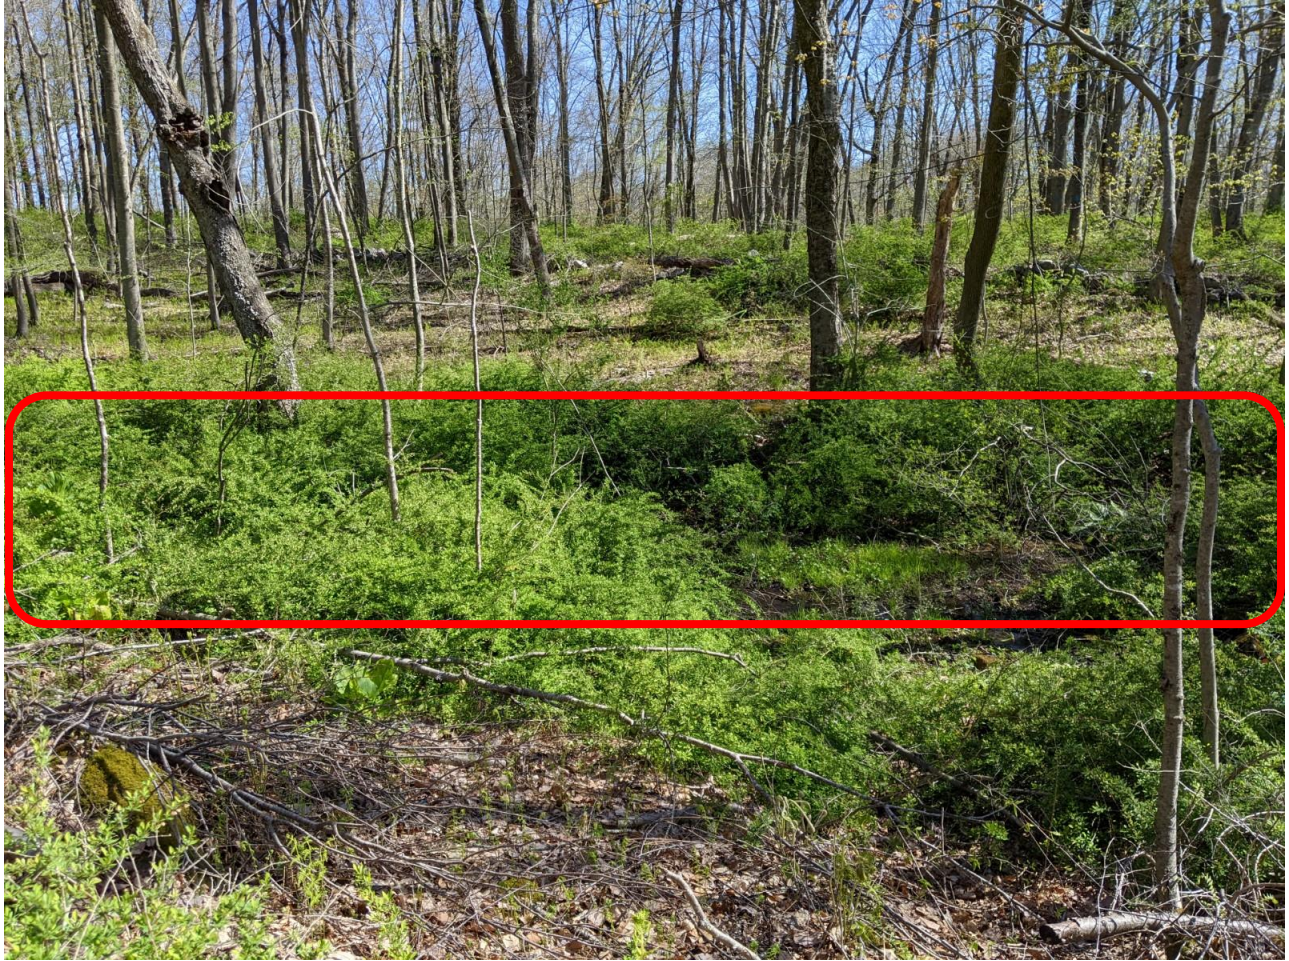
6- View of intermittent stream near location of proposed northwest wetlands crossing. Stream surrounded by invasive barberry and is in the center of photo. Approximate location of the stream is inside the red box in the photo.

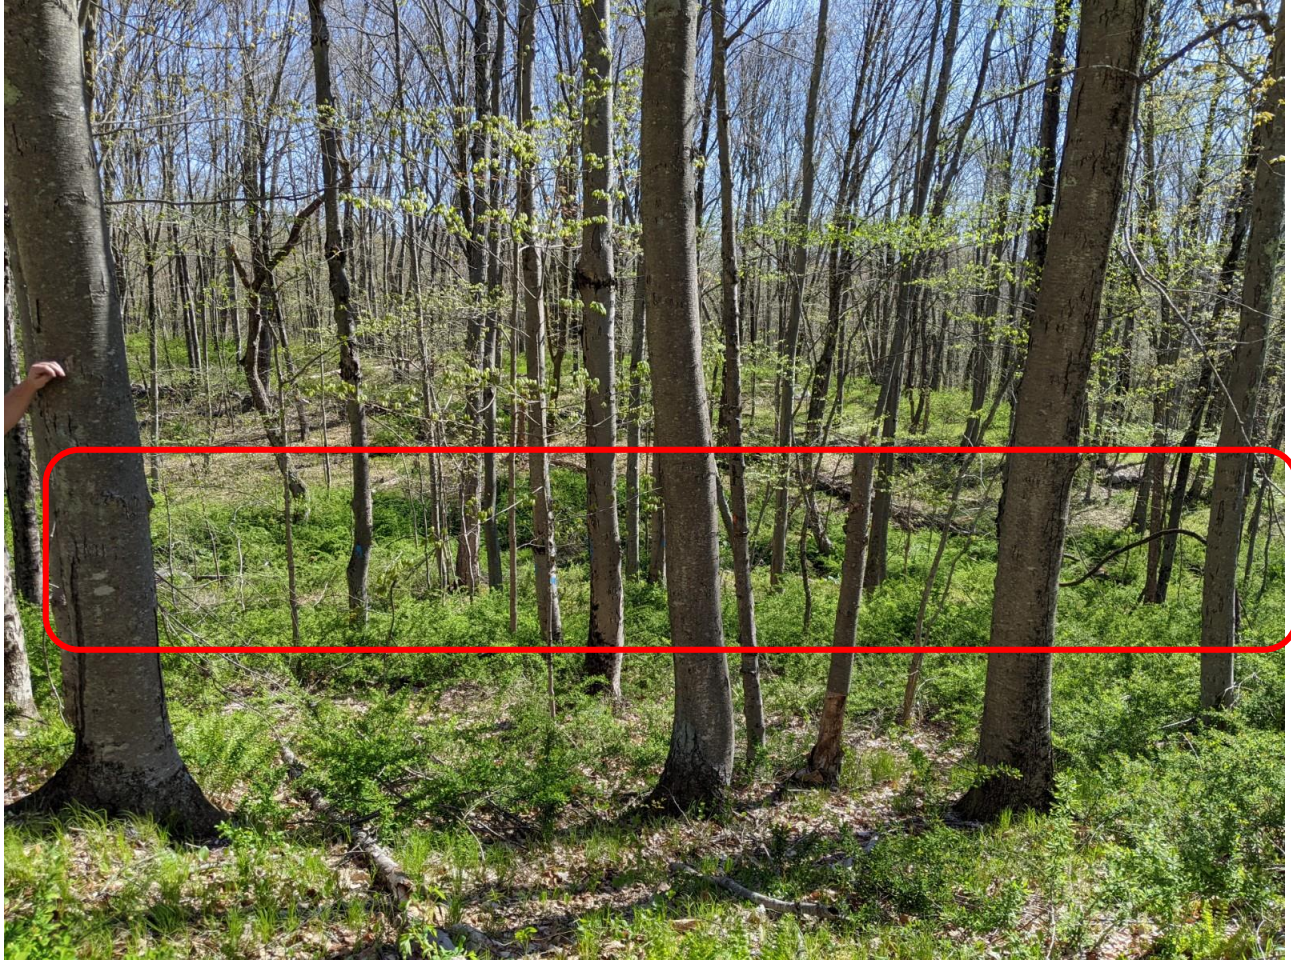
*7- View of approximate area of northwest wetlands crossing. General location of intermittent stream to be crossed is highlighted in red.*

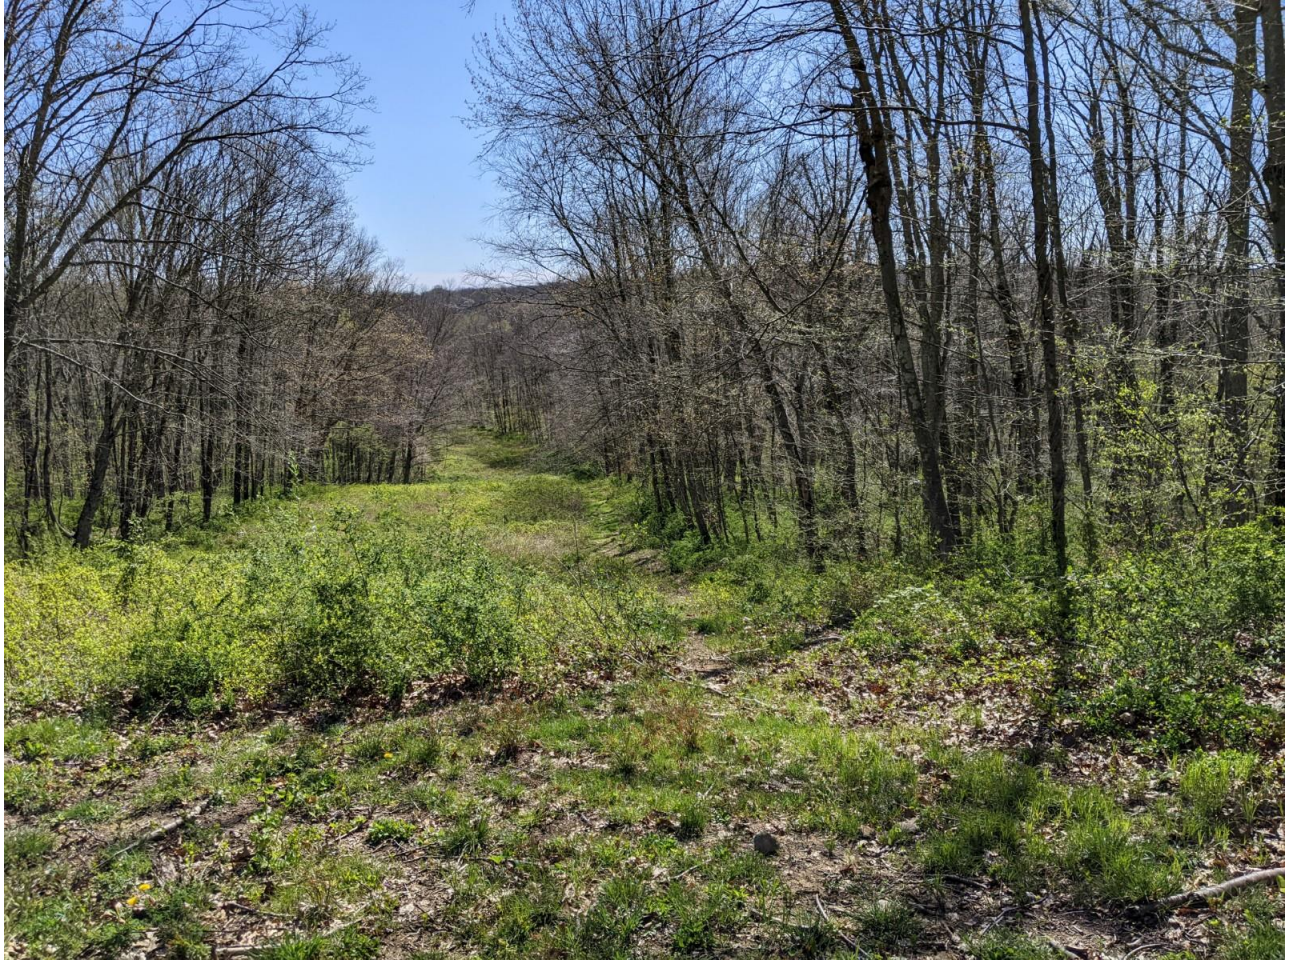
*8- View of gas line corridor on property, looking east. Northwest wetlands crossing is to the left of this corridor, and the southeastern proposed wetlands crossing is to the right of the corridor. As I took the photo, the house and driveway are located behind me. The intermittent stream flows through an existing pipe in the valley (near the center of photo).*
