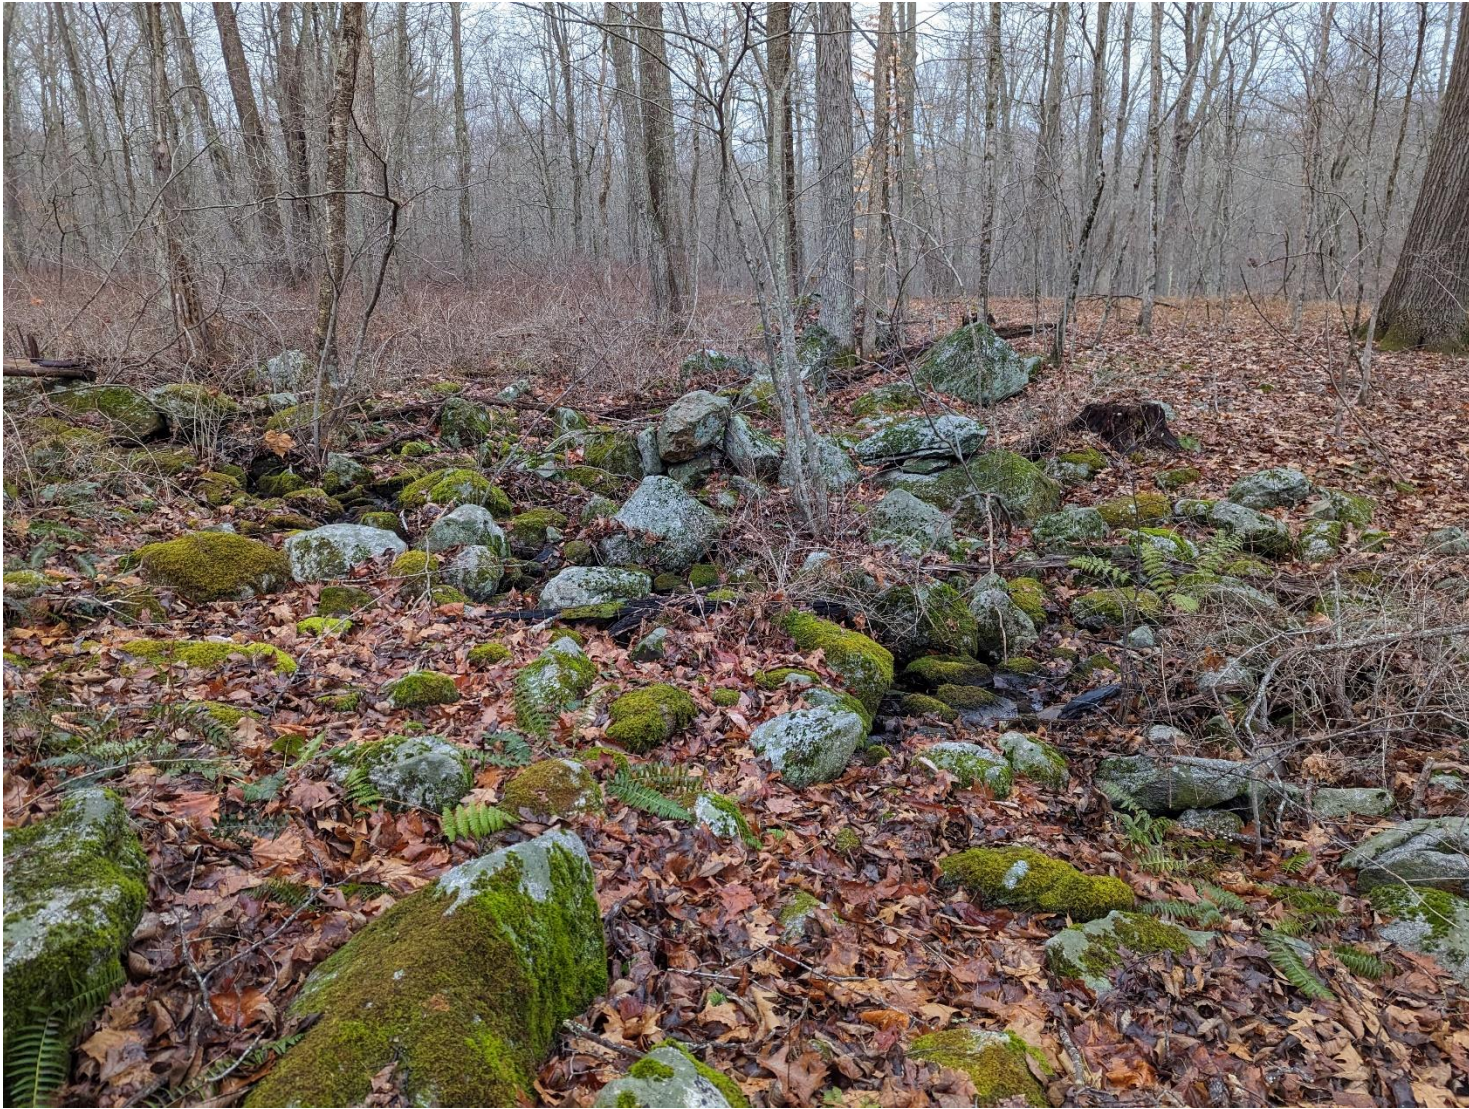
*1- View of southern watercourse crossing area, looking west toward larger wetland area. The crossing area is very rocky and should pose a low erosion risk.*

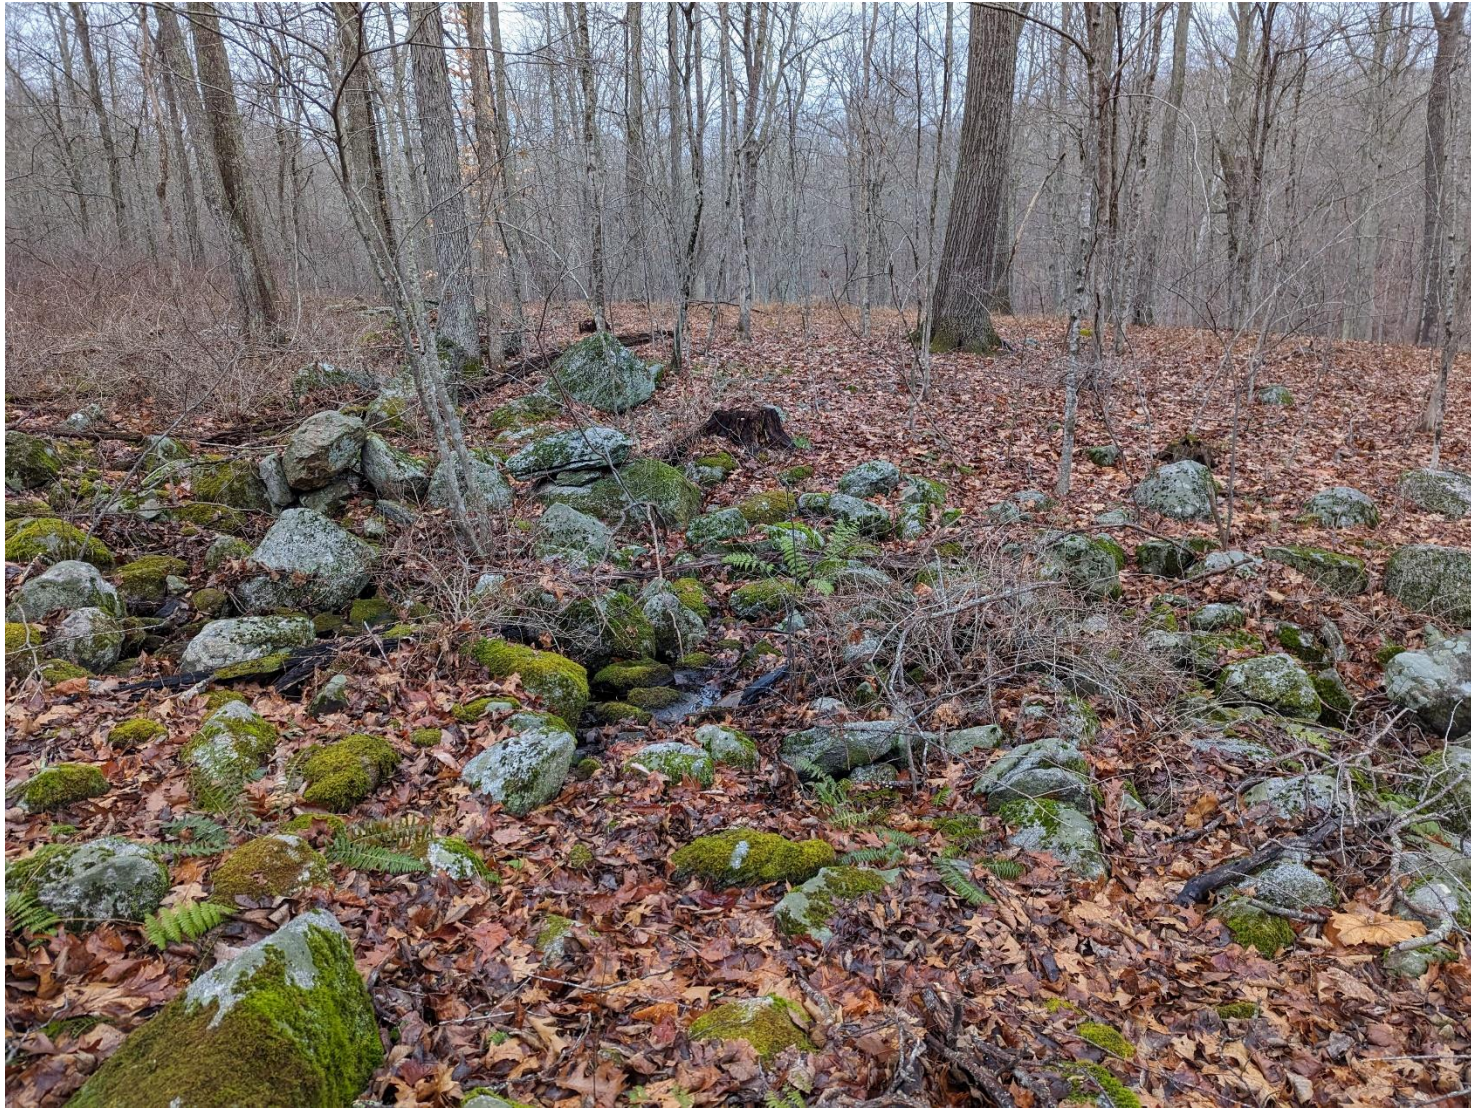
*2- Another view of the southern crossing area, looking upstream (west). Area of "patch cut" will be to the right, and the log landing area is to the left of the photo.*

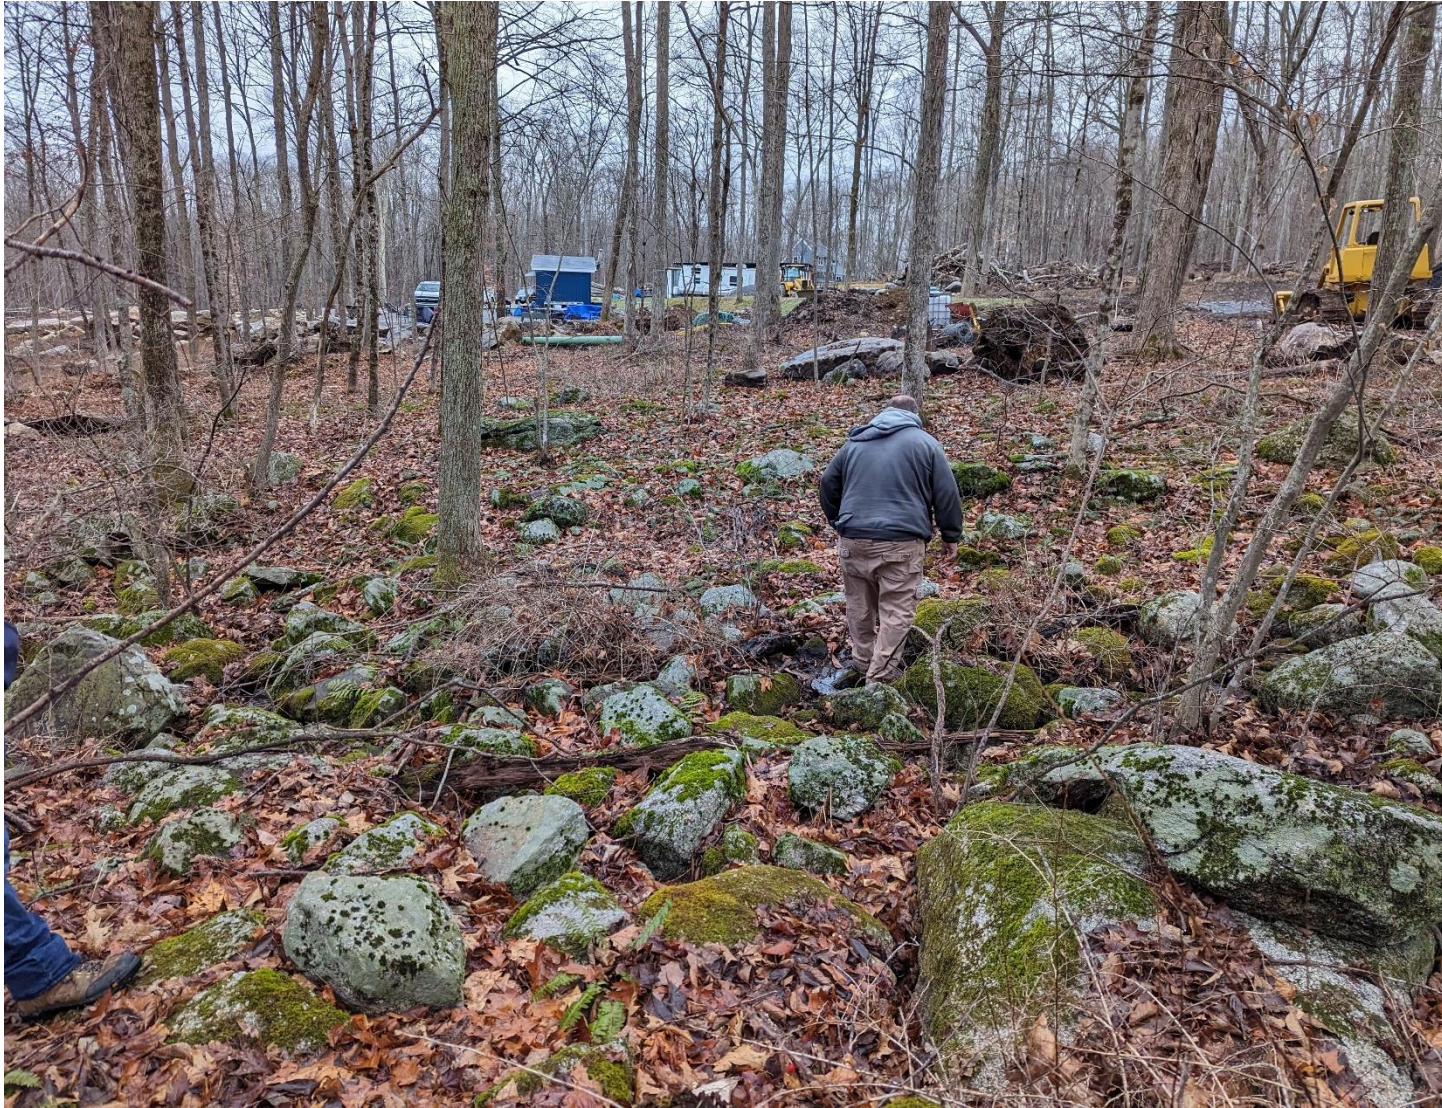
3- View of southern watercourse crossing, looking south toward road/landing area. This area is very rocky and should present a low erosion potential when used as a crossing.

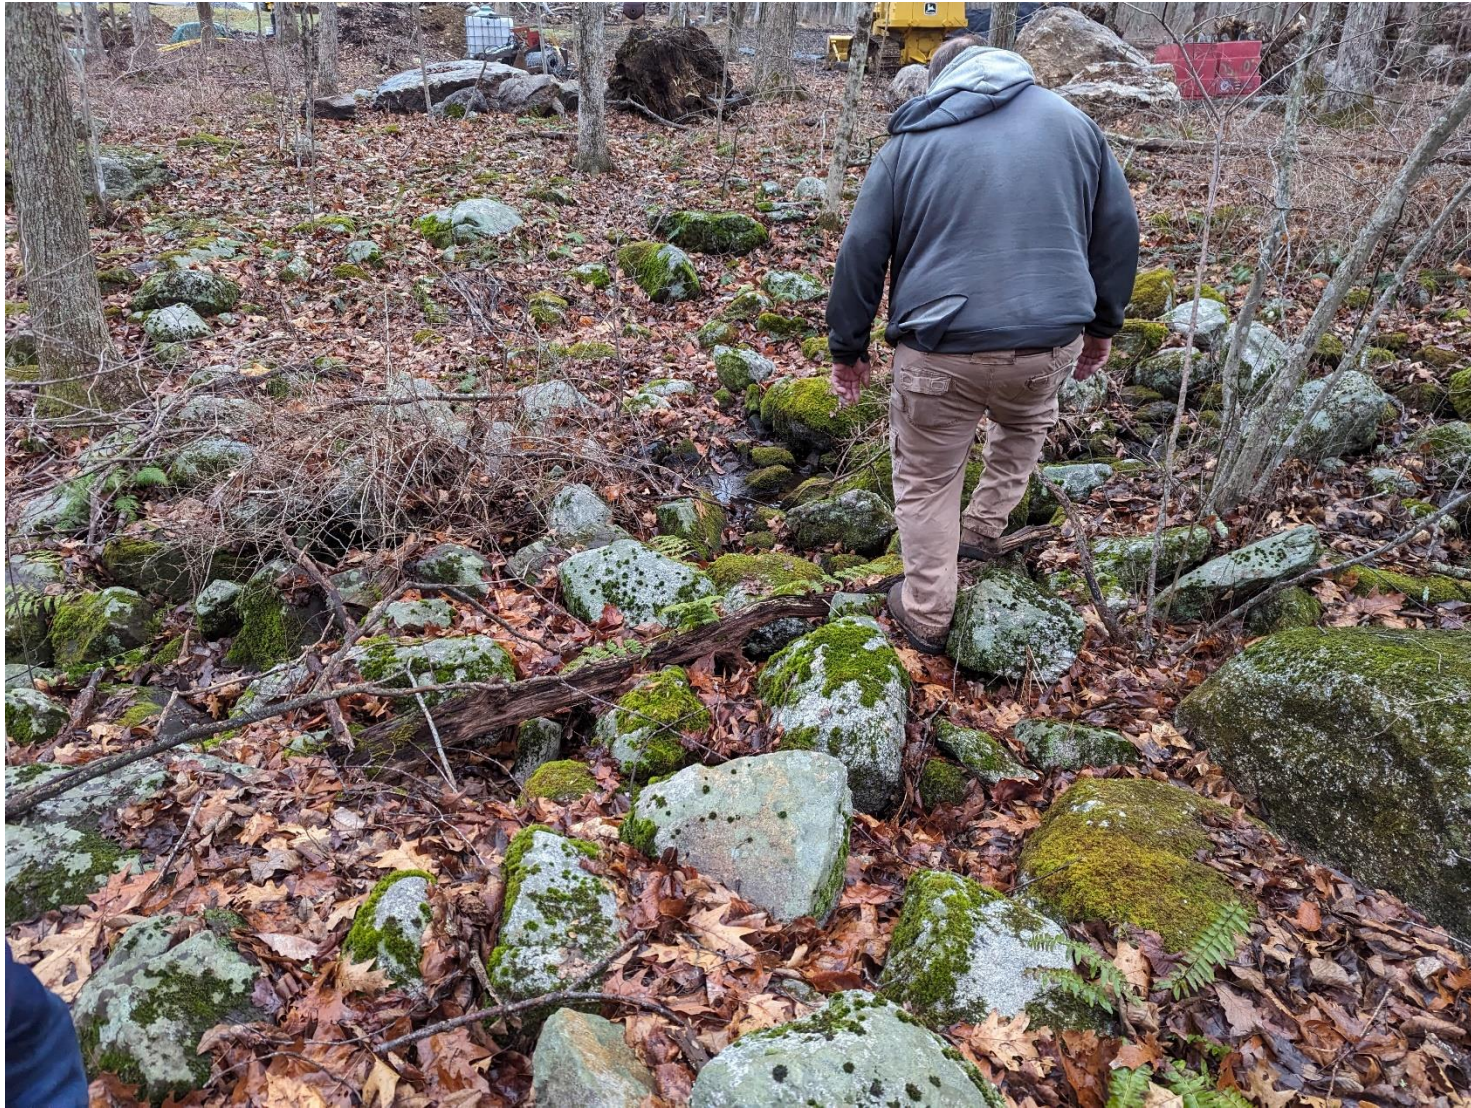
*4- Another view of the southern wetlands crossing, looking south toward the gravel parking/landing area.*

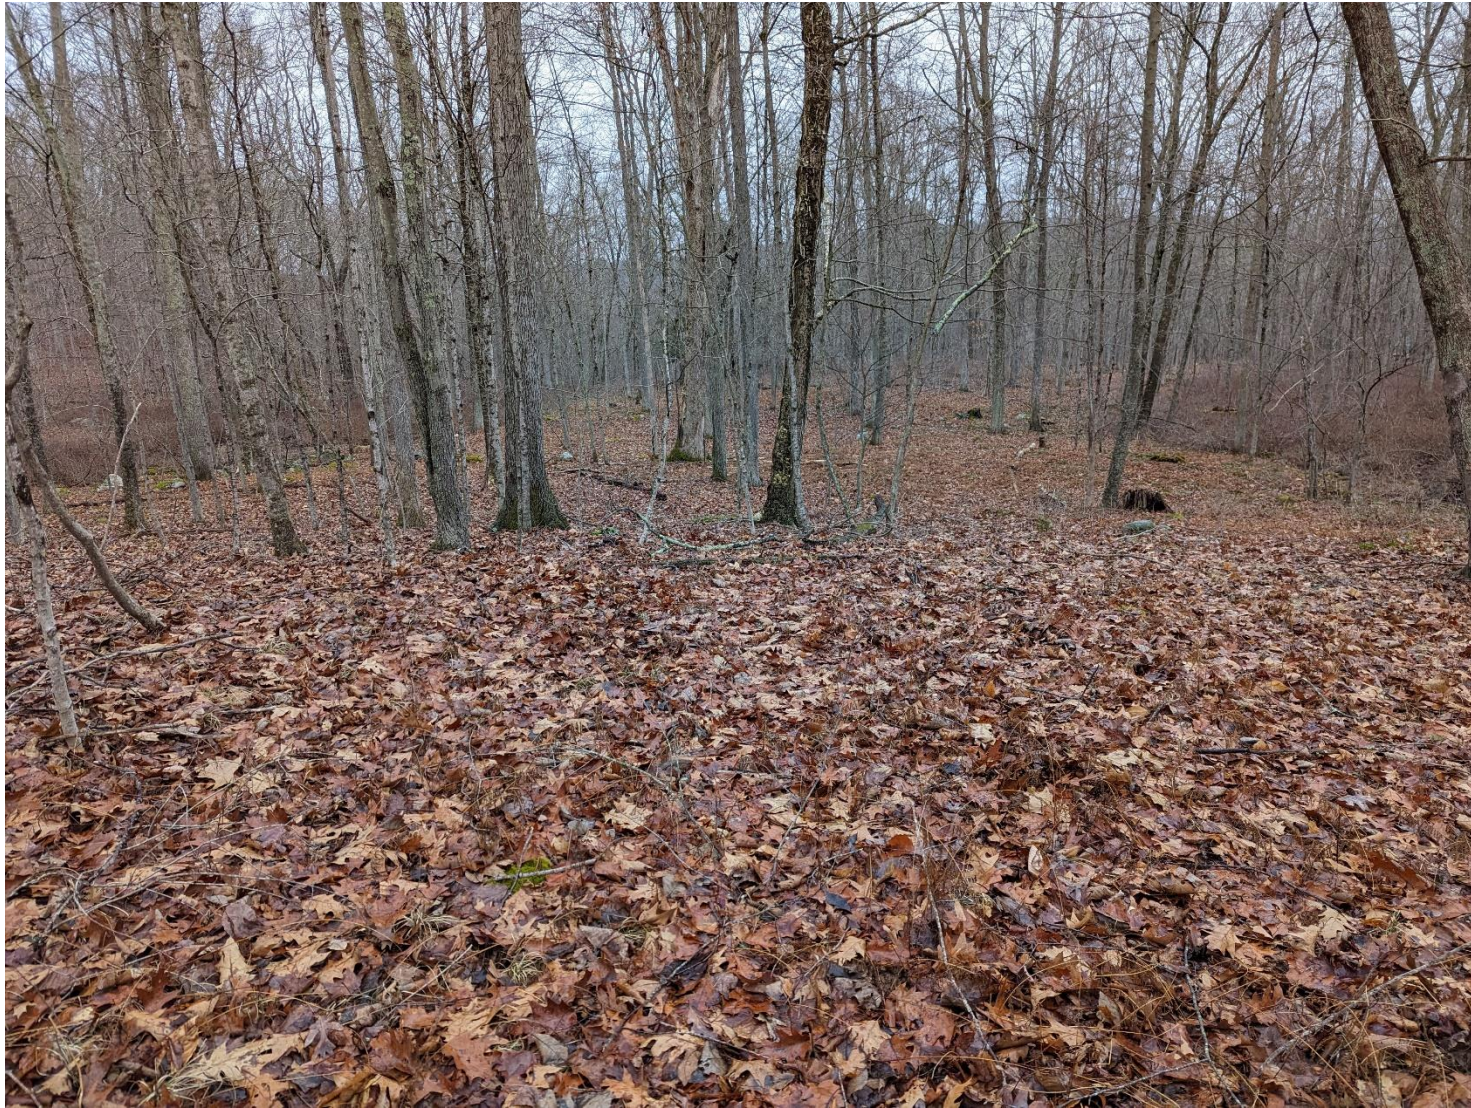
*5- View of the area in between the two wetlands crossings, looking east toward Merritt Valley Road. This is the area of the "patch cut," which will be used as agricultural land.*

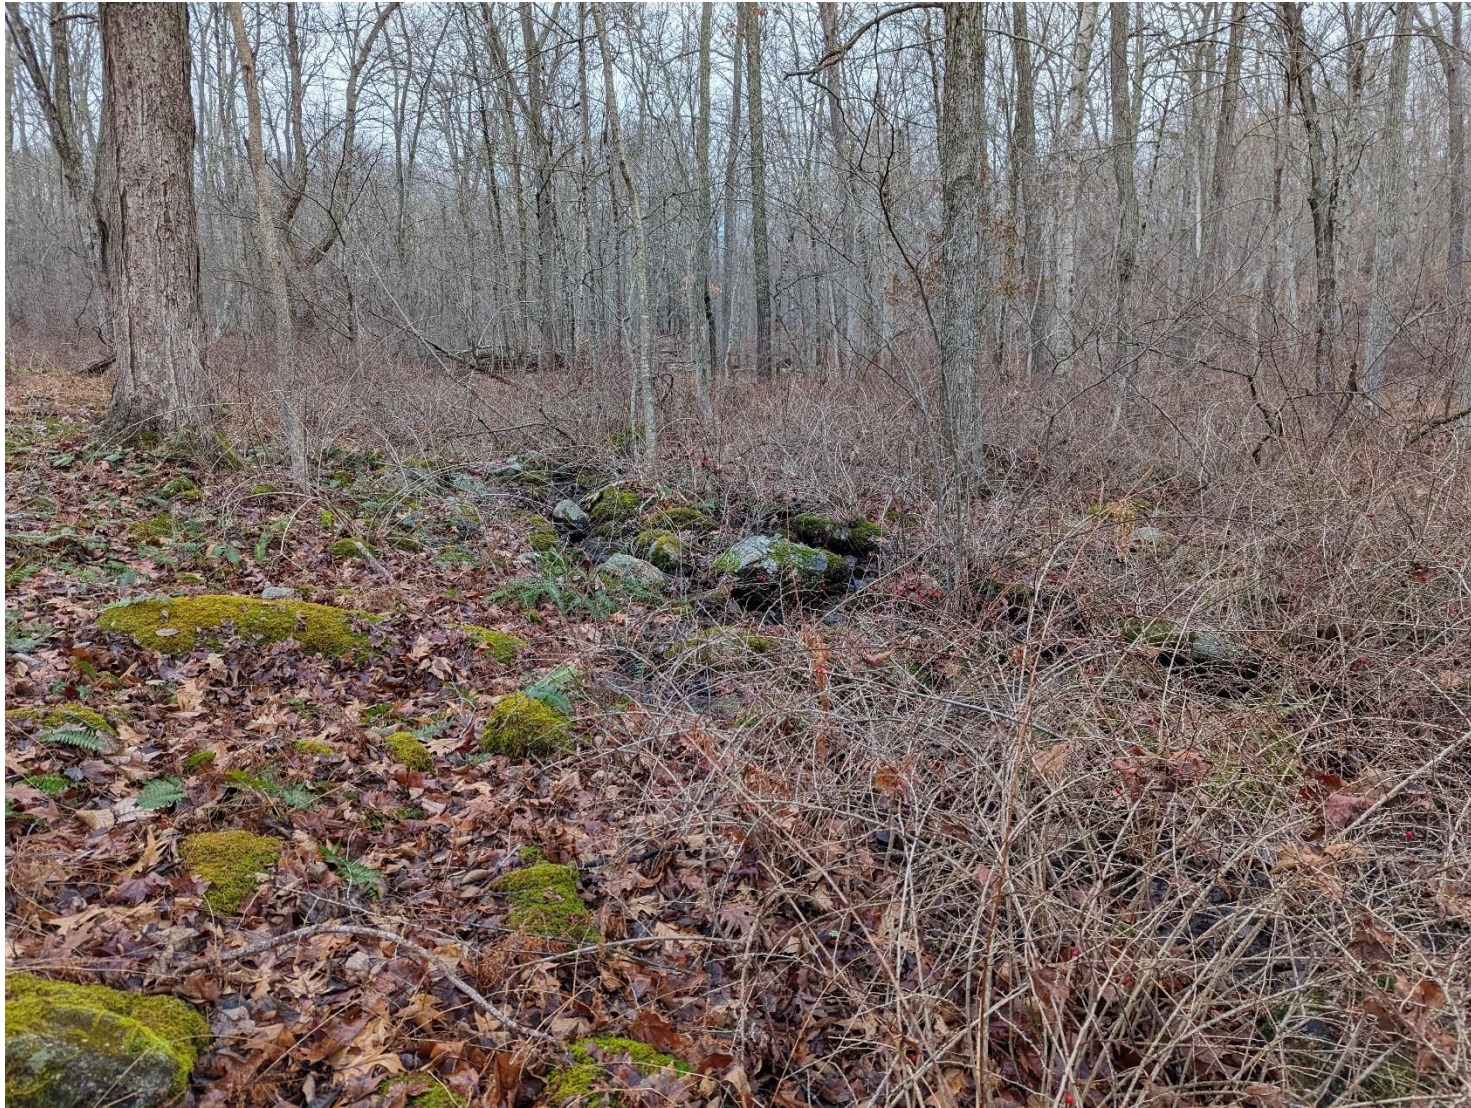
*6- View of northern wetlands crossing, looking west toward larger wetland area.*

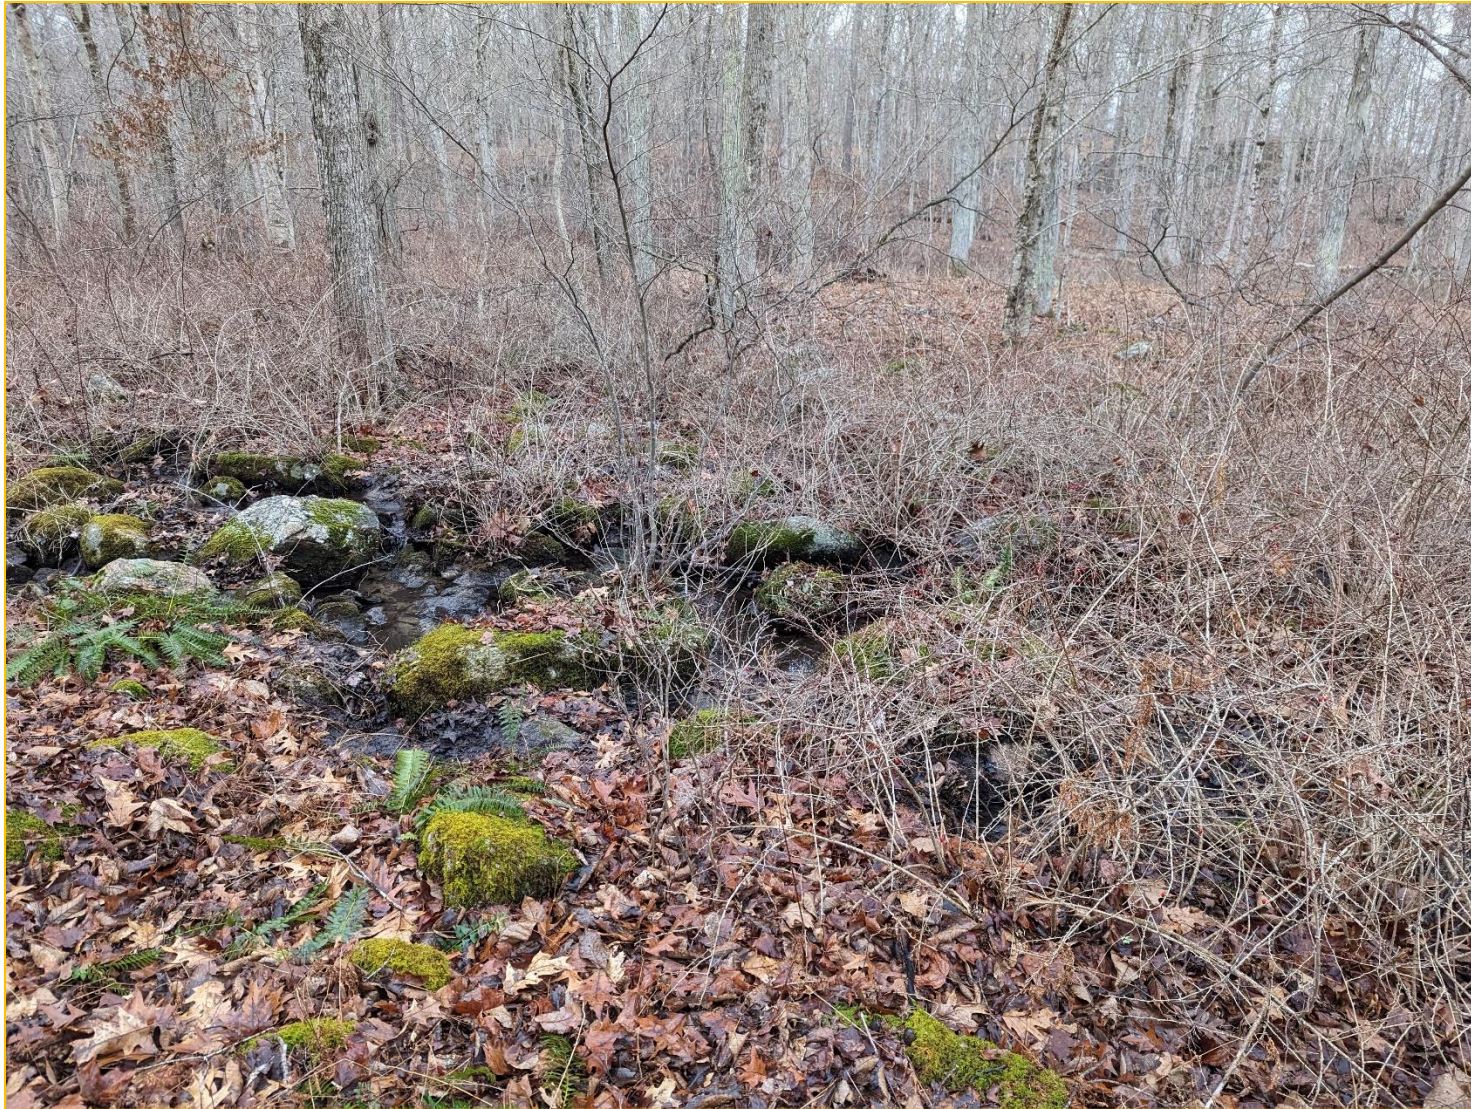
*7- Another view of northern wetlands crossing. This is the narrowest section of wetlands, and is at a relatively level and rocky area. Invasive barberry is well established within the stream and the crossing area, and is visible in the picture.*
