Photos #1 and #2 submitted March 21, 2020 regarding potential IWW violation at #129 Hebron Rd.

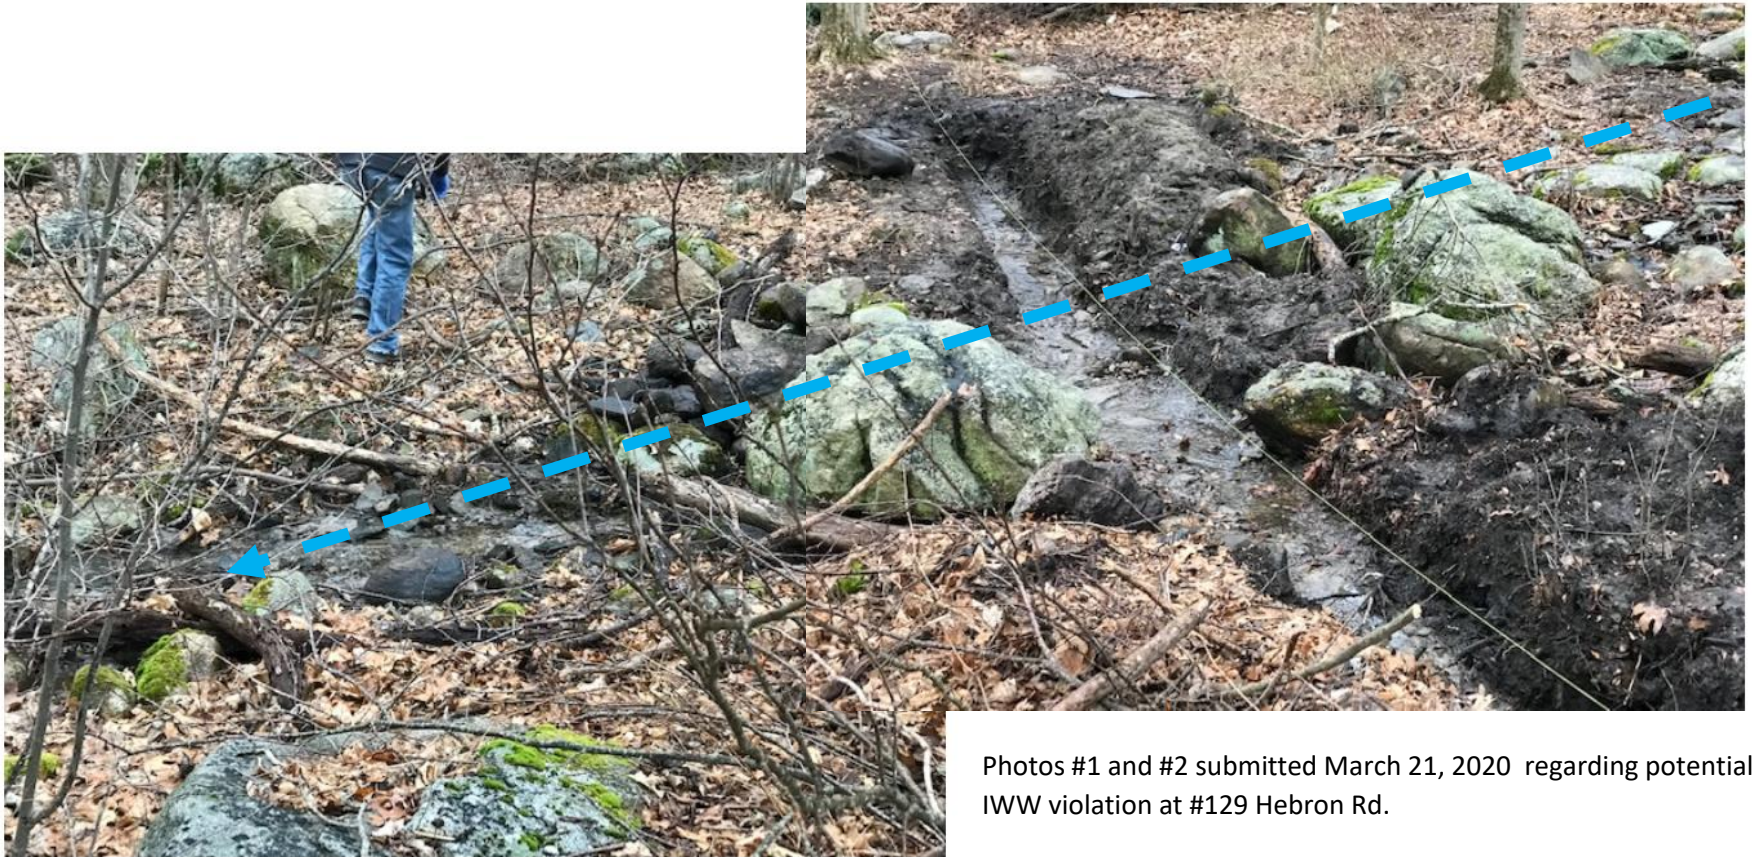
Photos joined by large boulder. Intermittent stream highlighted by blue dashed arrow

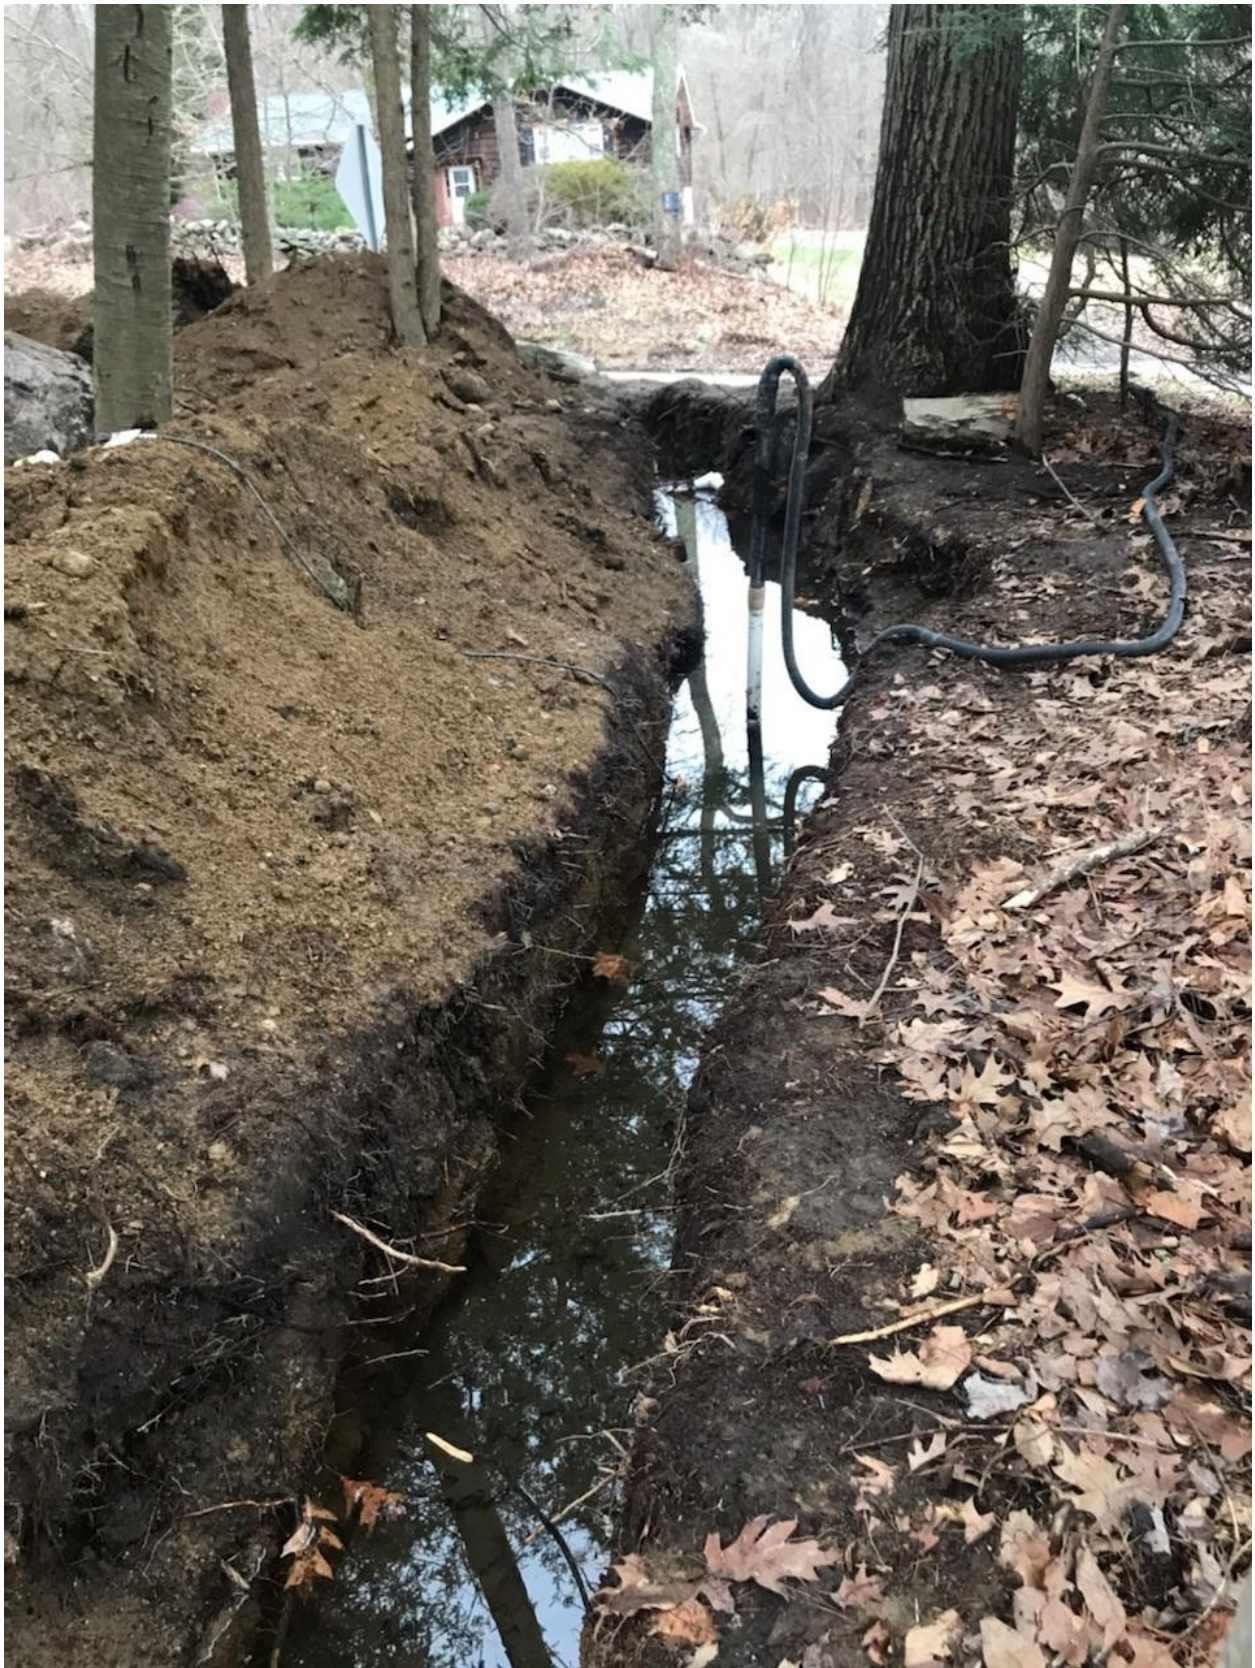
Photo #3 submitted on April 1, 2020 regarding complaint of an IWW violation at #129 Hebron Rd, Andover, CT. Hebron Road is visible at the top of the photo. #129 Hebron Road parcel is to photo left; neighboring property, #125 Hebron Road is to photo right.

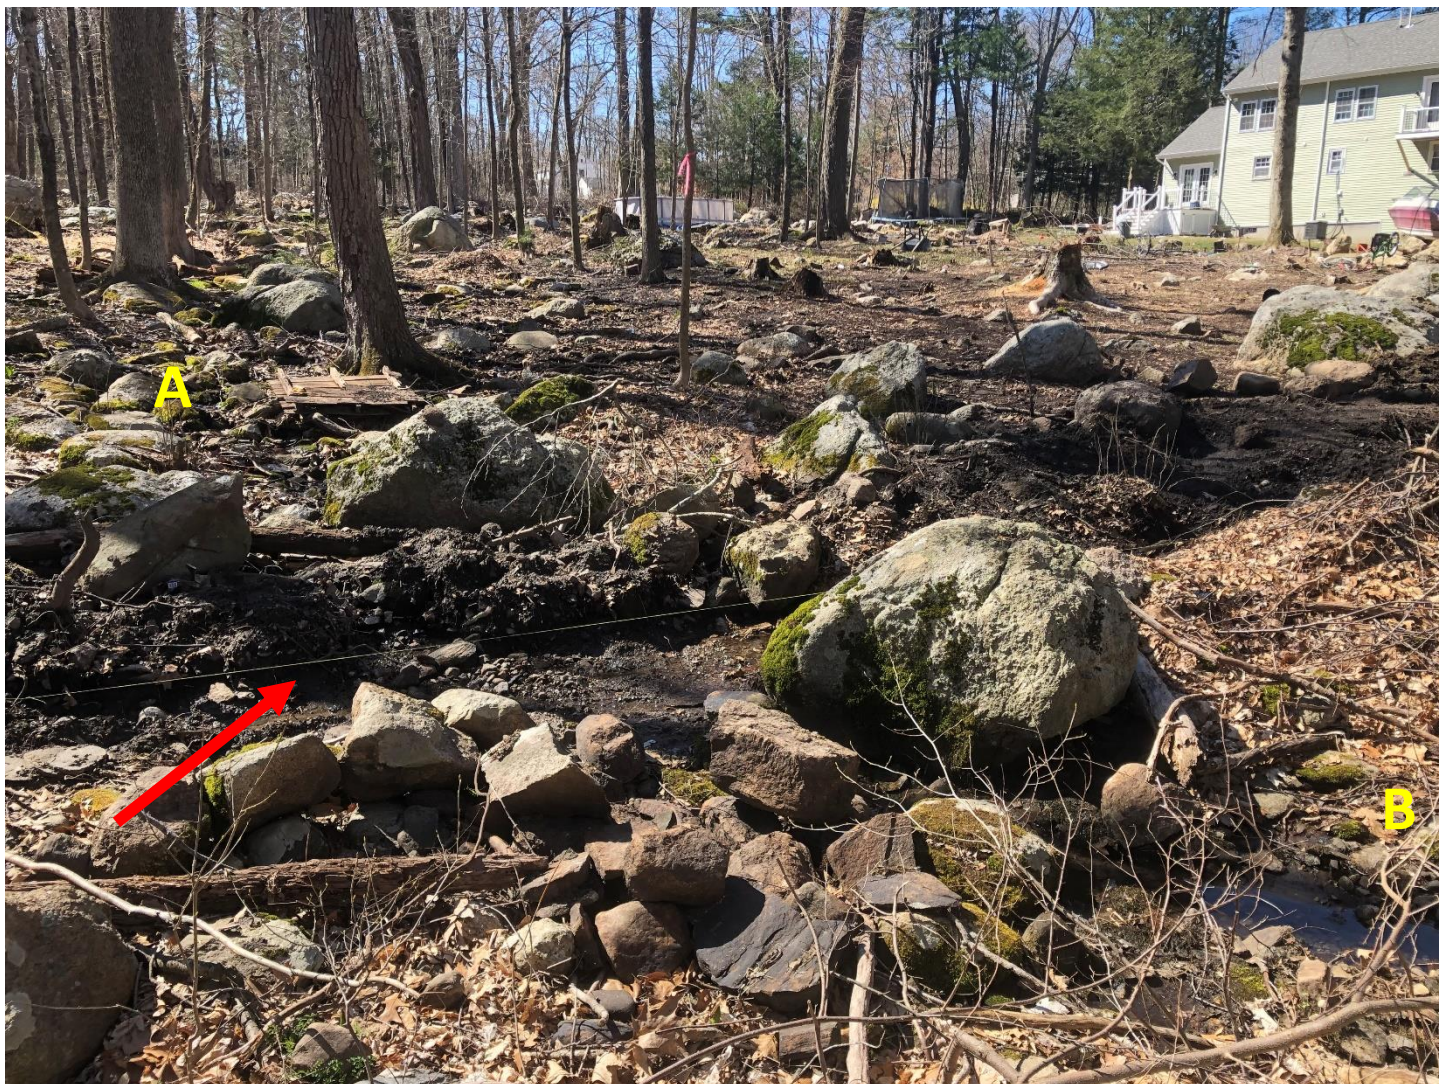
Photo #4 taken by IWWC chair on April 6, 2020.

#129 Hebron Road residence is shown in the upper right of the photo. The intermittent stream flows from A to B. Removal of material (trenching) is shown occurring across the stream in the center of the photo. A string (red arrow), presumably to guide digging of the trench line, is seen above the path of the trench.

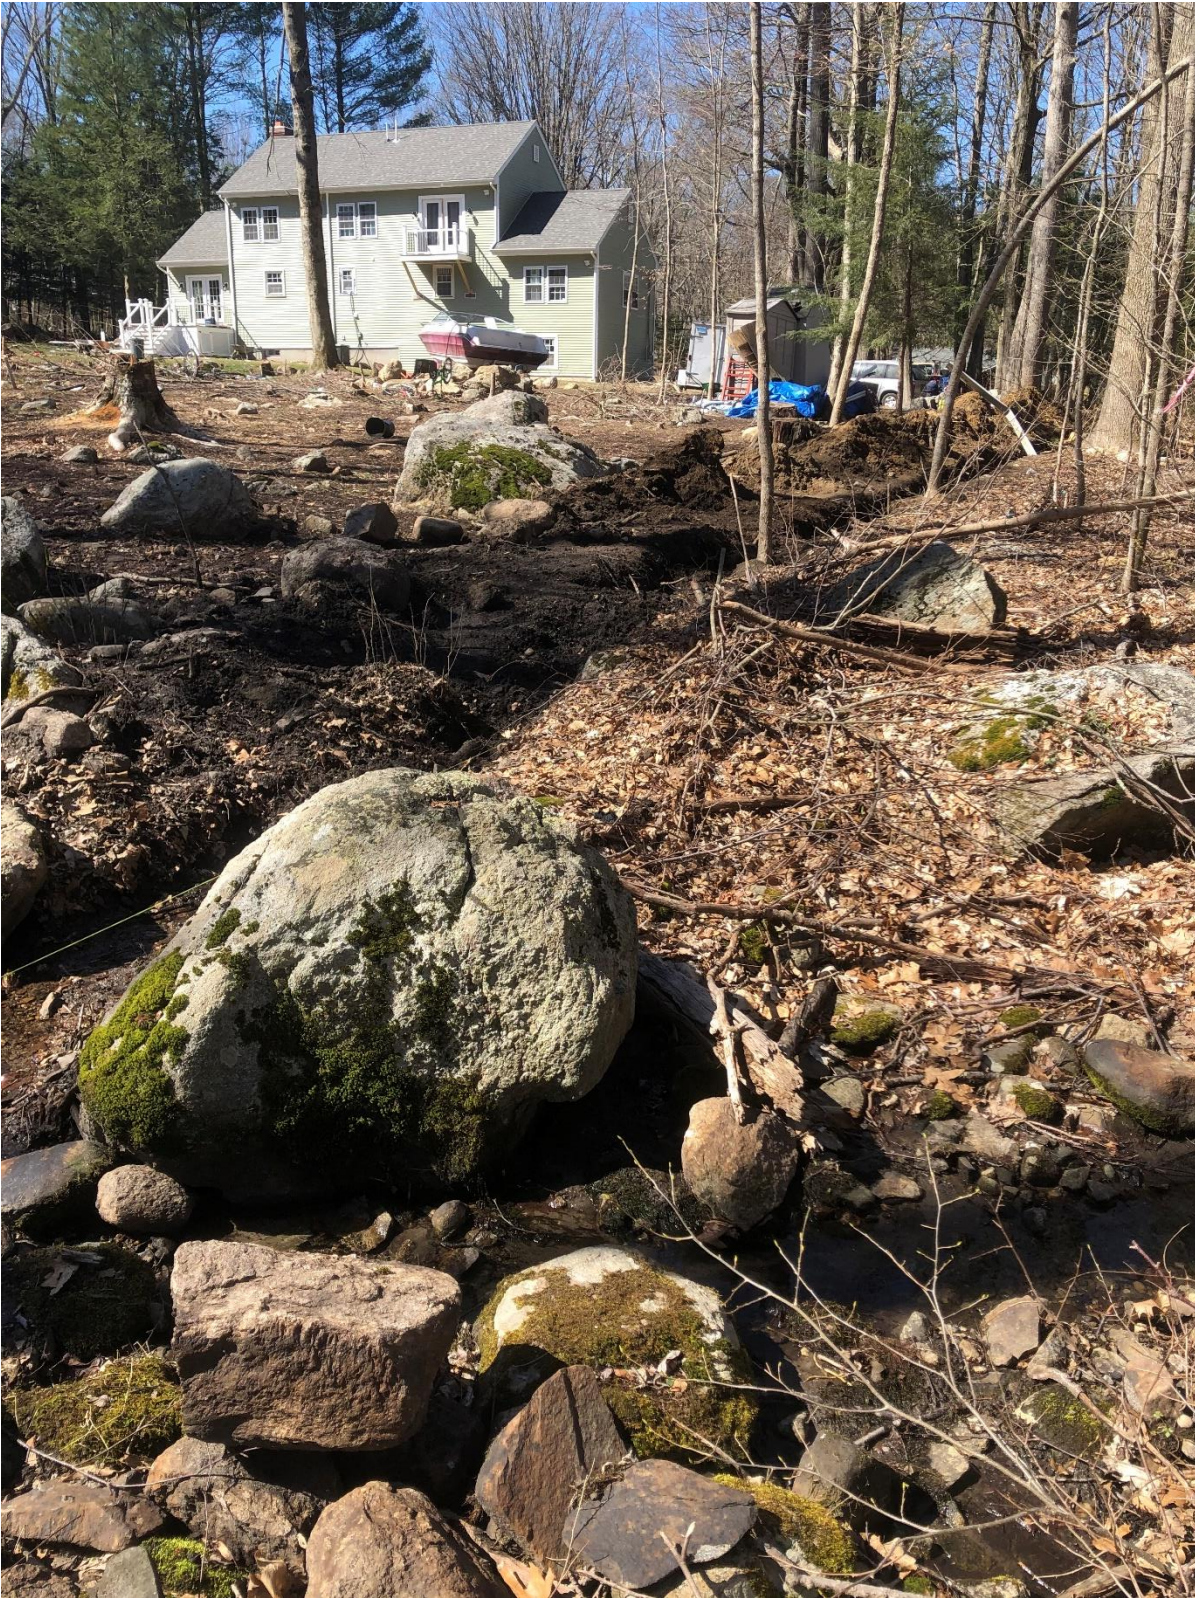
Photo #5 – Taken 04/06/2020 by IWWC Chair from #125 Hebron Road property line.

Intermittent stream is observed in the foreground and flows from left to right in the photo.

Removal of material along a linear path (e.g trench) is observed from the lower left of the photo extending up towards the upper right of the photo (towards Hebron Rd). Placement of material is observed adjacent to the area of removal.
