Invoice 22-01 222 Route 6 (Pallardi)  
Submitted 02-01-2022

Shed/pergola/patio site pictures for 222 Route 6:

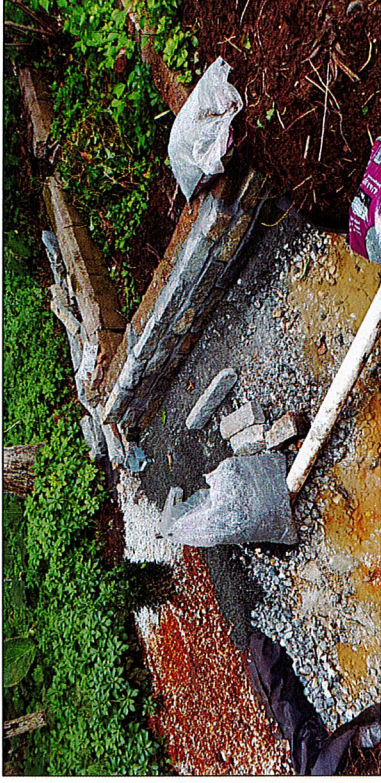
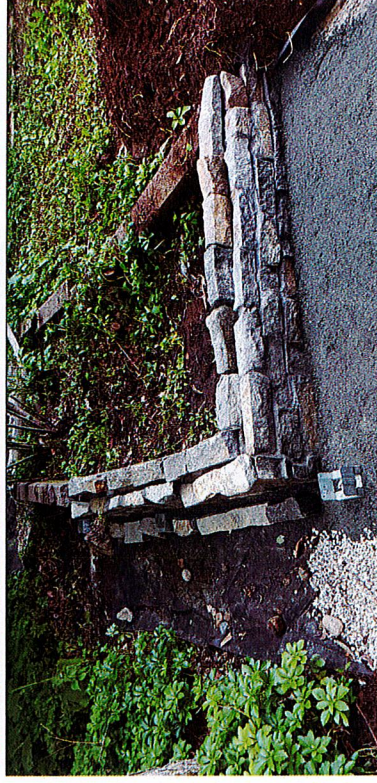
Dugout area on one side of 1800s outbuilding foundation (near sump drainage)

Patio preparation around sump drainage and 1800s outbuilding foundation. Dug out area filled with 6" of crushed stone, then 2" of crushed stone aggregate (sourced from Home Depot/Andover Landscaping). Sides of old concrete foundation were mortared and reinforced with stone veneers. A raised garden will be made out of this area:

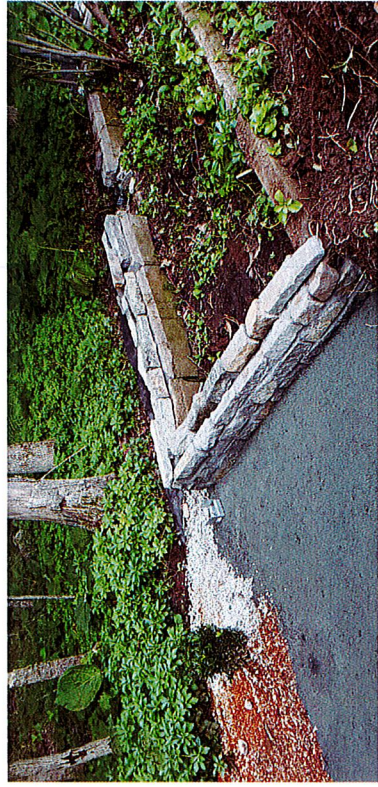
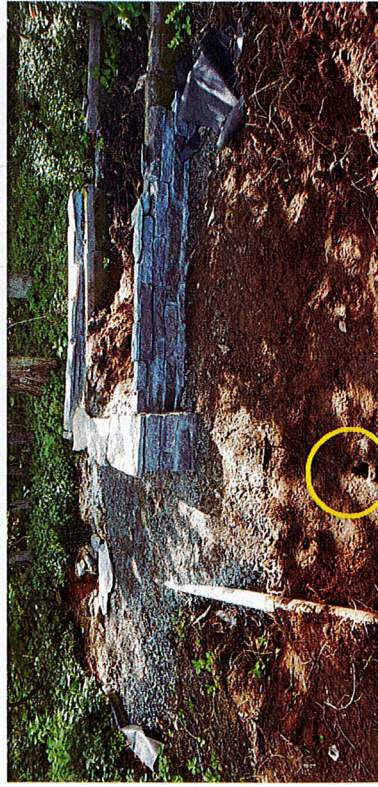
First layer of the buried foundation of the outbuilding can be seen in the yellow circle. These cinder blocks continue from and are the same dimensions as the above-ground structure shown here. This part of the building was buried under 6" of fill dirt (likely during construction of the house in 1937).

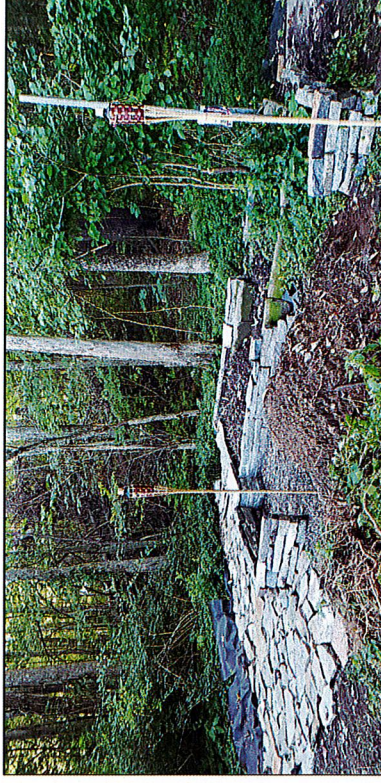
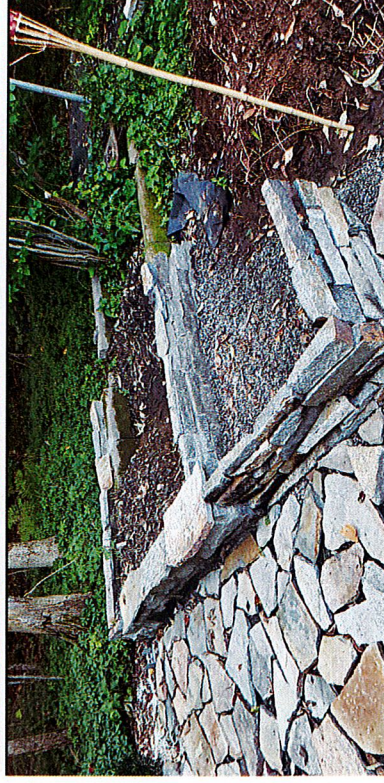
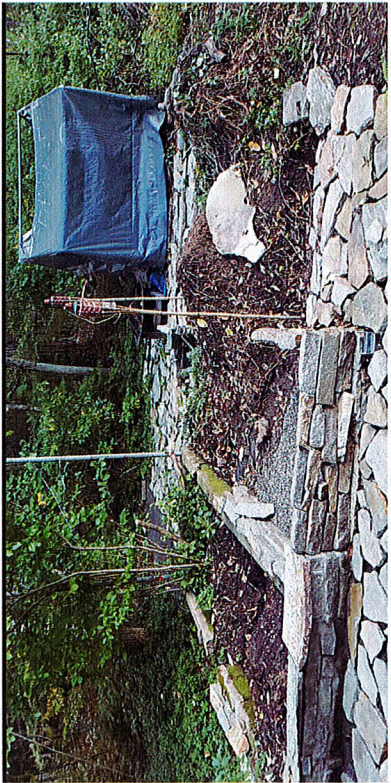
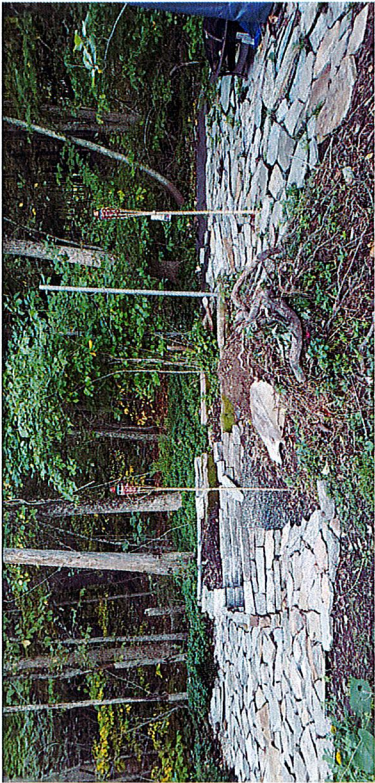
The following pictures are show what the layout of the old 1800s outbuilding, based on the foundation remnants still buried in the yard. This is **not** the final layout of the proposed patio/pergola

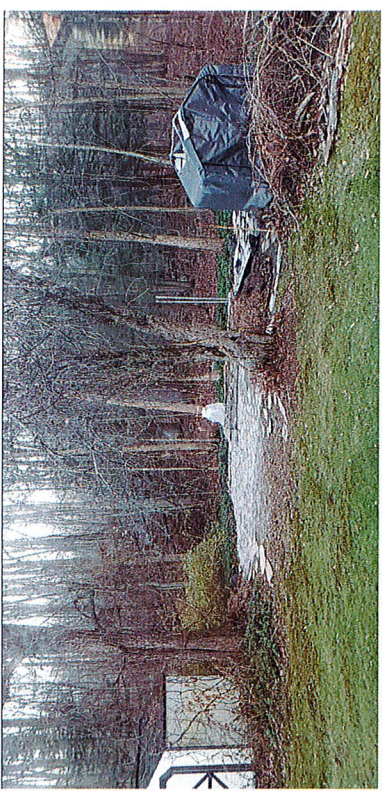
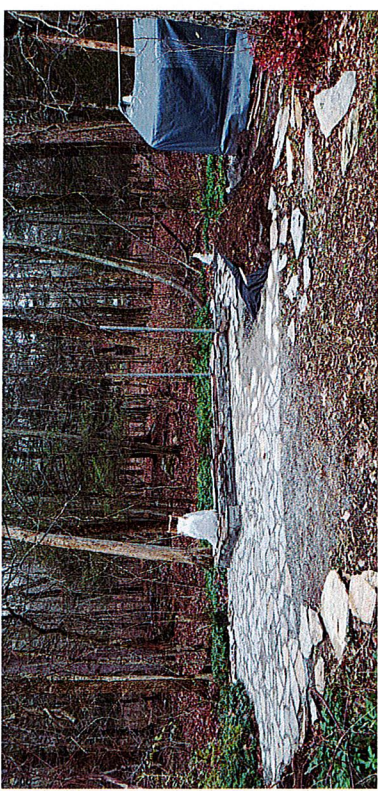
The following is the current state of the proposed site. The fabric shed to the right, and metal poles on the garden area will be removed. The fabric shed marks the location of a pre-existing 9' x 10' concrete slab. The largest part of the pergola will be located over/next to this slab. The stones used here are 1" - 2" flagstone sourced from Skyline Quarry in Stafford Springs, CT.

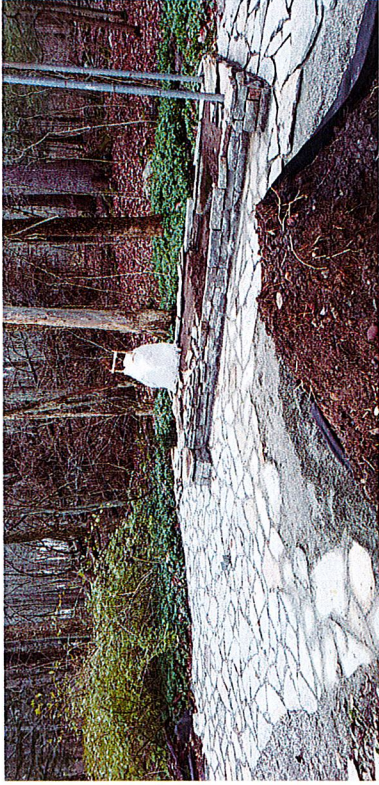
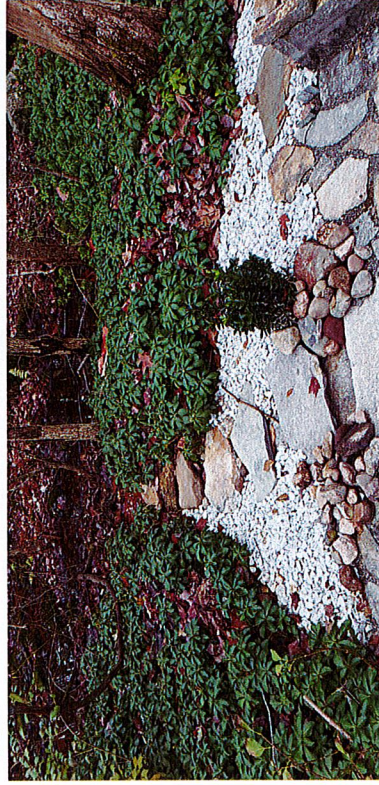
The rock walkway here lays over the sump drainage (I extended it out beyond the proposed patio area). You can see there is ponding where the sump drains out. This ponding is typical.
