IWWC22-02\_Shoddy Mill Rd (TOA) Pictures of Proposed Drainage Project (existing conditions)  
Photos taken by Agent 04-20-2022

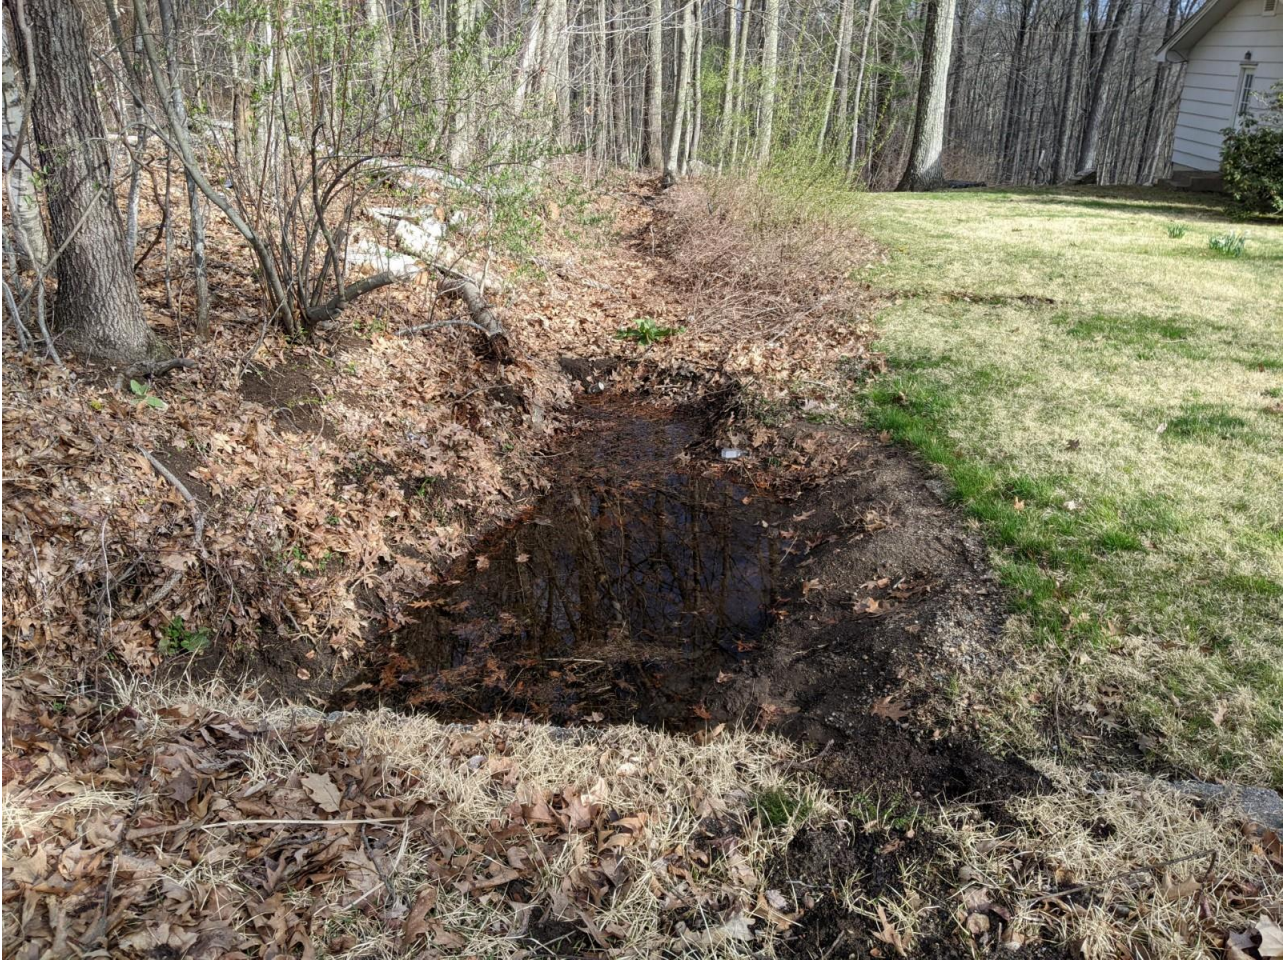
*1- View of culvert outlet and watercourse, looking north along the west edge of 43 Shoddy Mill Rd property. This stream channel will be cleared of debris to allow water to drain to the wetland downhill and to the north of 43 Shoddy Mill.*

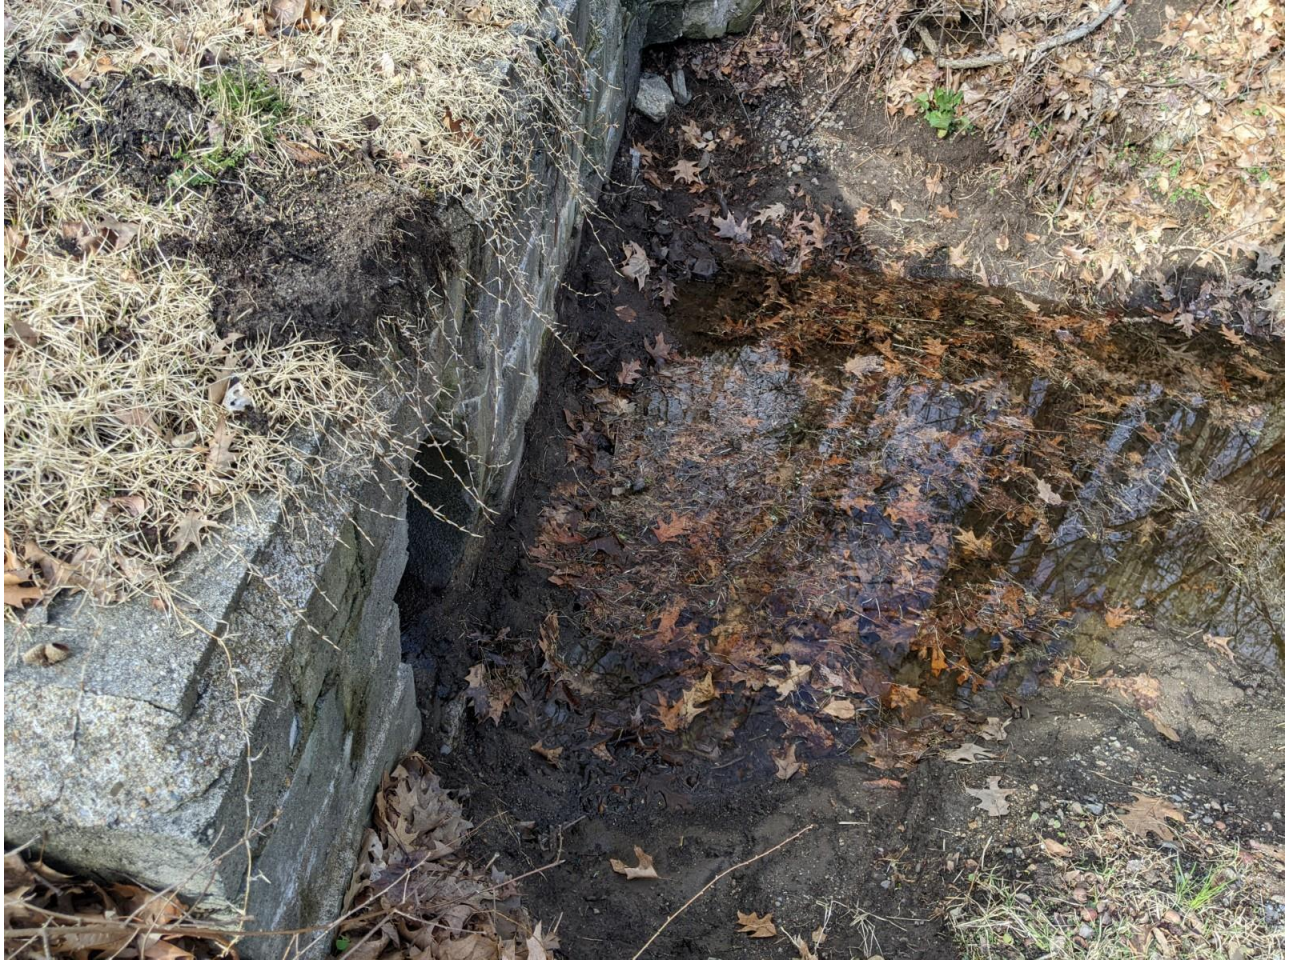
*2- Looking down at the culvert outlet to the west of 43 Shoddy Mill Rd.*

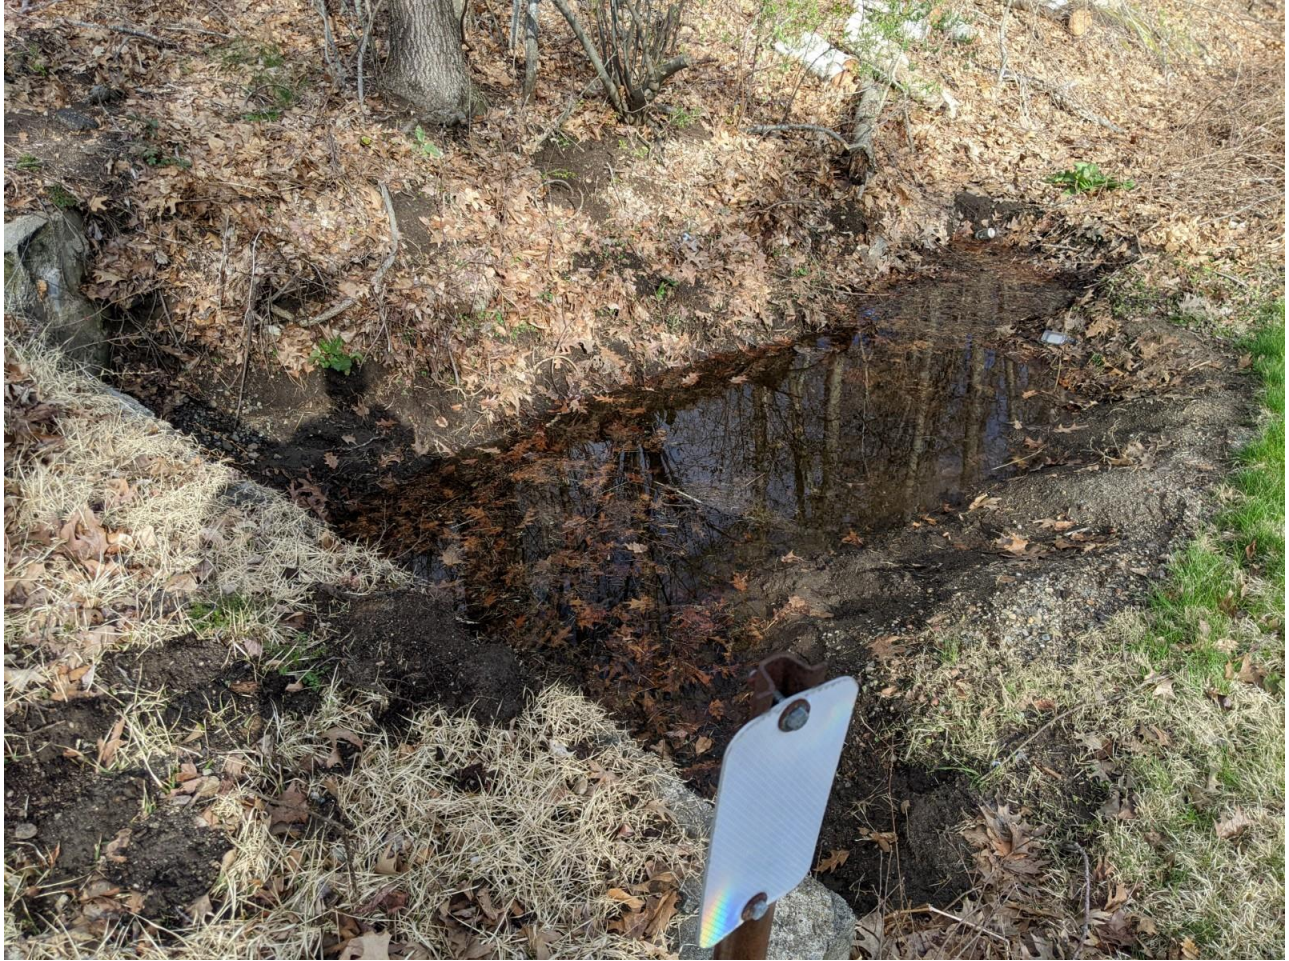
*3- Another view of the outlet and watercourse north of 43 Shoddy Mill. Debris and sediment buildup is visible in the top right of the photo--this will be removed to allow better flow.*

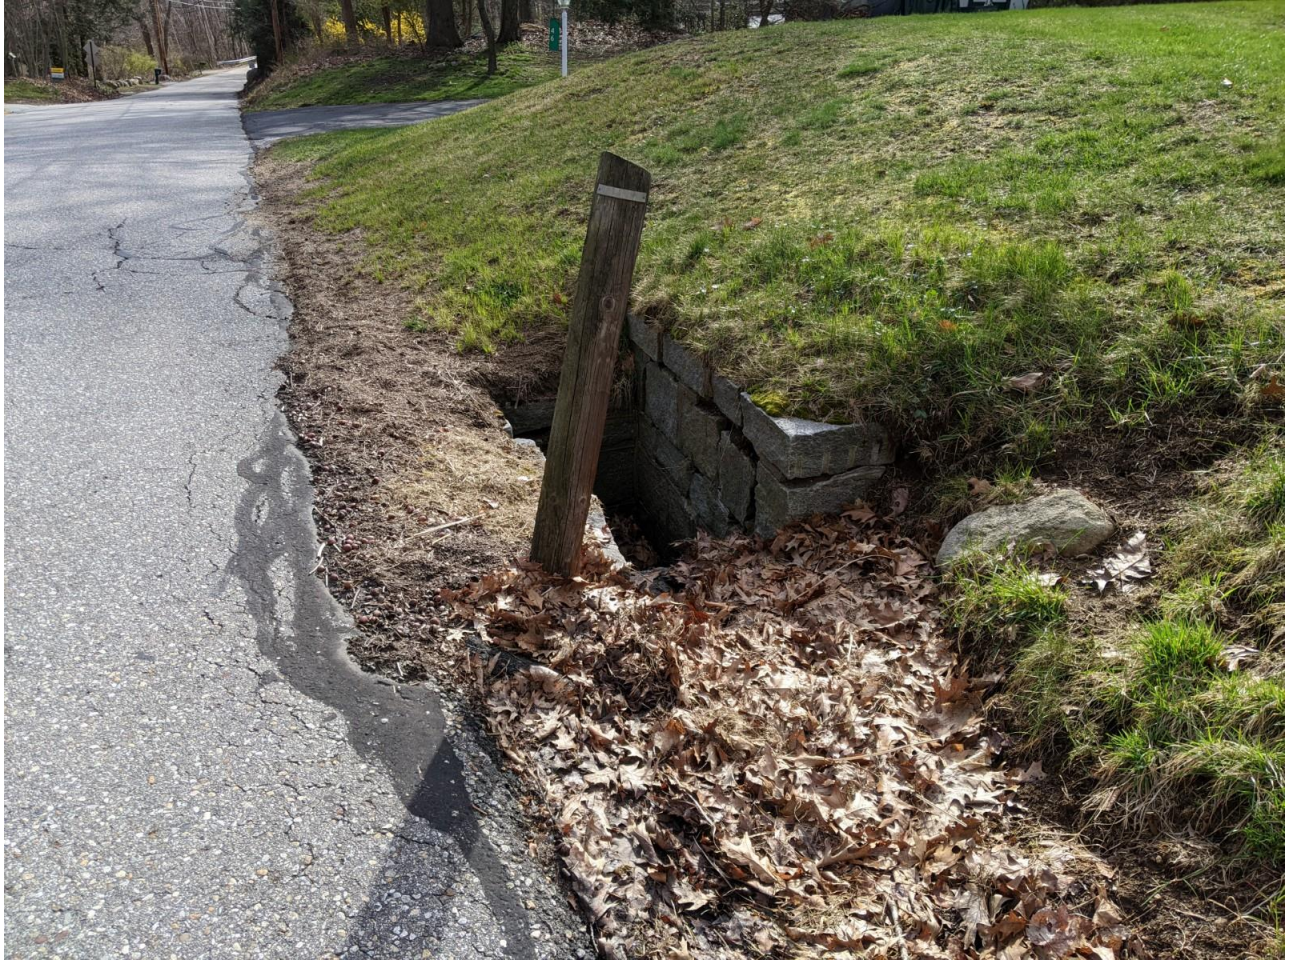
*4- View of existing basin on the right-hand (south) side of Shoddy Mill Rd. Pipe runs under the street to the outlet west of 43 Shoddy Mill Road. This pipe and catch basin will be replaced.*

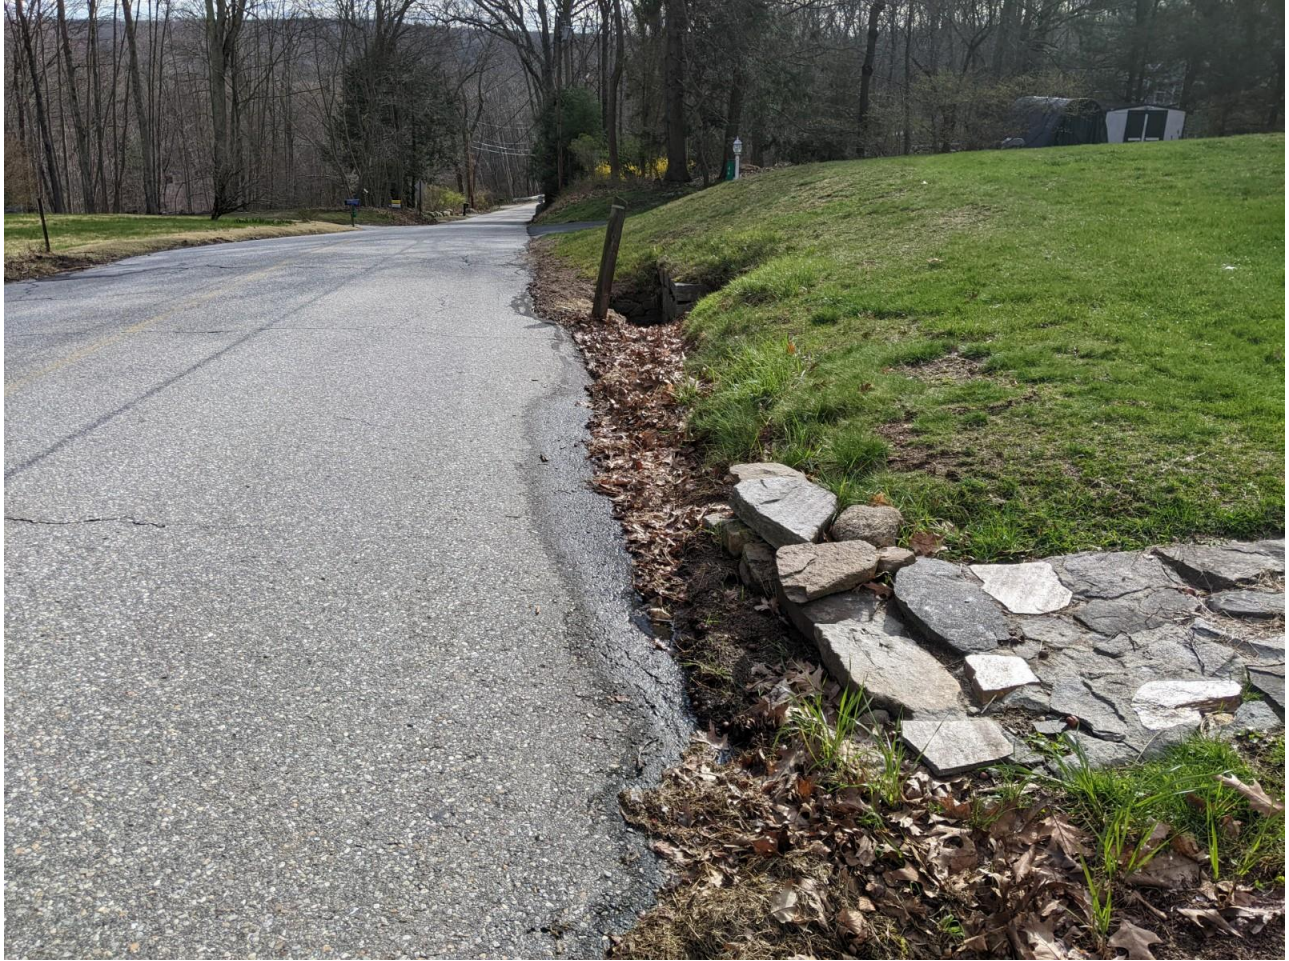
*5- View of the right-hand (south) side of Shoddy Mill Rd, looking east. Birch Dr. is behind the photo. Pipe will be installed in this section connecting to a catch basin (the existing basin is in the center of the photo).*

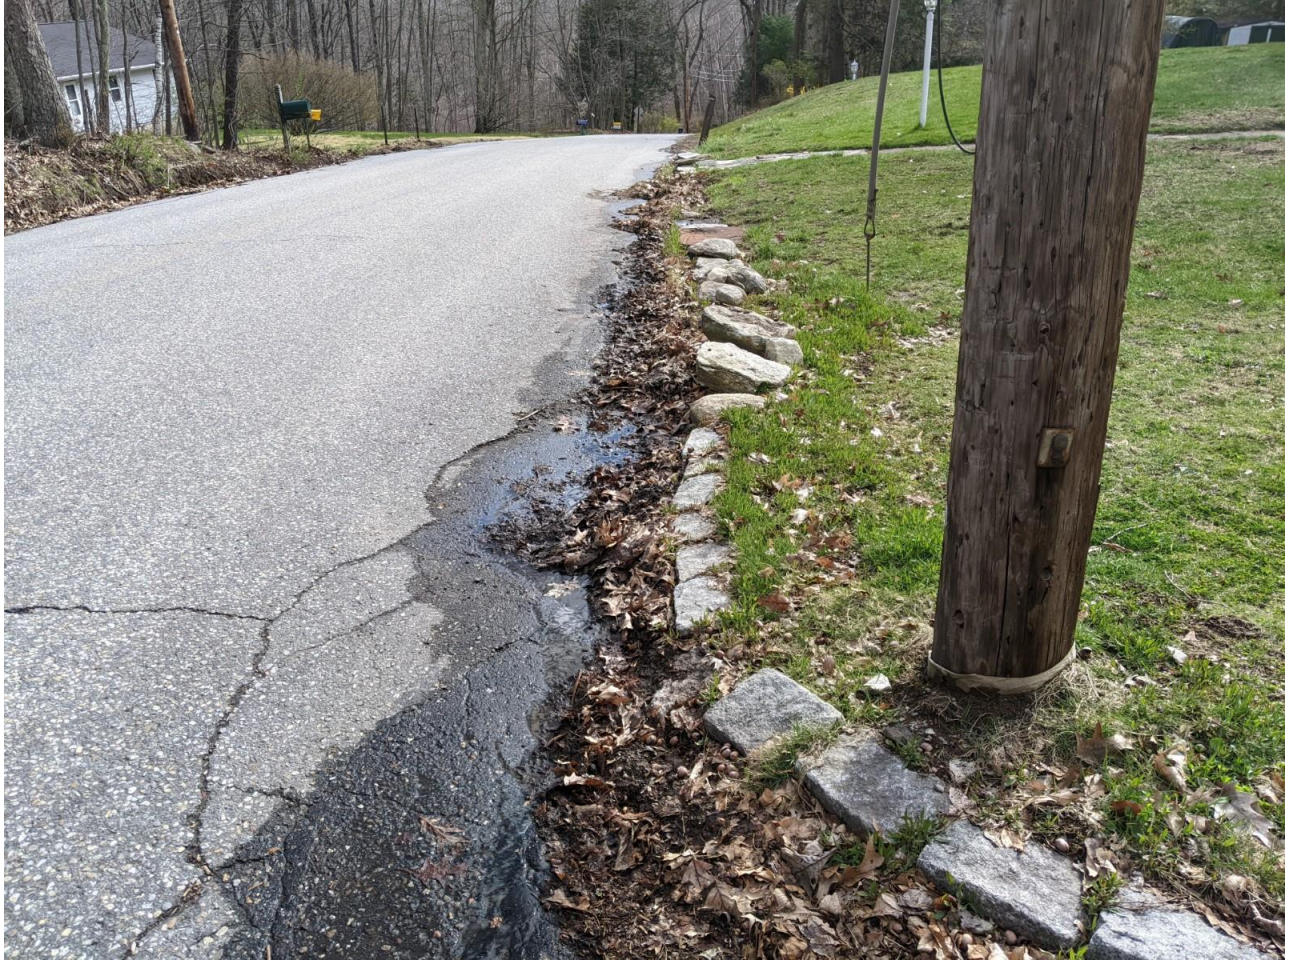
6- View from right-hand corner of Birch Dr. looking east on Shoddy Mill Rd. 43 Shoddy Mill is visible on the left. A catch basin will be installed at this corner and pipe will be run along right-hand side of Shoddy Mill to a catch basin.

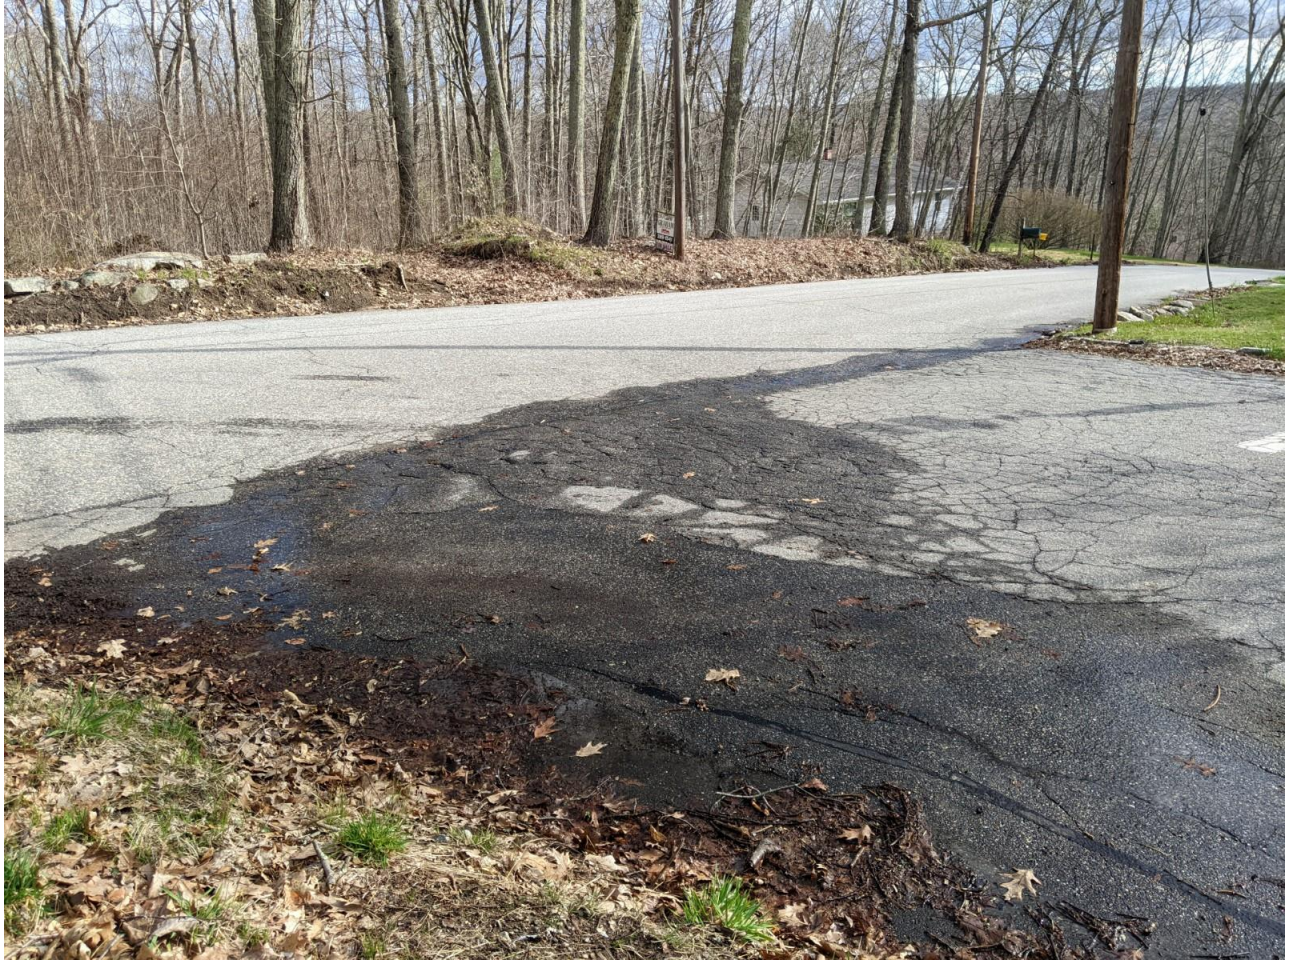
*7- View of intersection of Birch Drive and Shoddy Mill Rd, looking northeast toward Shoddy Mill Rd. 43 Shoddy Mill Rd. is near the top right of the photo. Catch basins will be installed and connected with pipe at each corner of Birch Dr.*

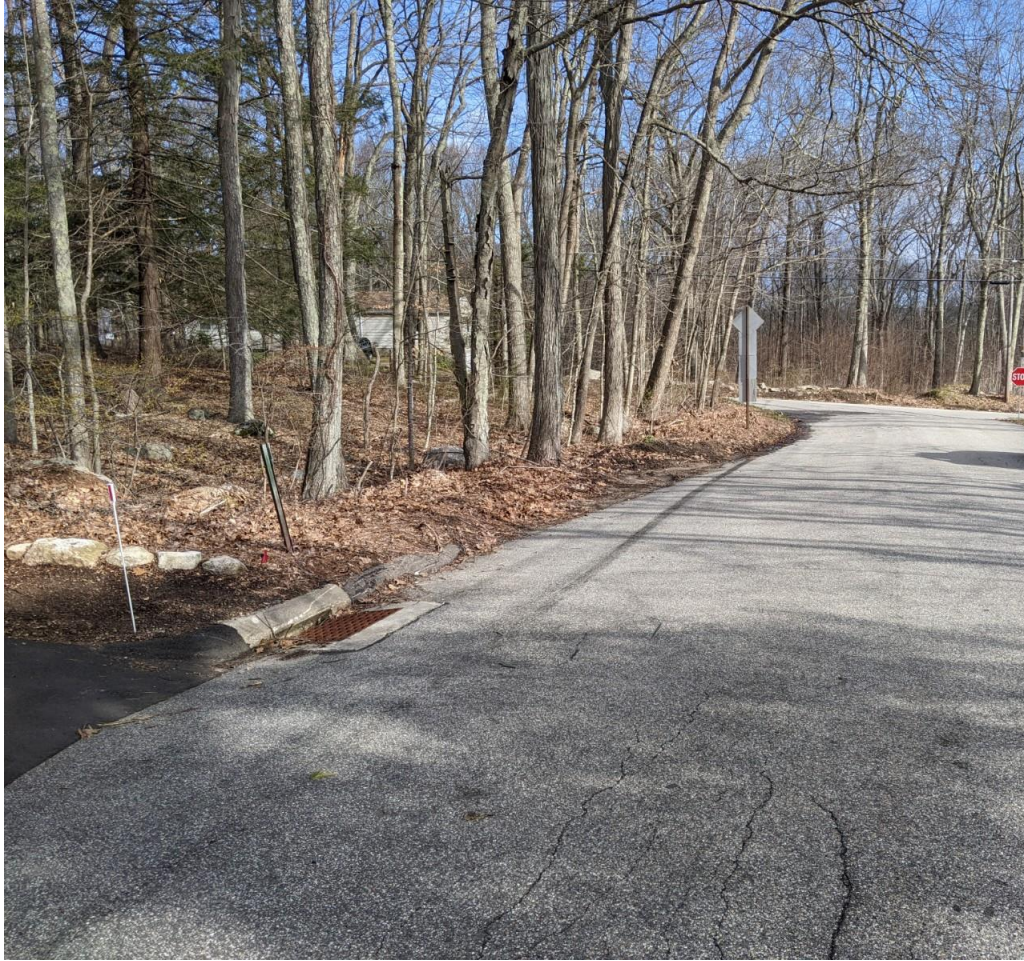
*8- View of left-hand side of Birch Drive. Shoddy Mill intersection is in the background. New catch basins, curbing, and piping will be installed in this area to capture runoff that currently flows onto the road.*

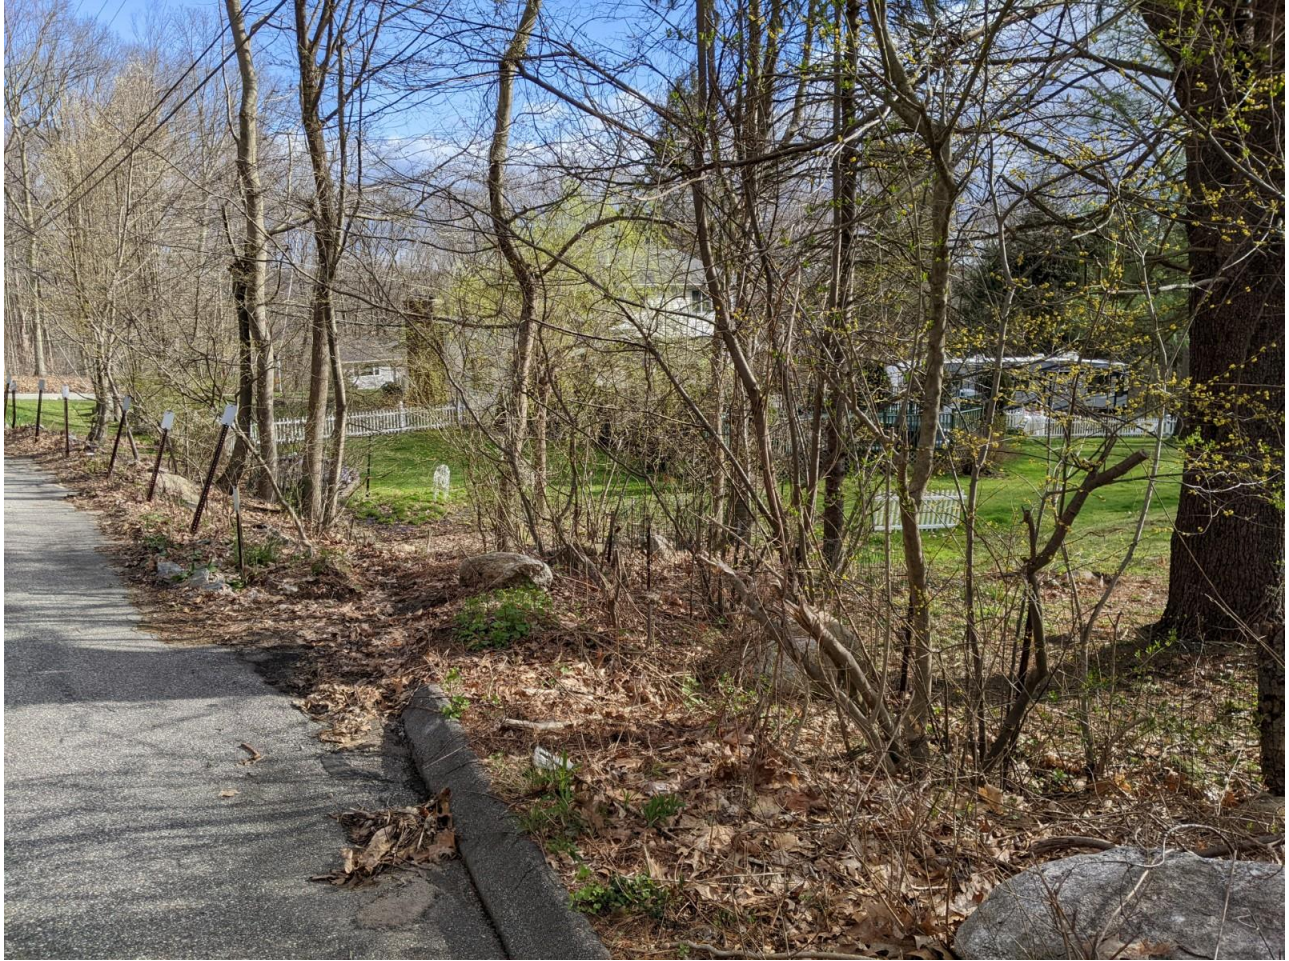
9- View of right-hand side of Birch Dr. 46 Shoddy Mill Rd. is in the top right of the photo. Curbing will be extended to redirect road runoff to the improved storm drains, away from the watercourse and undersized pipe on the 46 Shoddy Mill Rd. property.

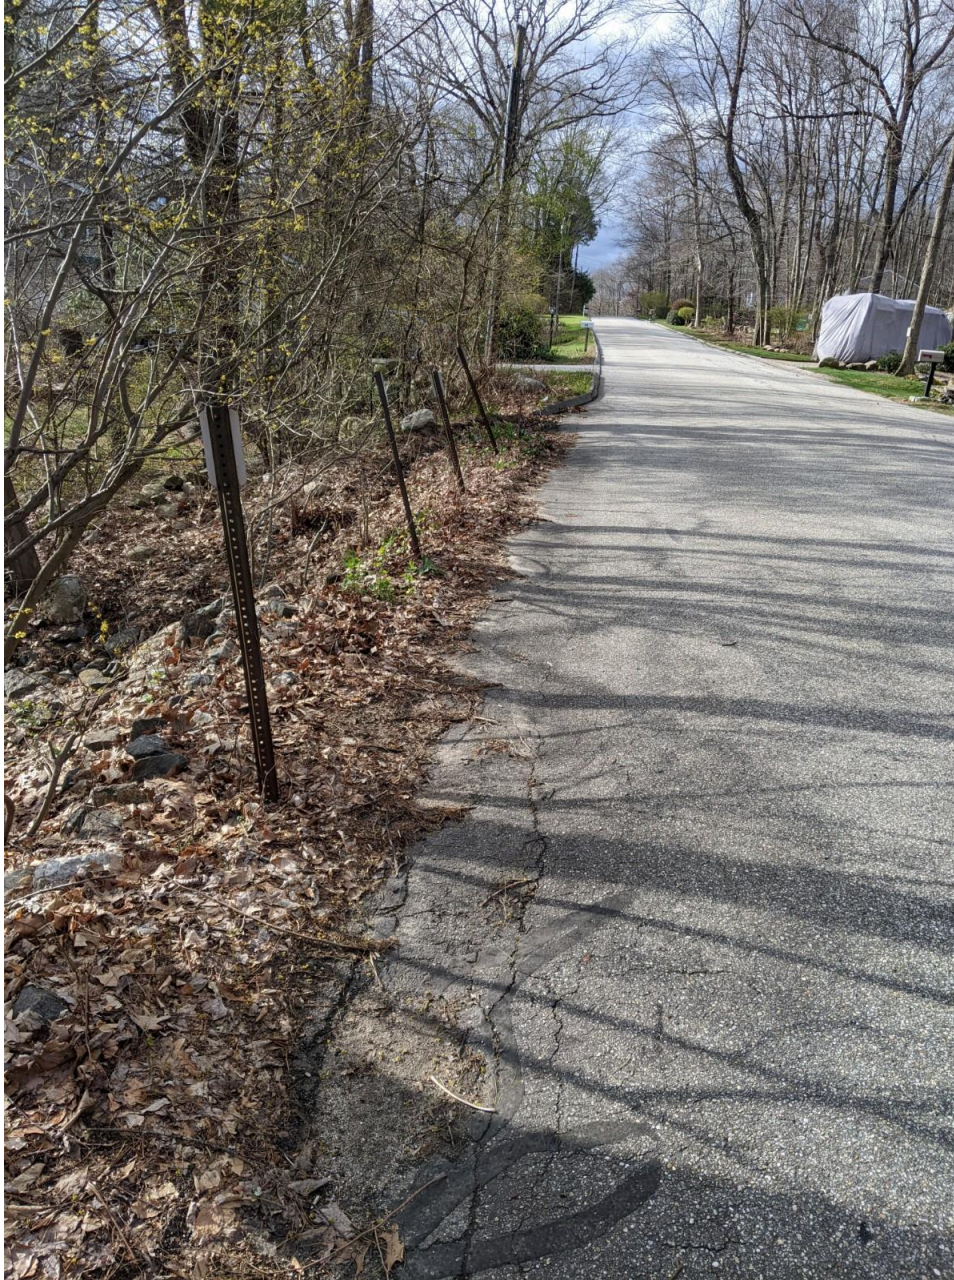
*10- Looking south along Birch Dr. 10 Birch Dr. is on the right of the photo. The curbing that will be extended is visible in the center of the photo.*

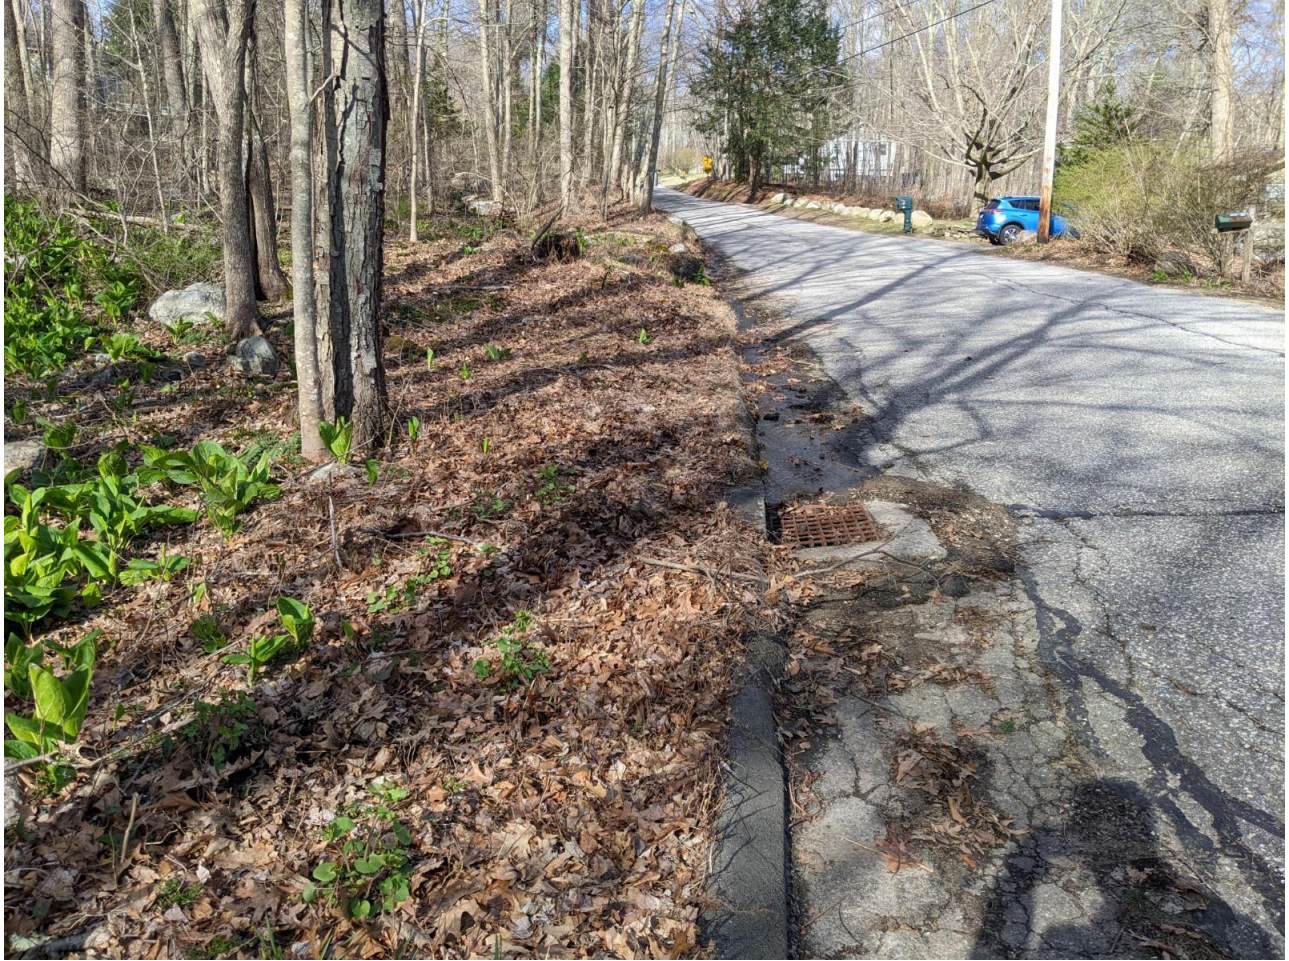
*11- Looking west along Shoddy Mill Rd. Watercourse is seen flowing along roadside and draining into a catch basin near 34 Shoddy Mill Rd.*

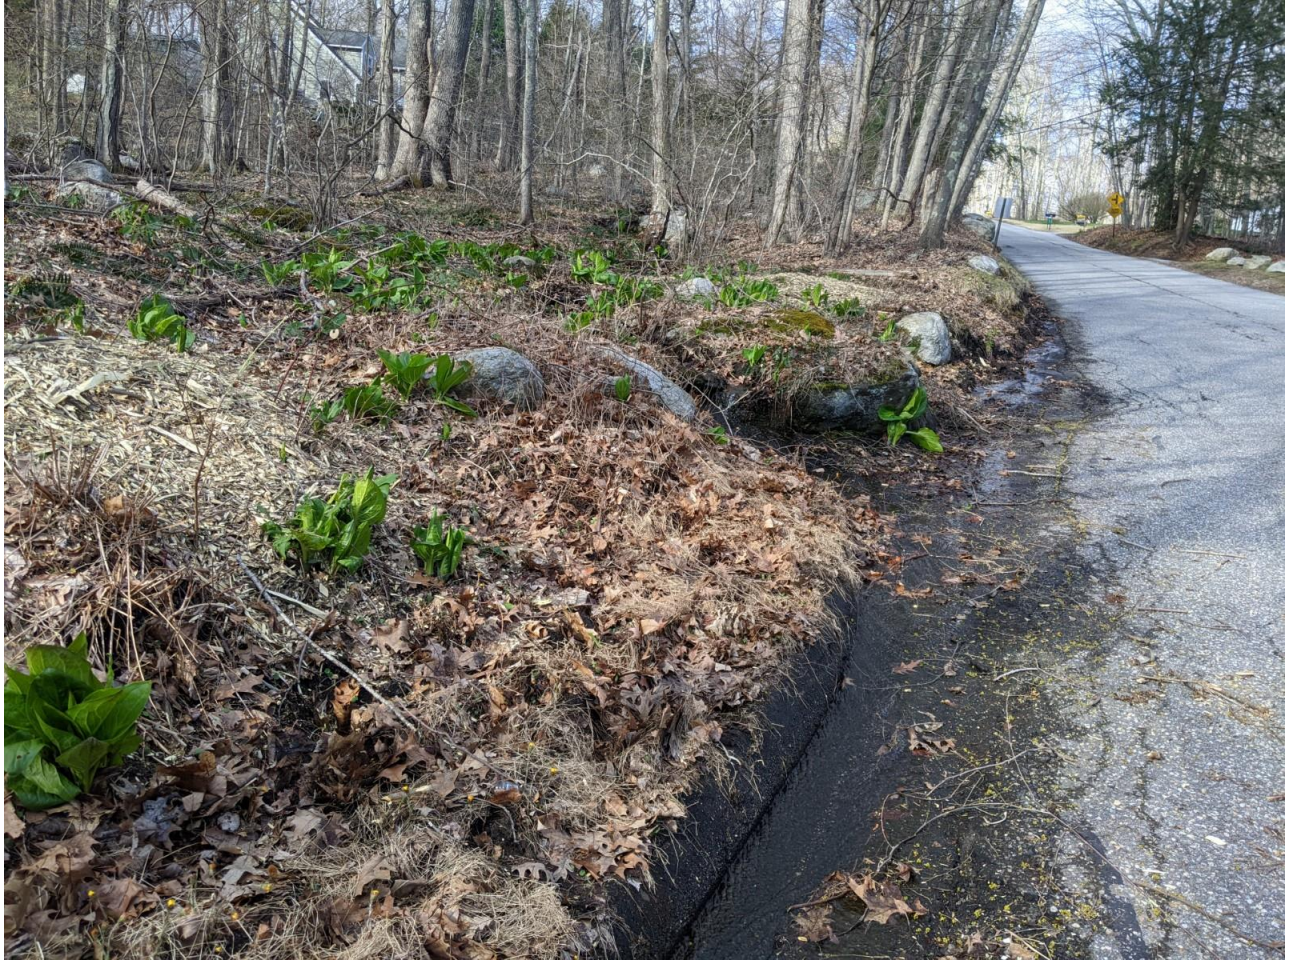
*12- Looking west at watercourse flowing off hillside and onto Shoddy Mill Rd near 34 Shoddy Mill Rd property.*

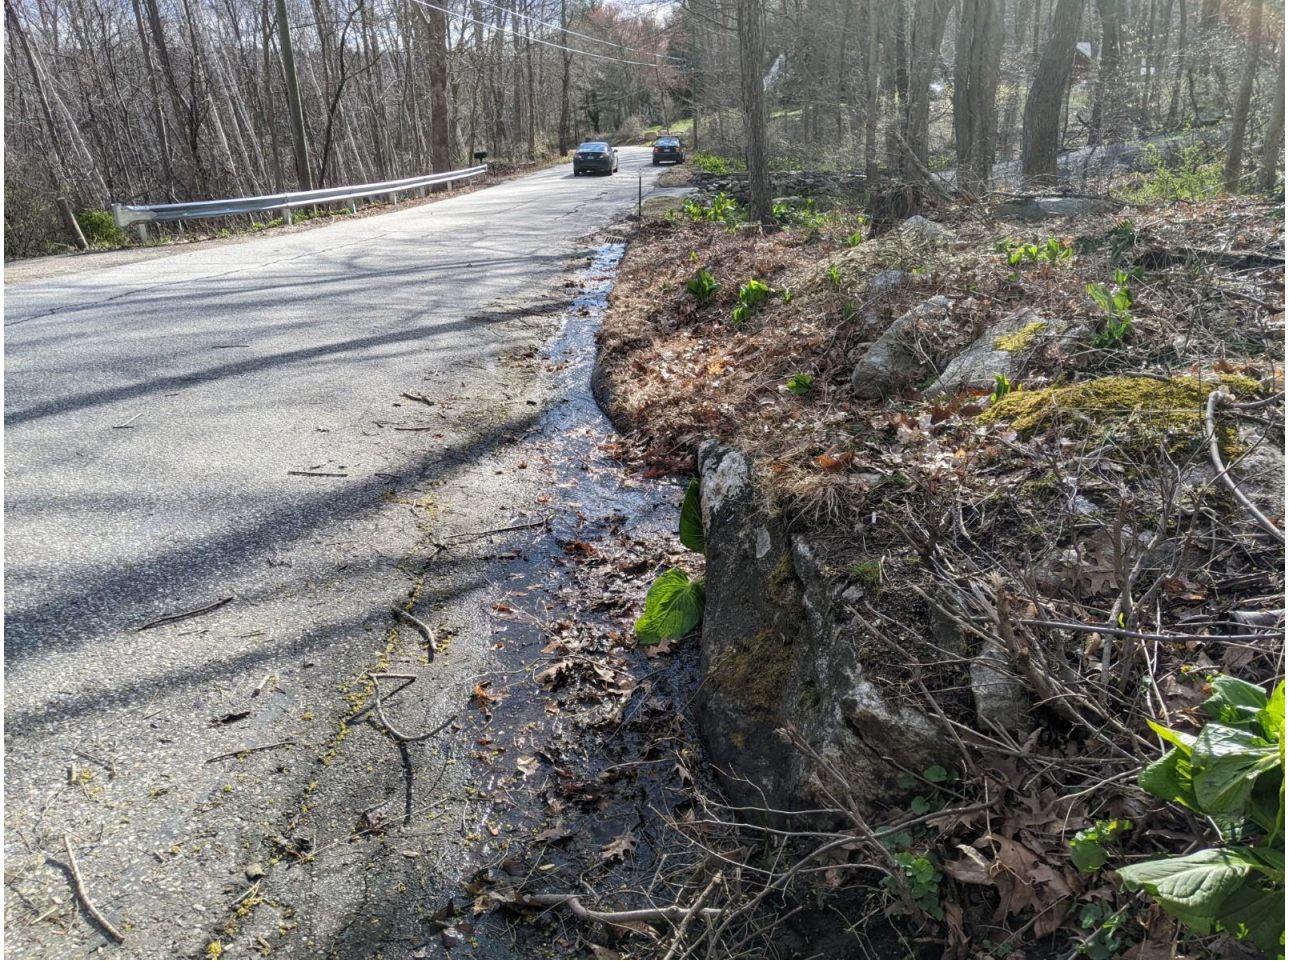
*13- Looking east along Shoddy Mill Rd. House #34 is on the right. Watercourse is seen flowing along edge of road until it enters a catch basin.*

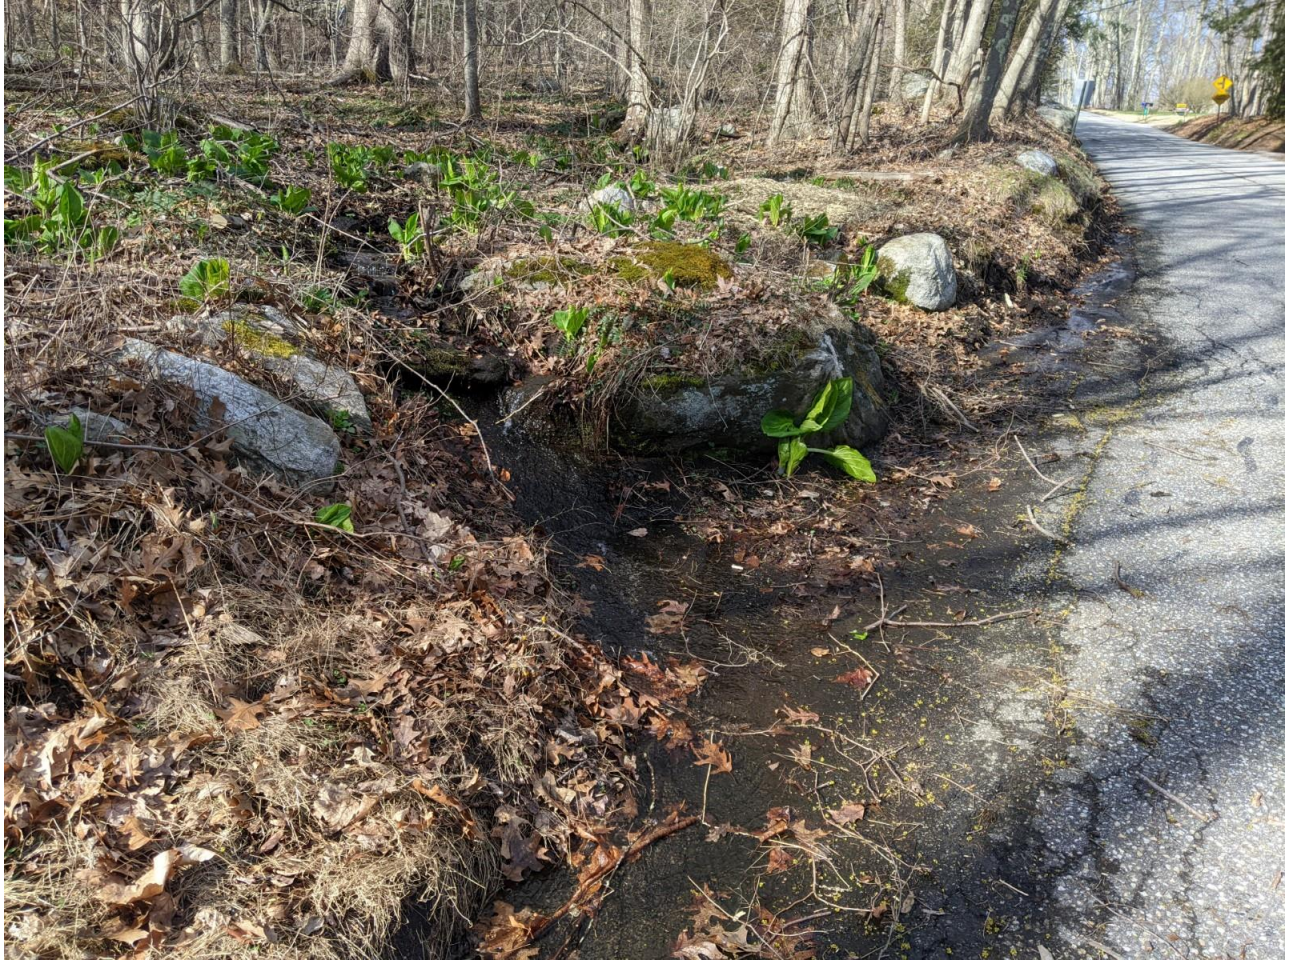
14- View of watercourse flowing down hill and onto Shoddy Mill Rd on/near the 34 Shoddy Mill Rd. property.

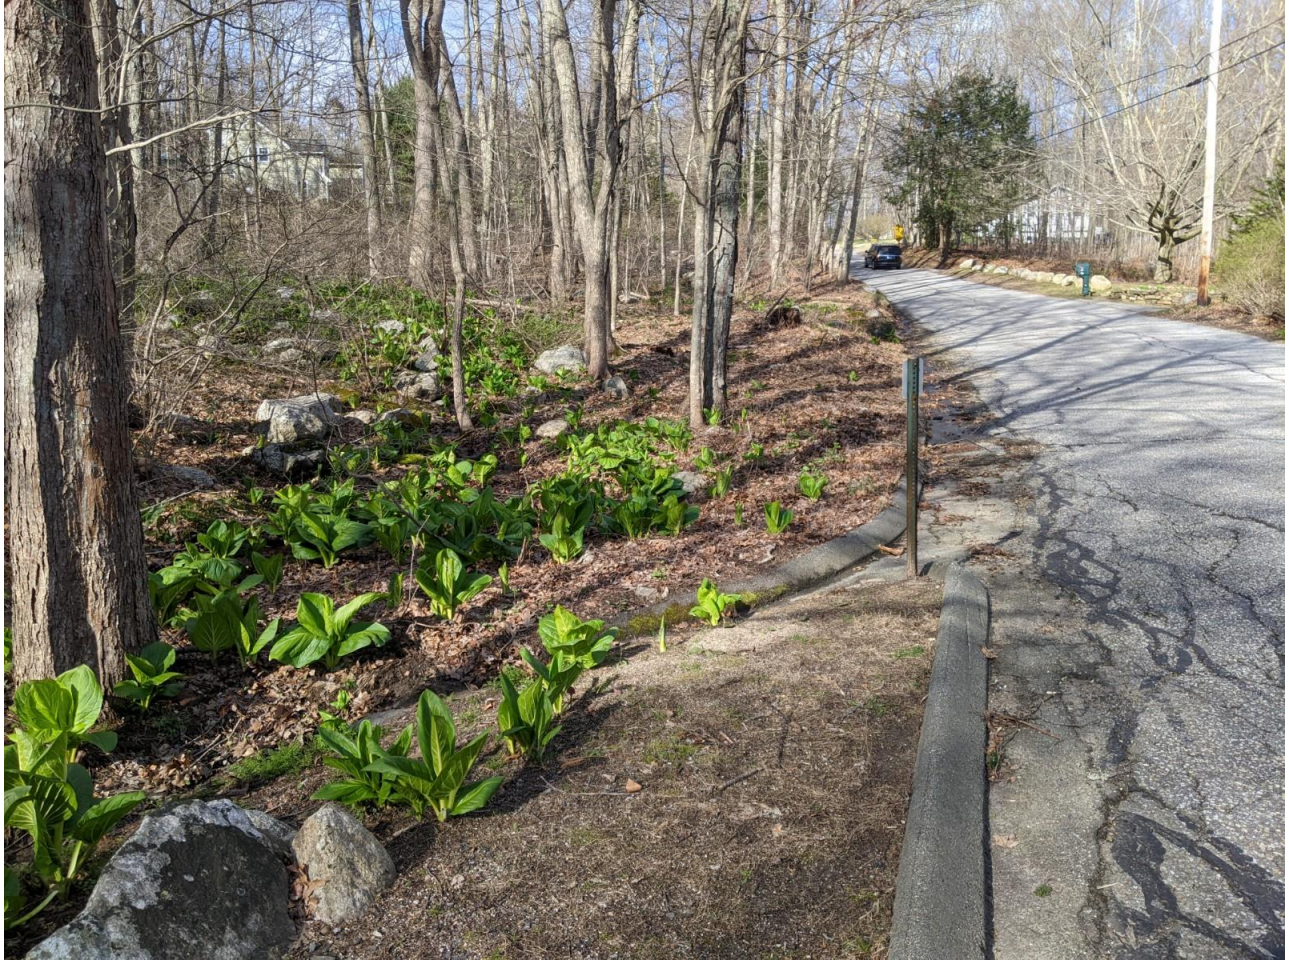
*15- Looking west along Shoddy Mill Rd. House #34 is on the left. The watercourse will be relocated off the road and a plunge pool will be constructed near the center of the photo. Pipes will connect the pool to the catch basin and to the other stream.*

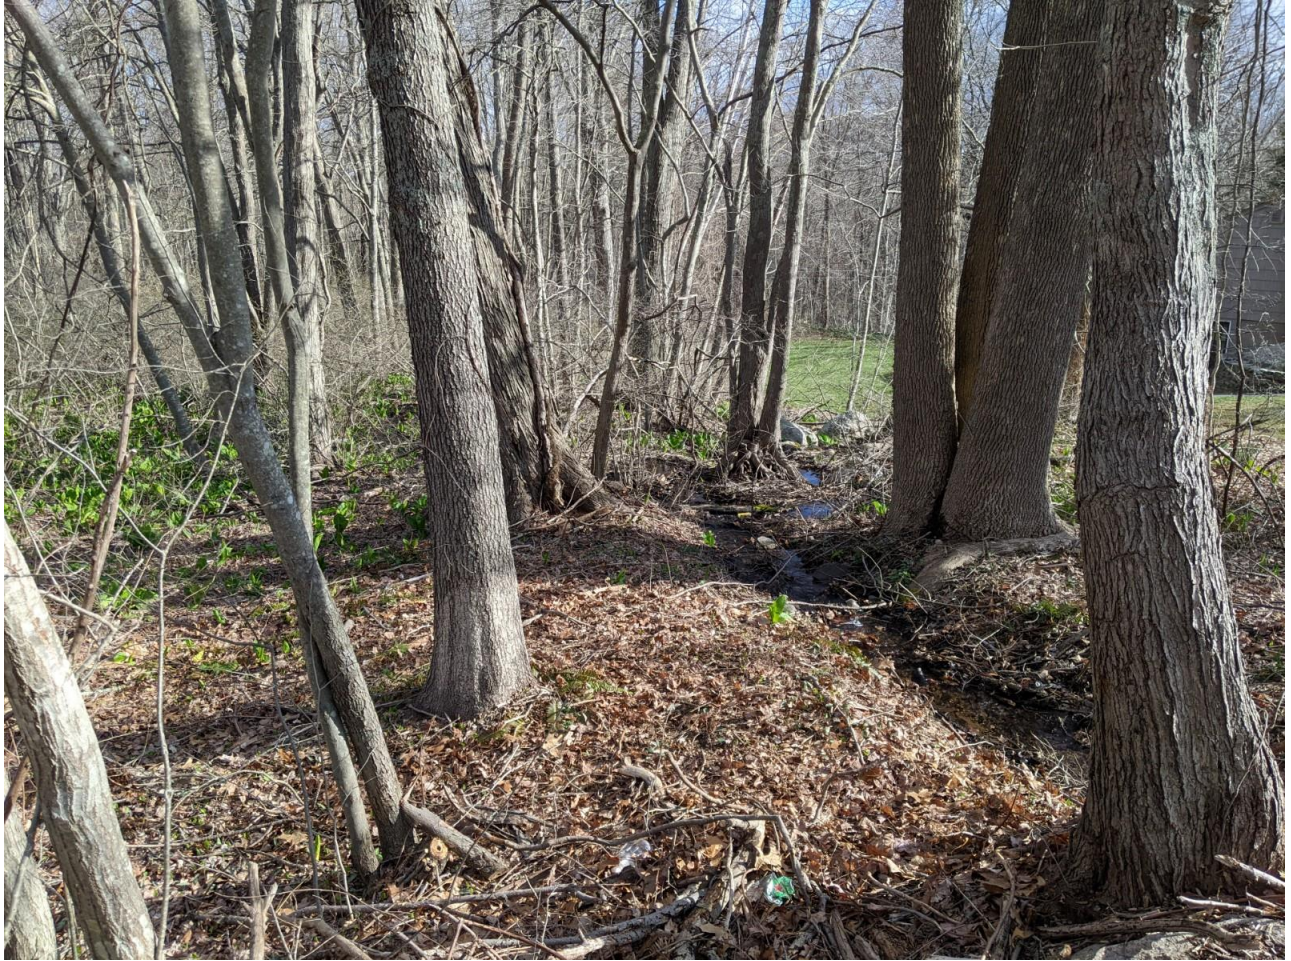
*16- View of stream as it exits culvert and flows north along 23 Shoddy Mill Rd property. Channel split can be seen near the center of the photo, where the water exits the channel and flows onto the yard of 23 Shoddy Mill Rd.*

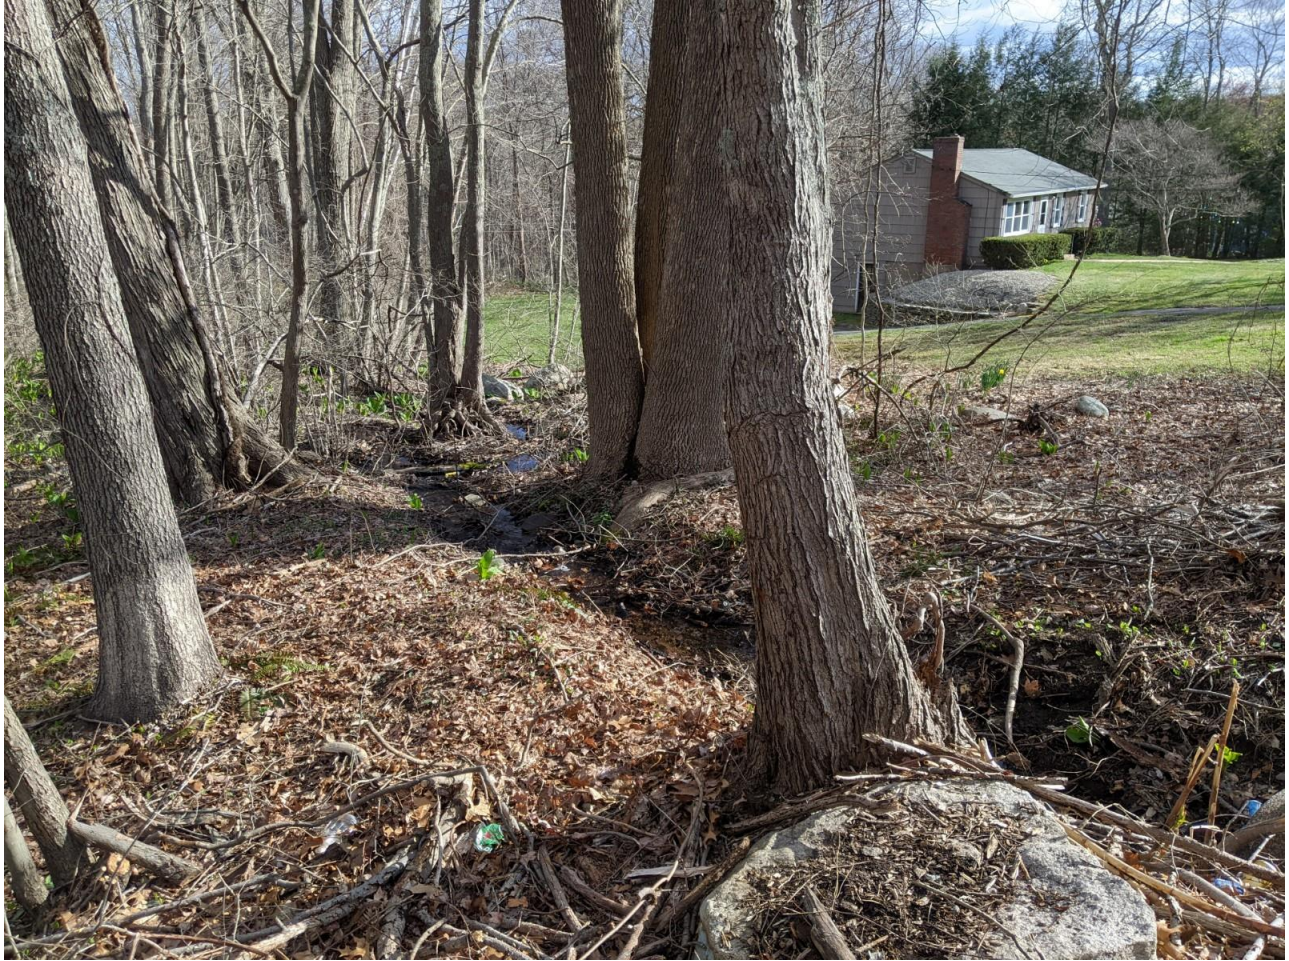
*17- Another view of stream as it exits culvert and flows north along 23 Shoddy Mill Rd property. Channel split can be seen near the center of the photo, where the water exits the channel and flows onto the yard of 23 Shoddy Mill Rd.*

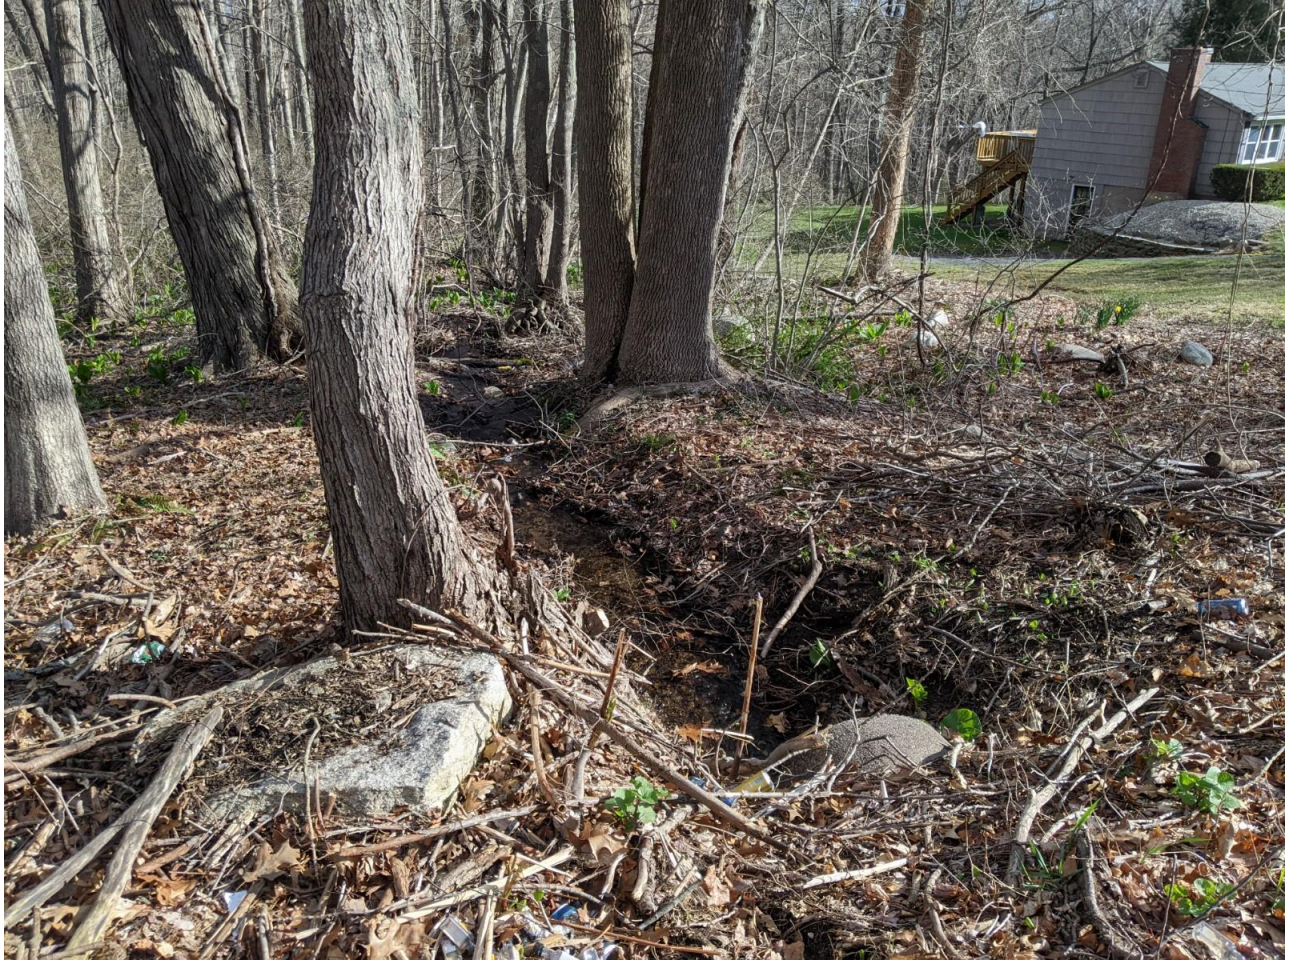
*18- View of outlet to the west of 23 Shoddy Mill Rd. property.*
