IWWC22-02\_Shoddy Mill Rd (TOA) Pictures of Proposed Drainage Project (existing conditions)  
Photos taken by Agent 04-20-2022

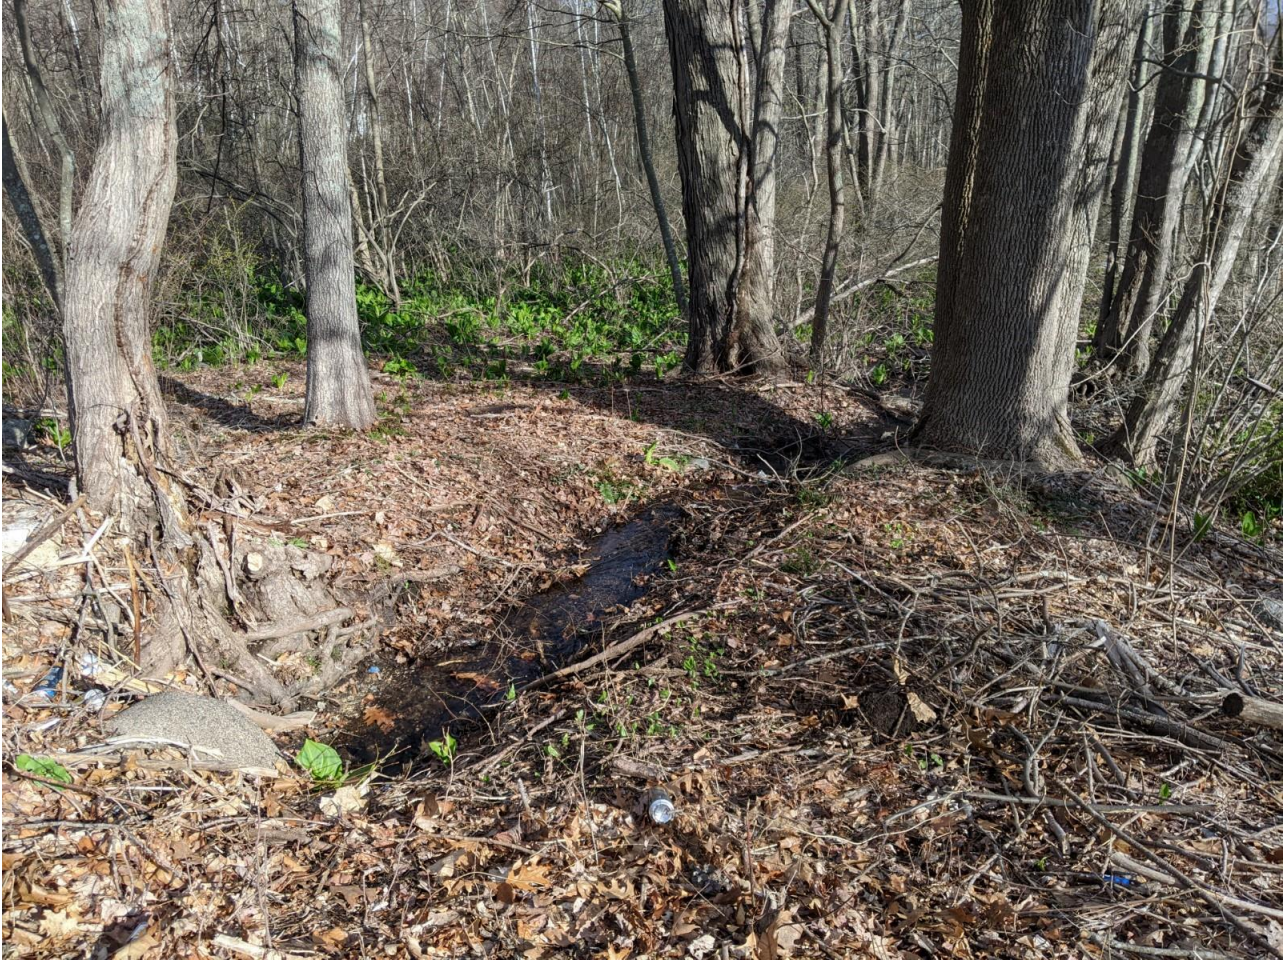
*19- View of outlet to the west of 23 Shoddy Mill Rd property. Stream will be redirected to flow into the wetlands to the north, which are visible in the center-left of the photo.*

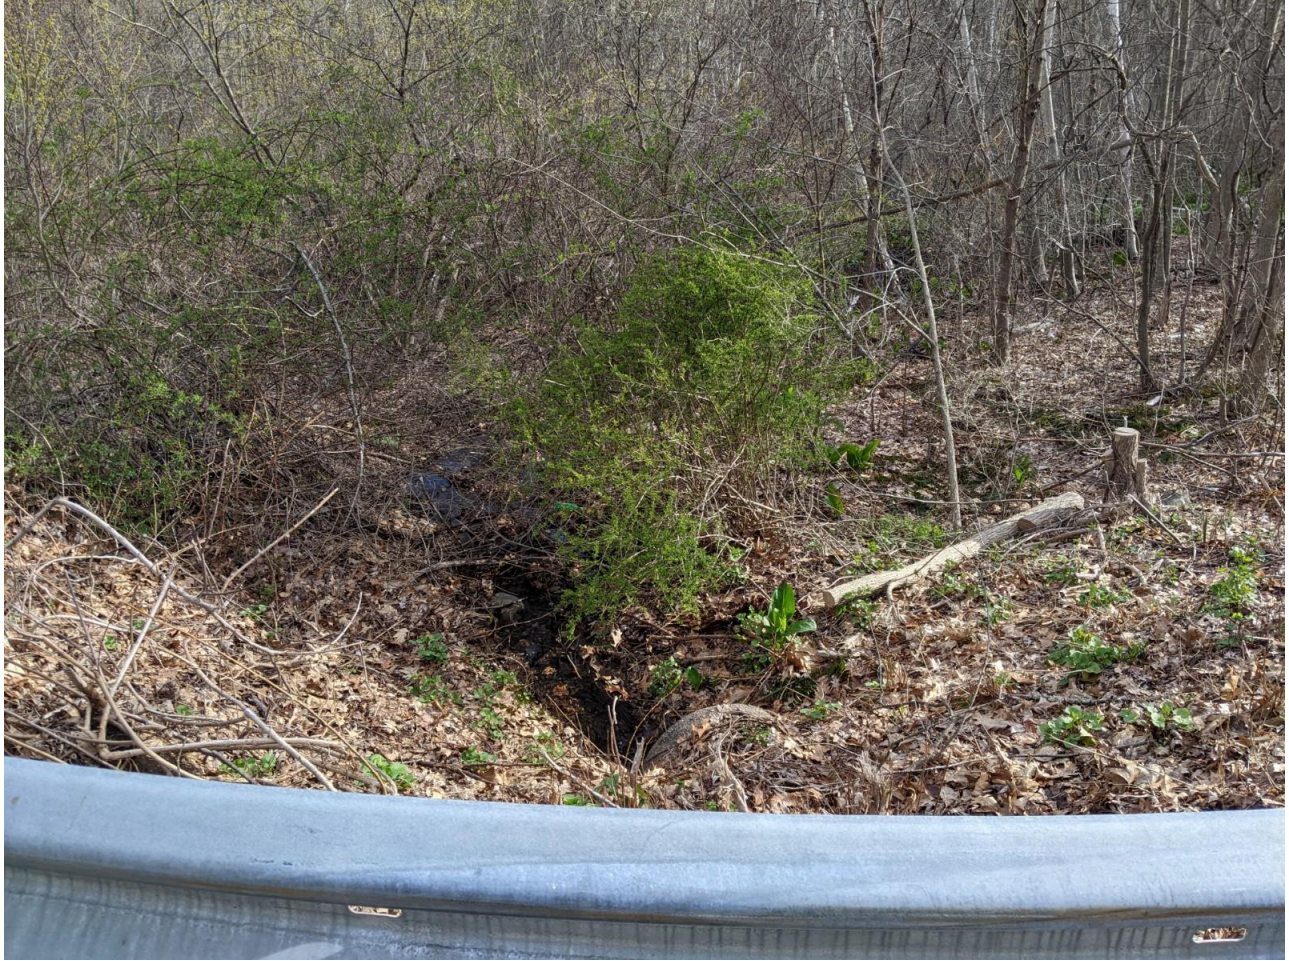
*20- View of western outlet that is across from 34 Shoddy Mill Rd. This outlet drains the watercourse that is currently flowing on the Shoddy Mill road surface.*

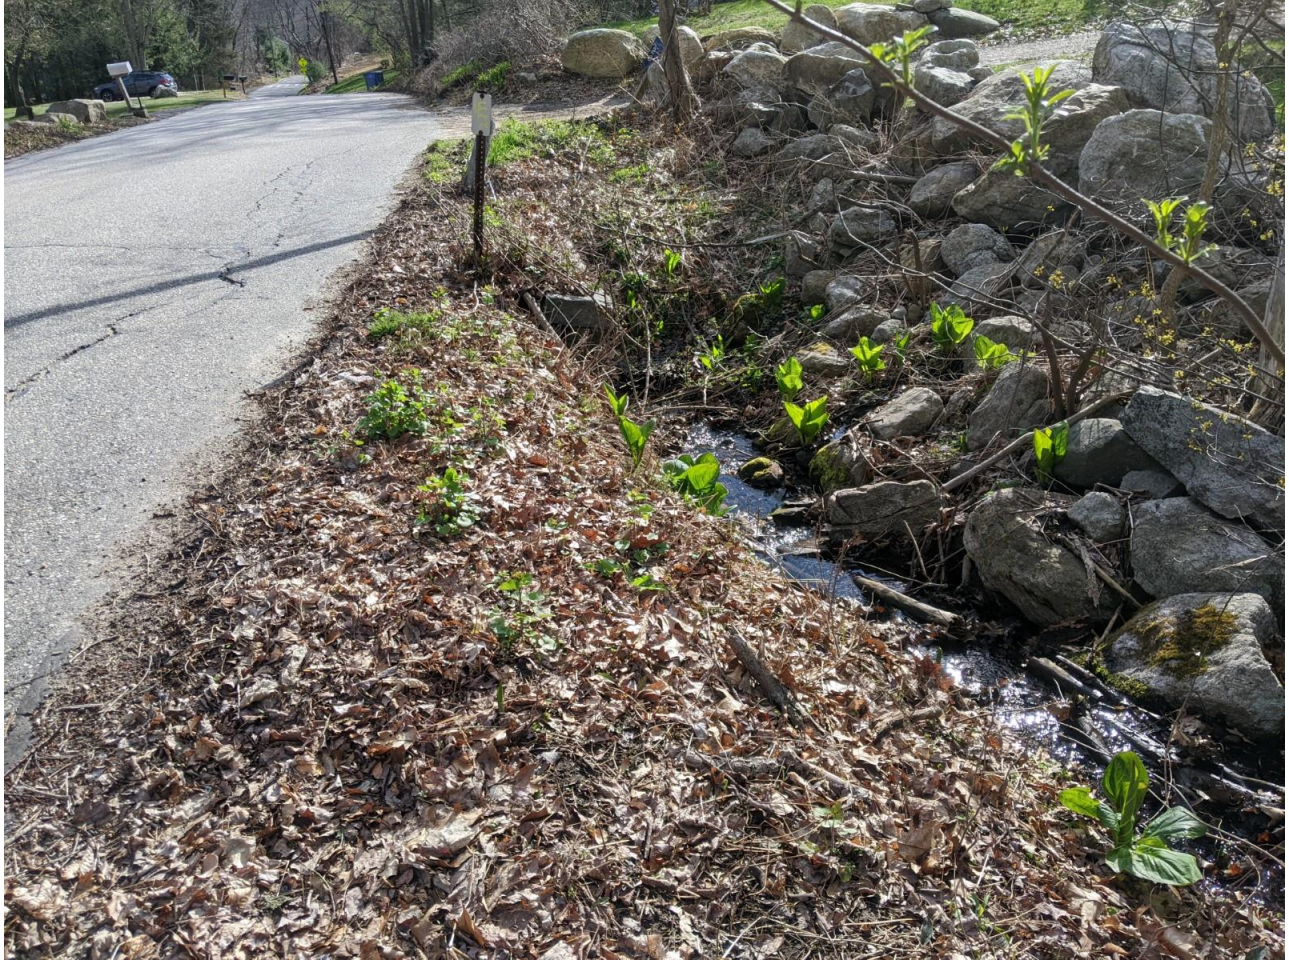
21- View of stream as it enters basin. Water flows under Shoddy Mill Rd and exits to the west of 23 Shoddy Mill Rd.
