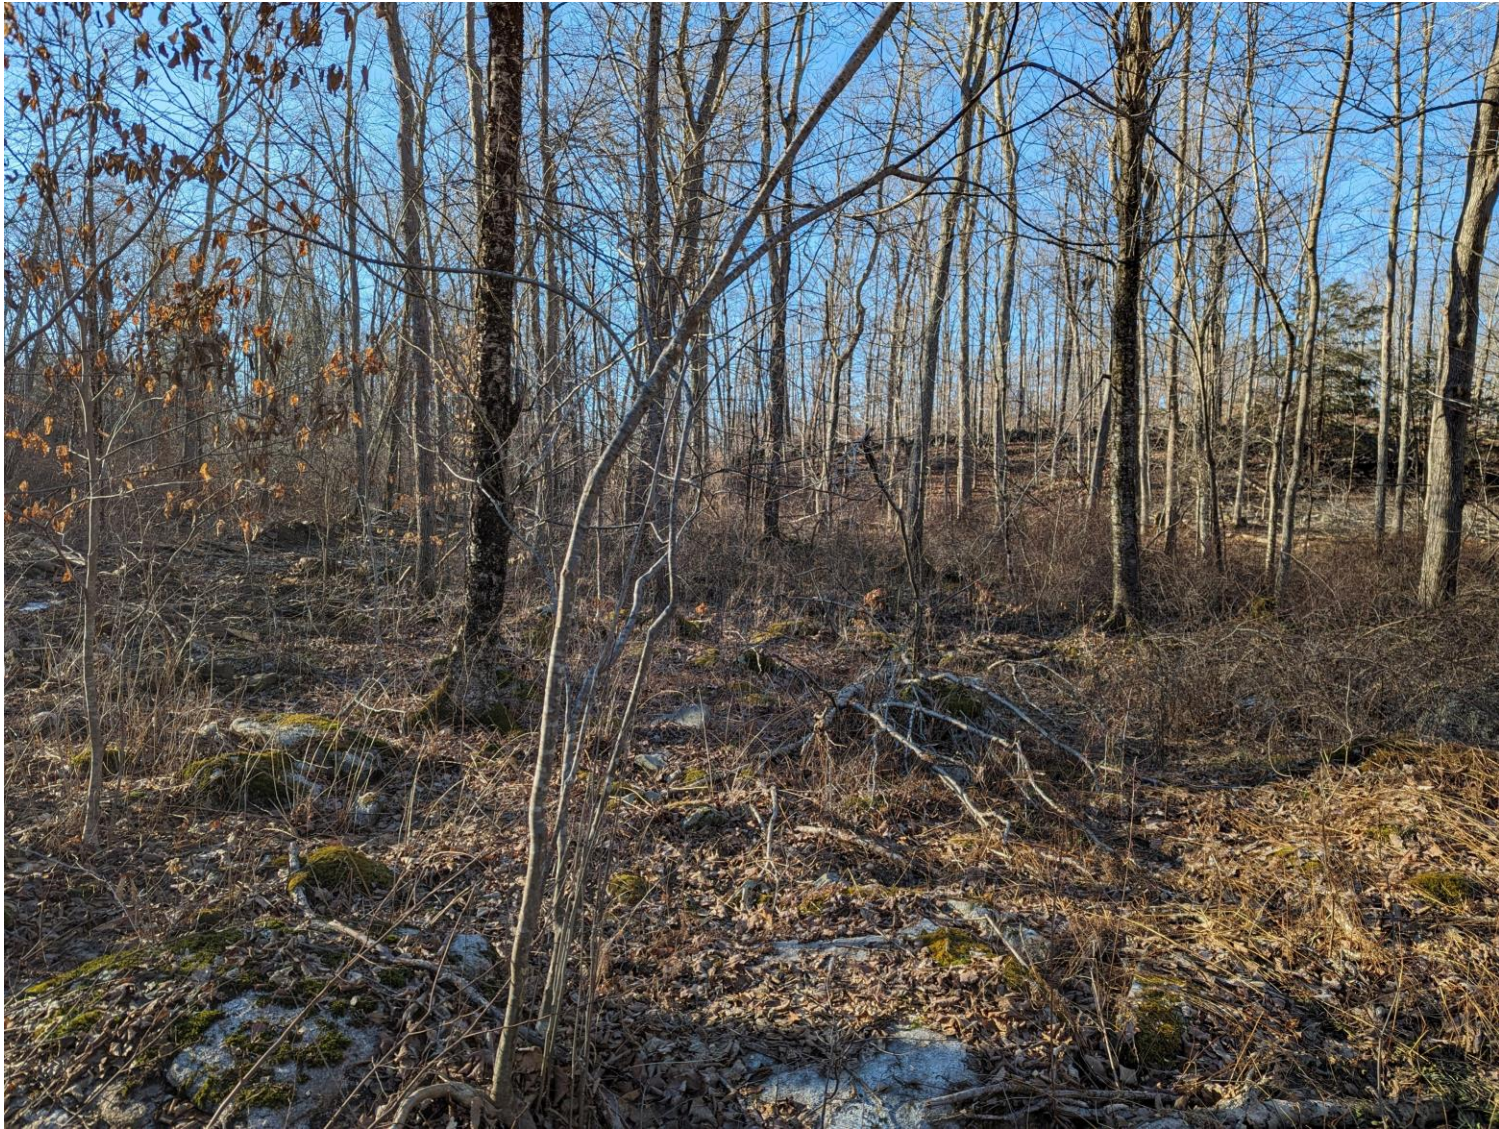
*1 View of unused wetlands crossing, north of main wetlands crossing on the southern end of the harvest*

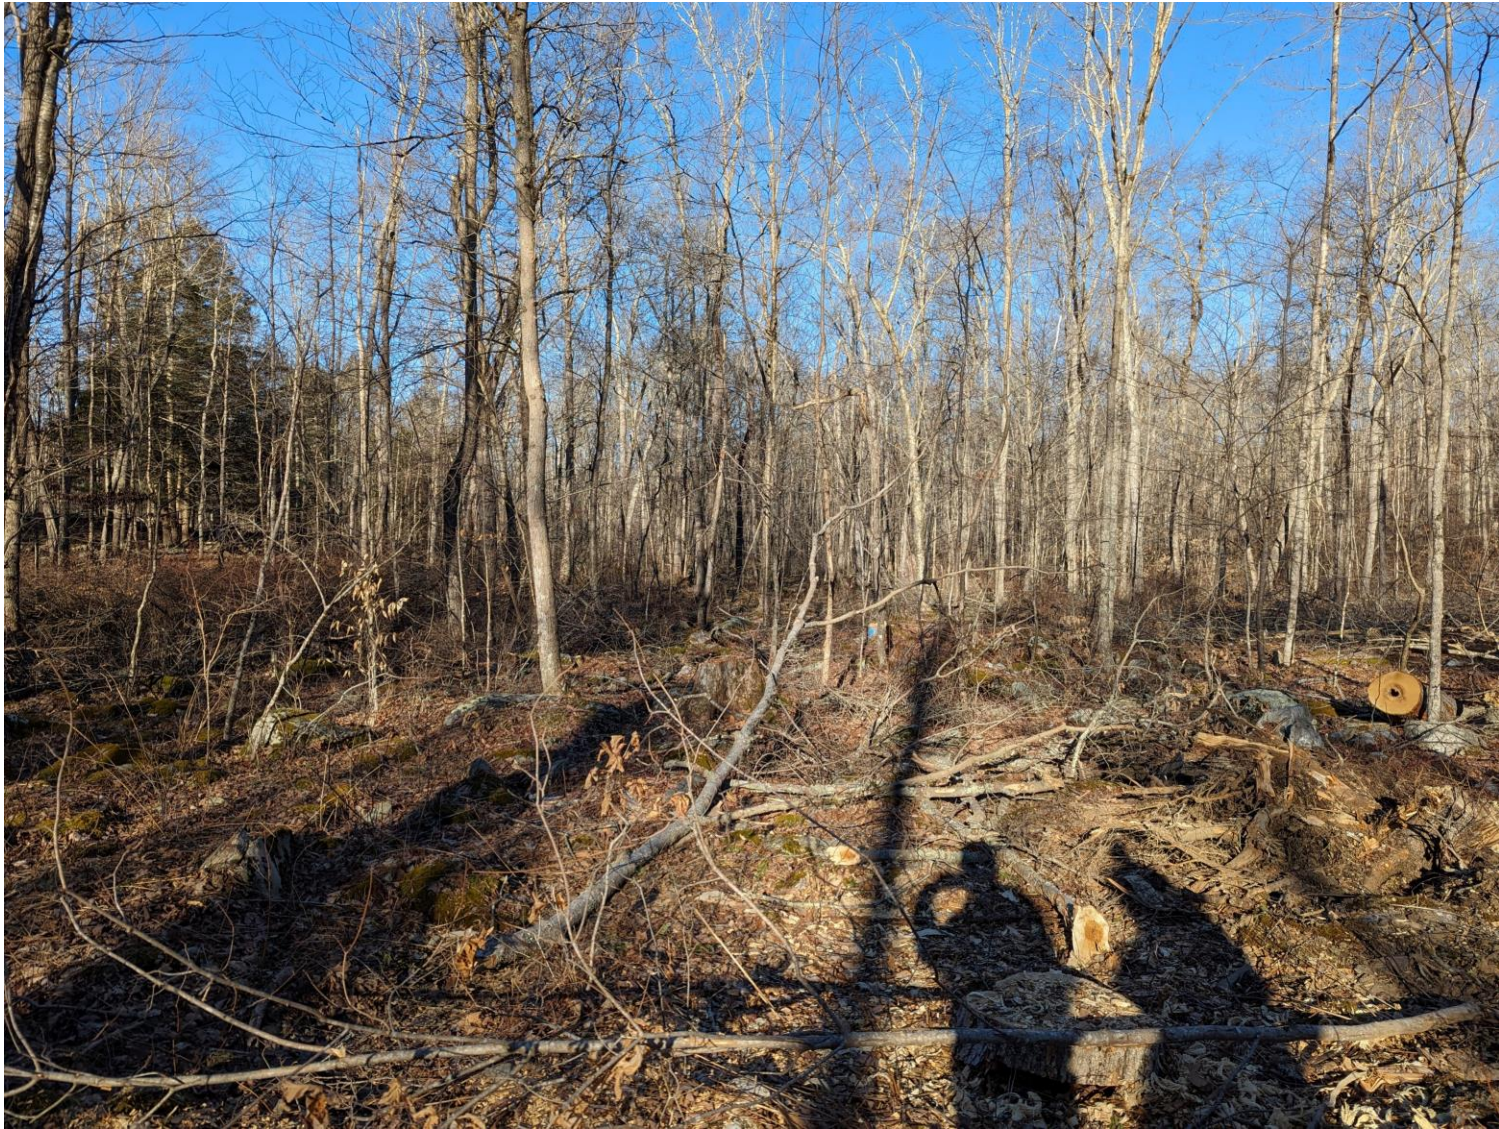
*2 Looking southwest toward main wetlands area. Picture is taken from main skid trail just north of the large wetlands crossing area on the southern end of the property.*

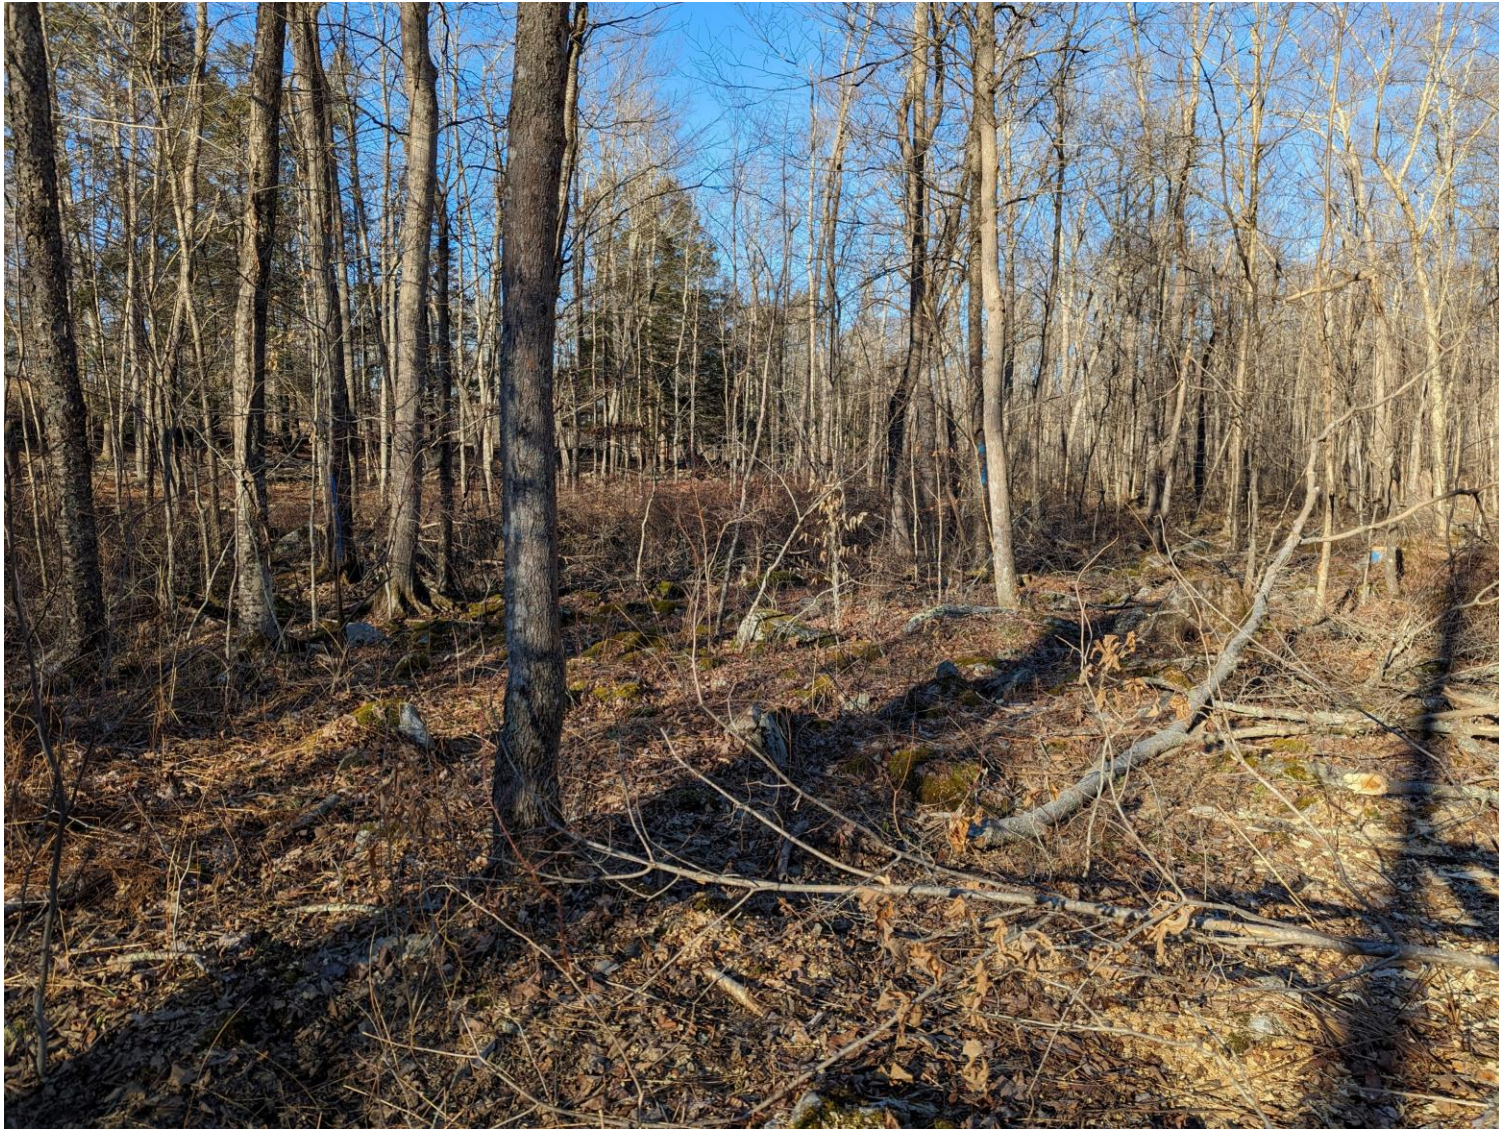
*3 Looking southwest toward main wetlands area. Picture is taken from main skid trail just north of the large wetlands crossing area on the southern end of the property.*

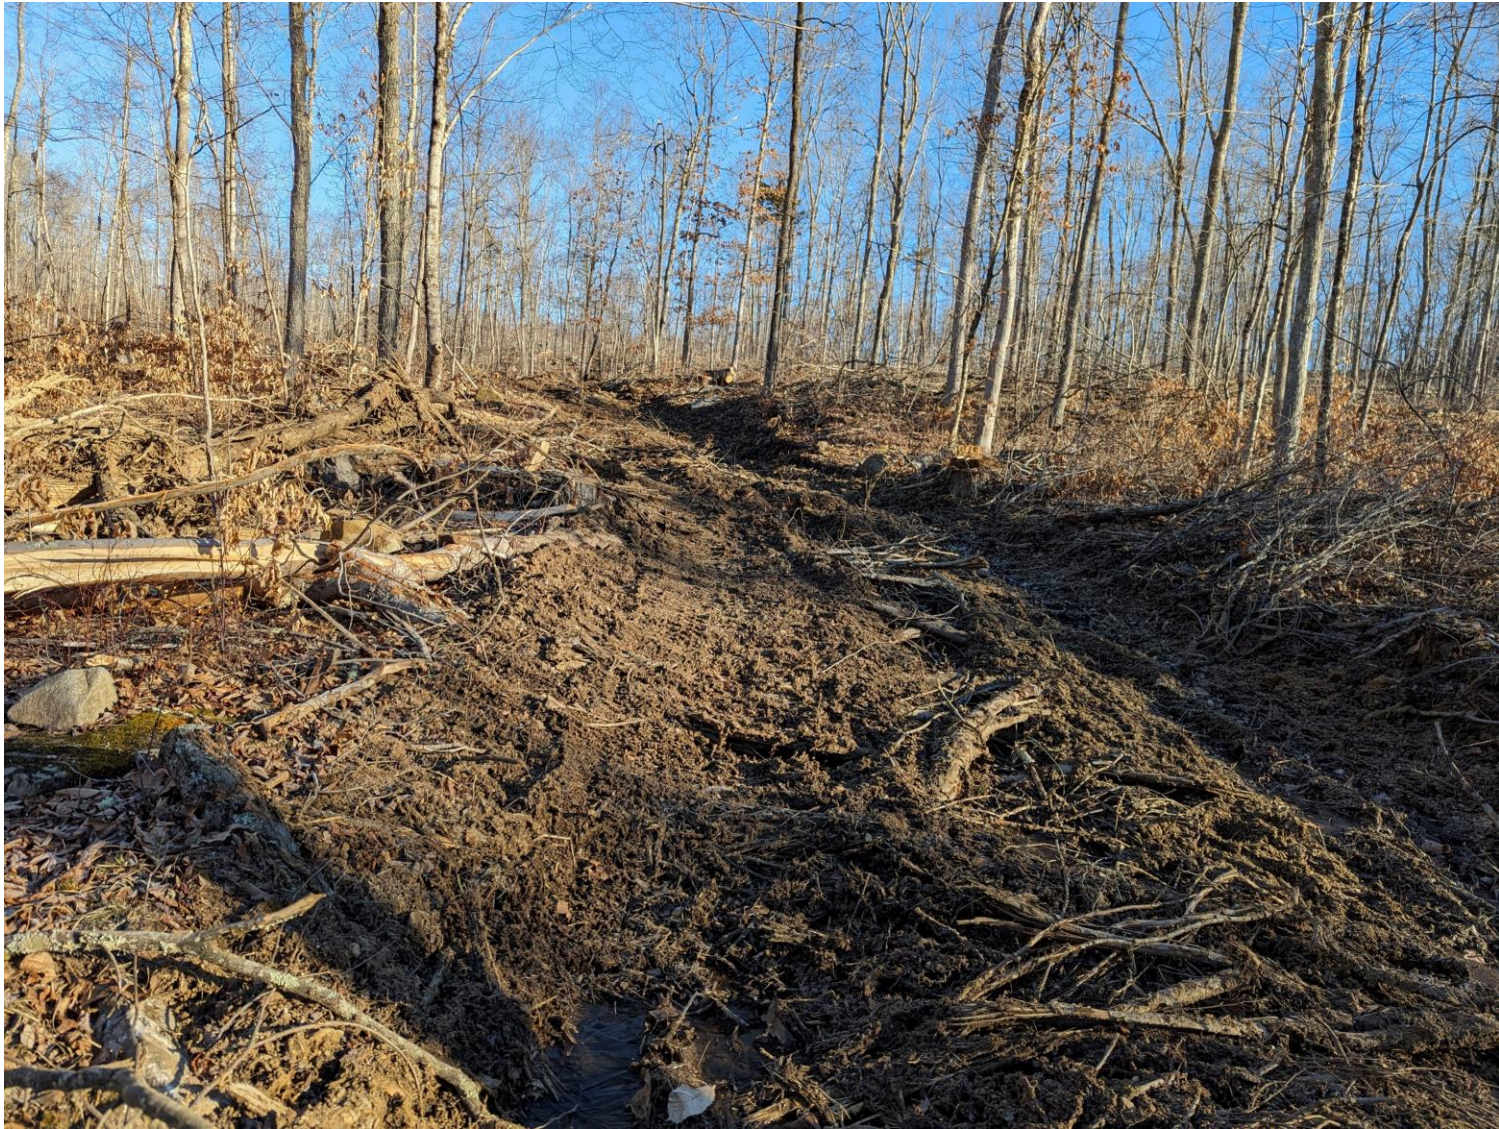
*4- Looking north on main skid trail, north of the large southern wetlands crossing. This area is the most rutted area of the trail and is outside the URA. Area will be filled and raked to eliminate the large rut, and will be seeded in the spring.*

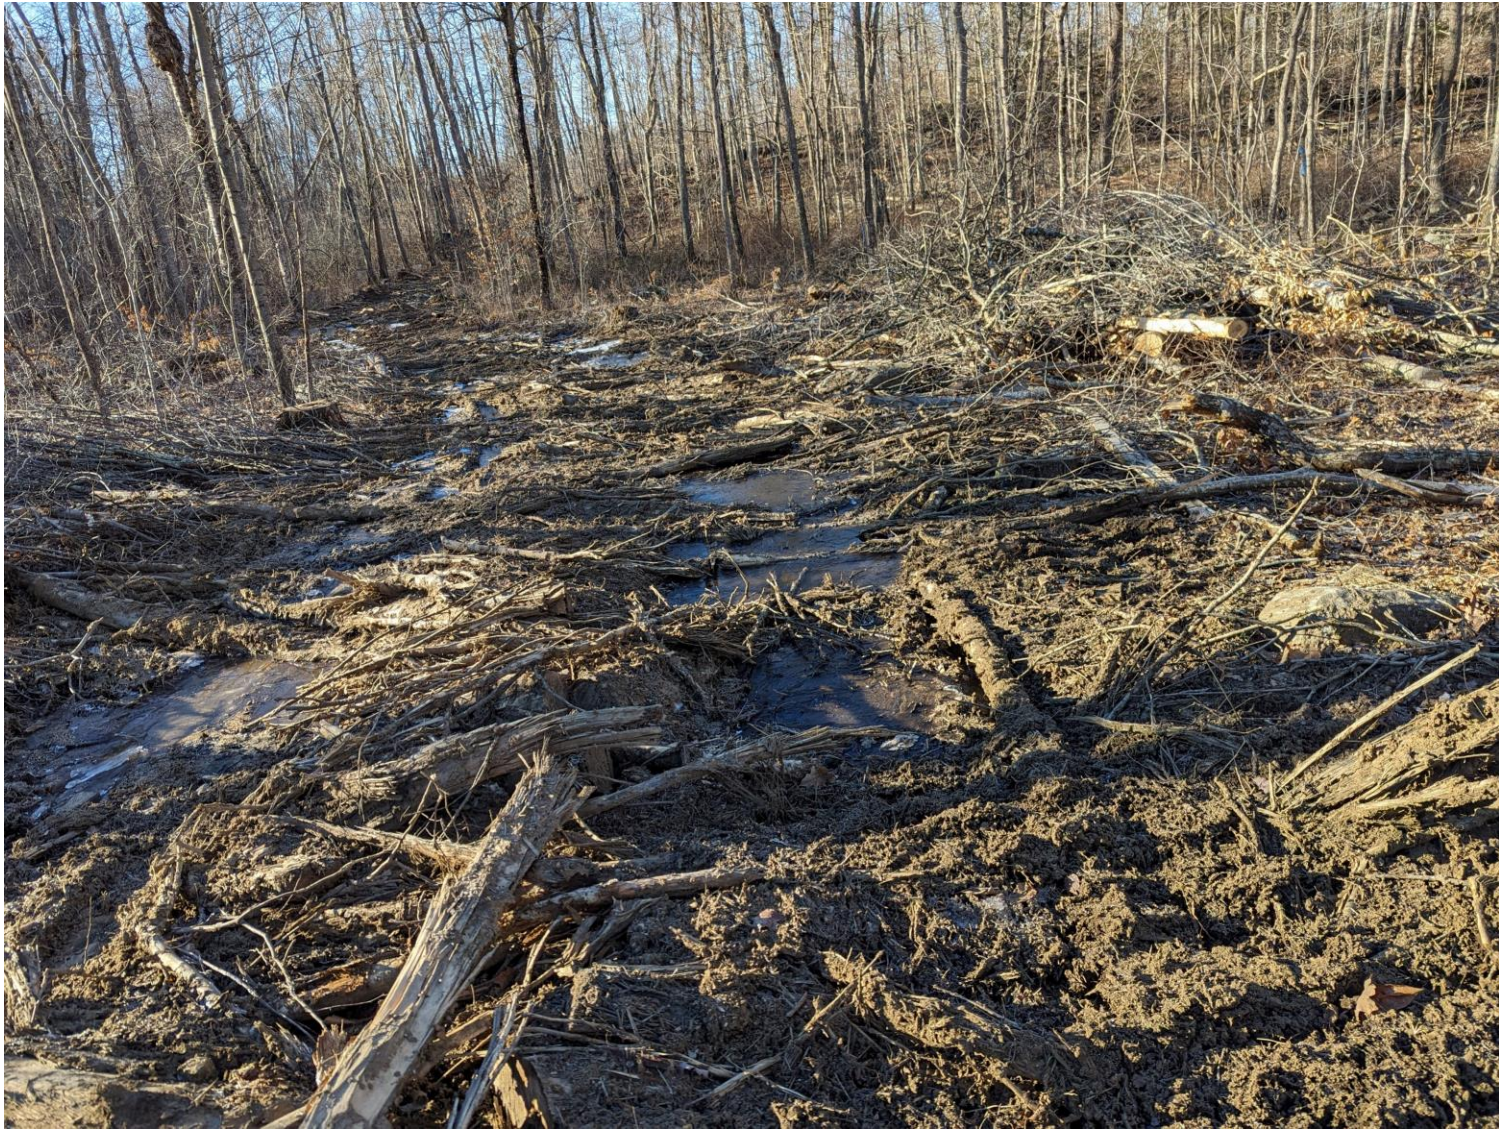
*5- View of approach to wetlands crossing, which is behind me in the photo. Logs and woody debris will remain in trail to stabilize area and limit erosion into the wetland. Exposed soil will be seeded in spring.*

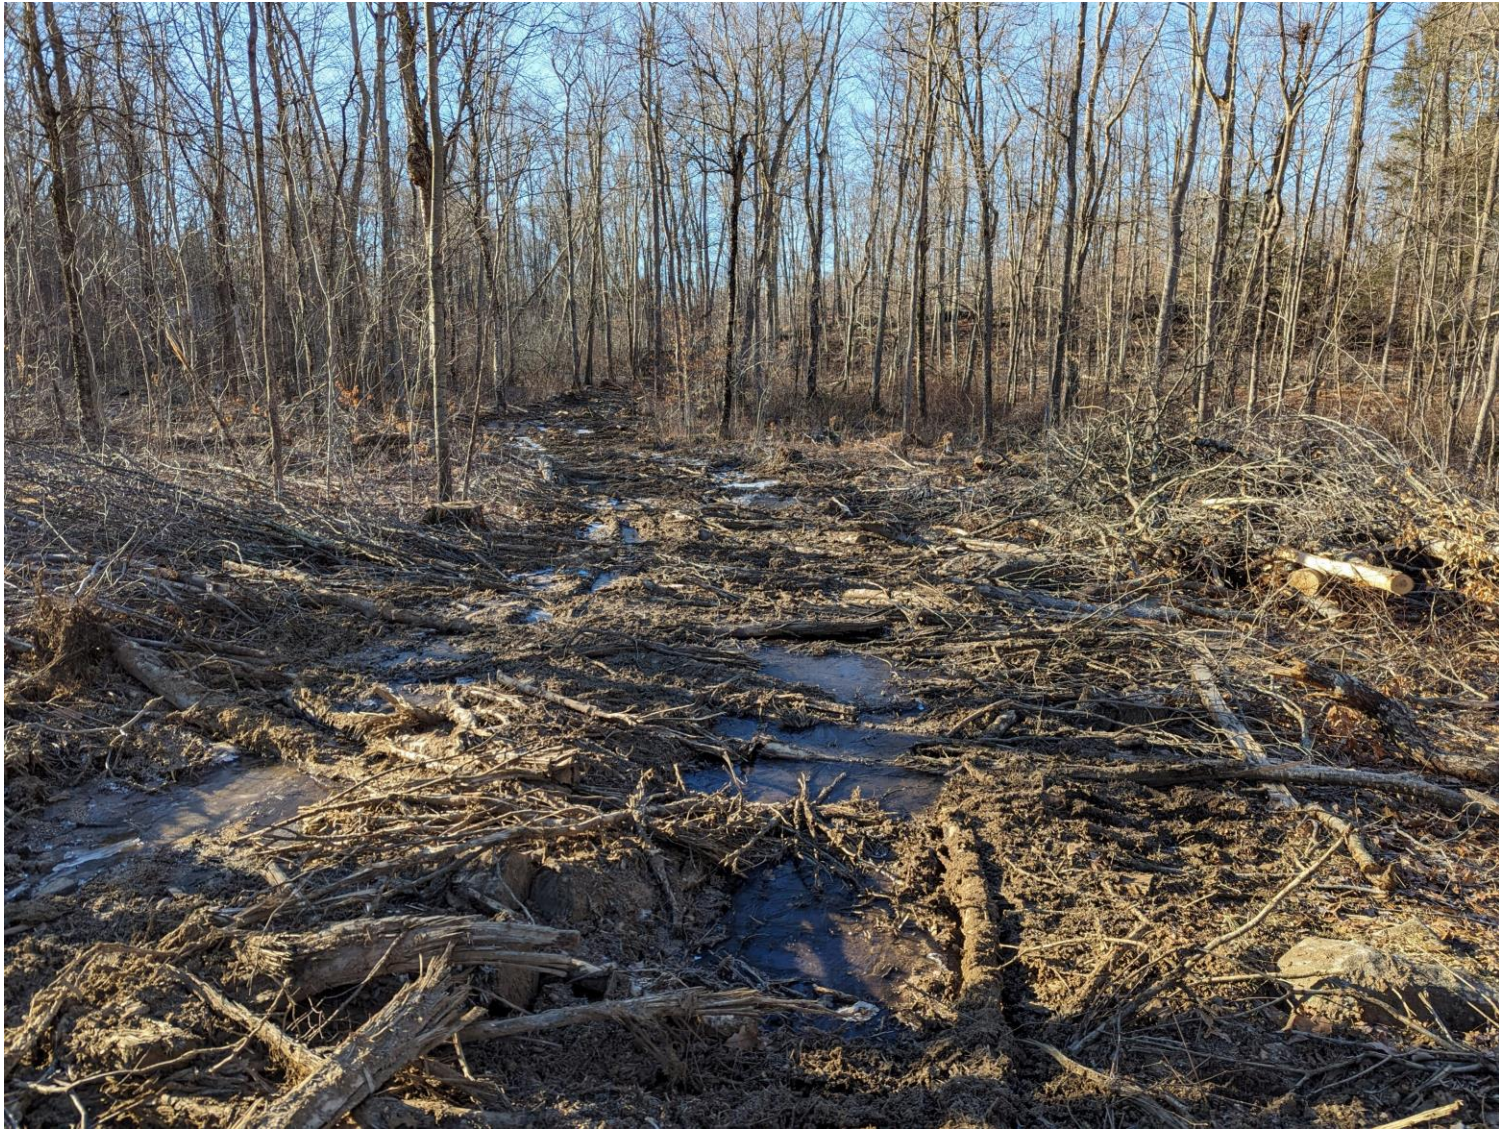
*6 - View of approach to wetlands crossing, which is behind me in the photo. Logs and woody debris will remain in trail to stabilize area and limit erosion into the wetland. Exposed soil will be seeded in spring.*

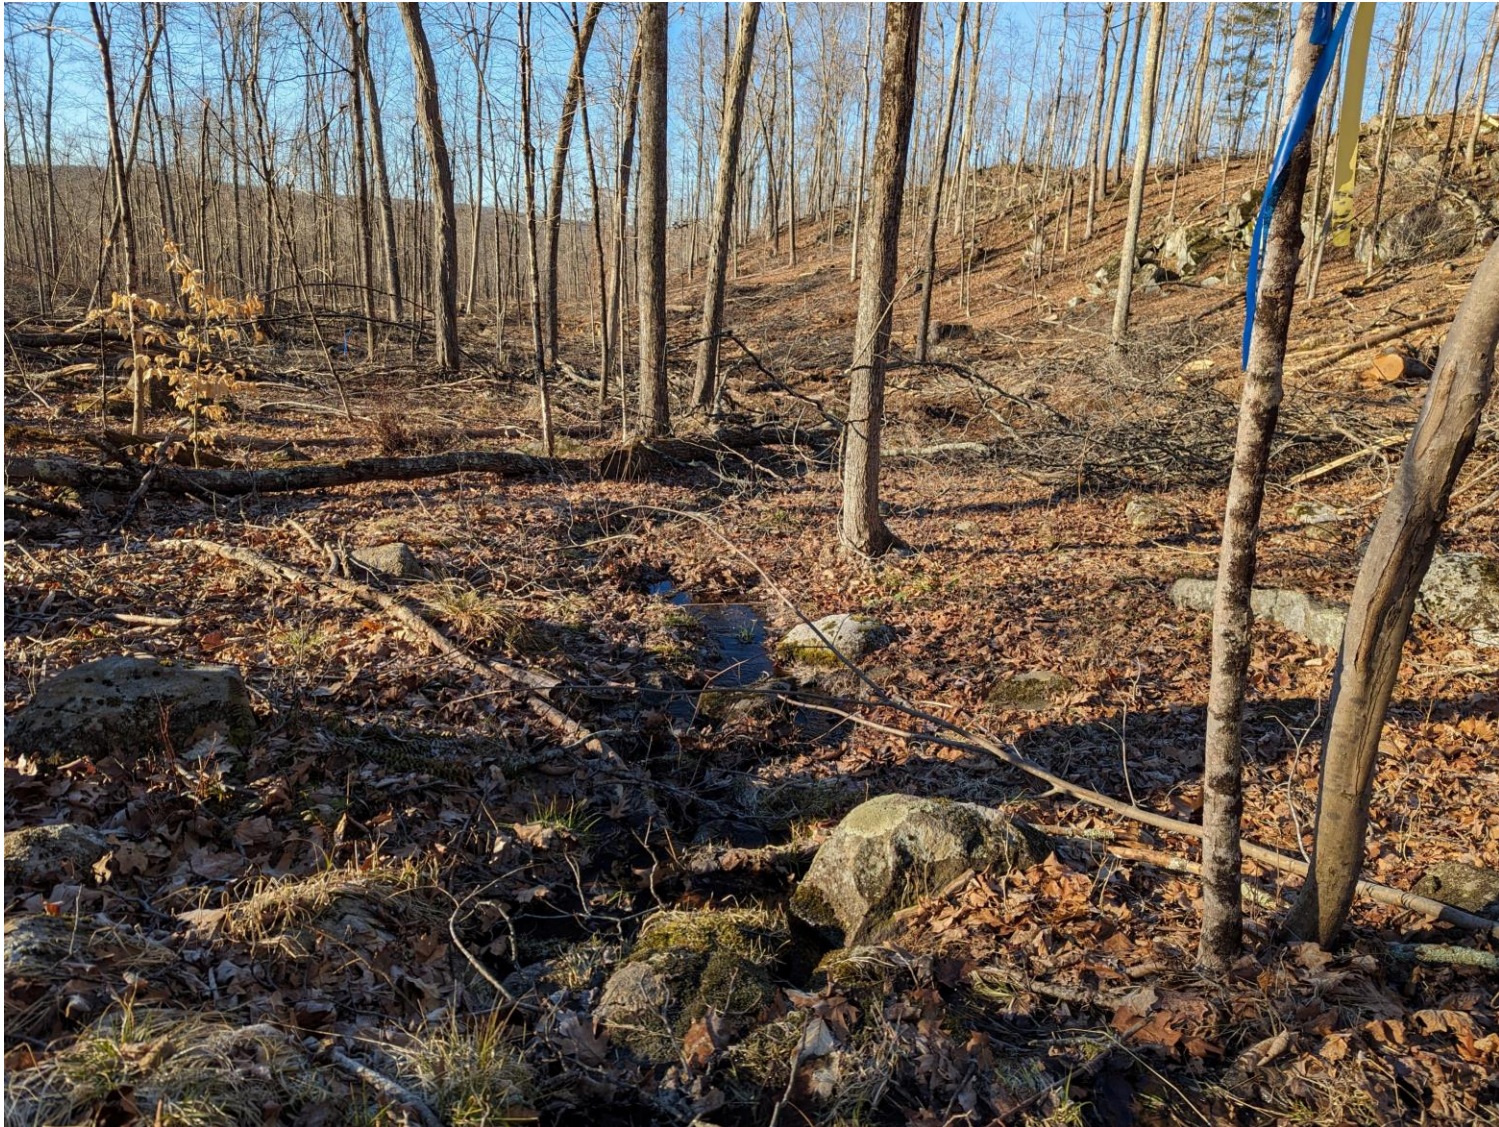
*7- View from northernmost wetlands crossing, which was unused in this harvest. I am looking south toward harvest area and western edges of property.*

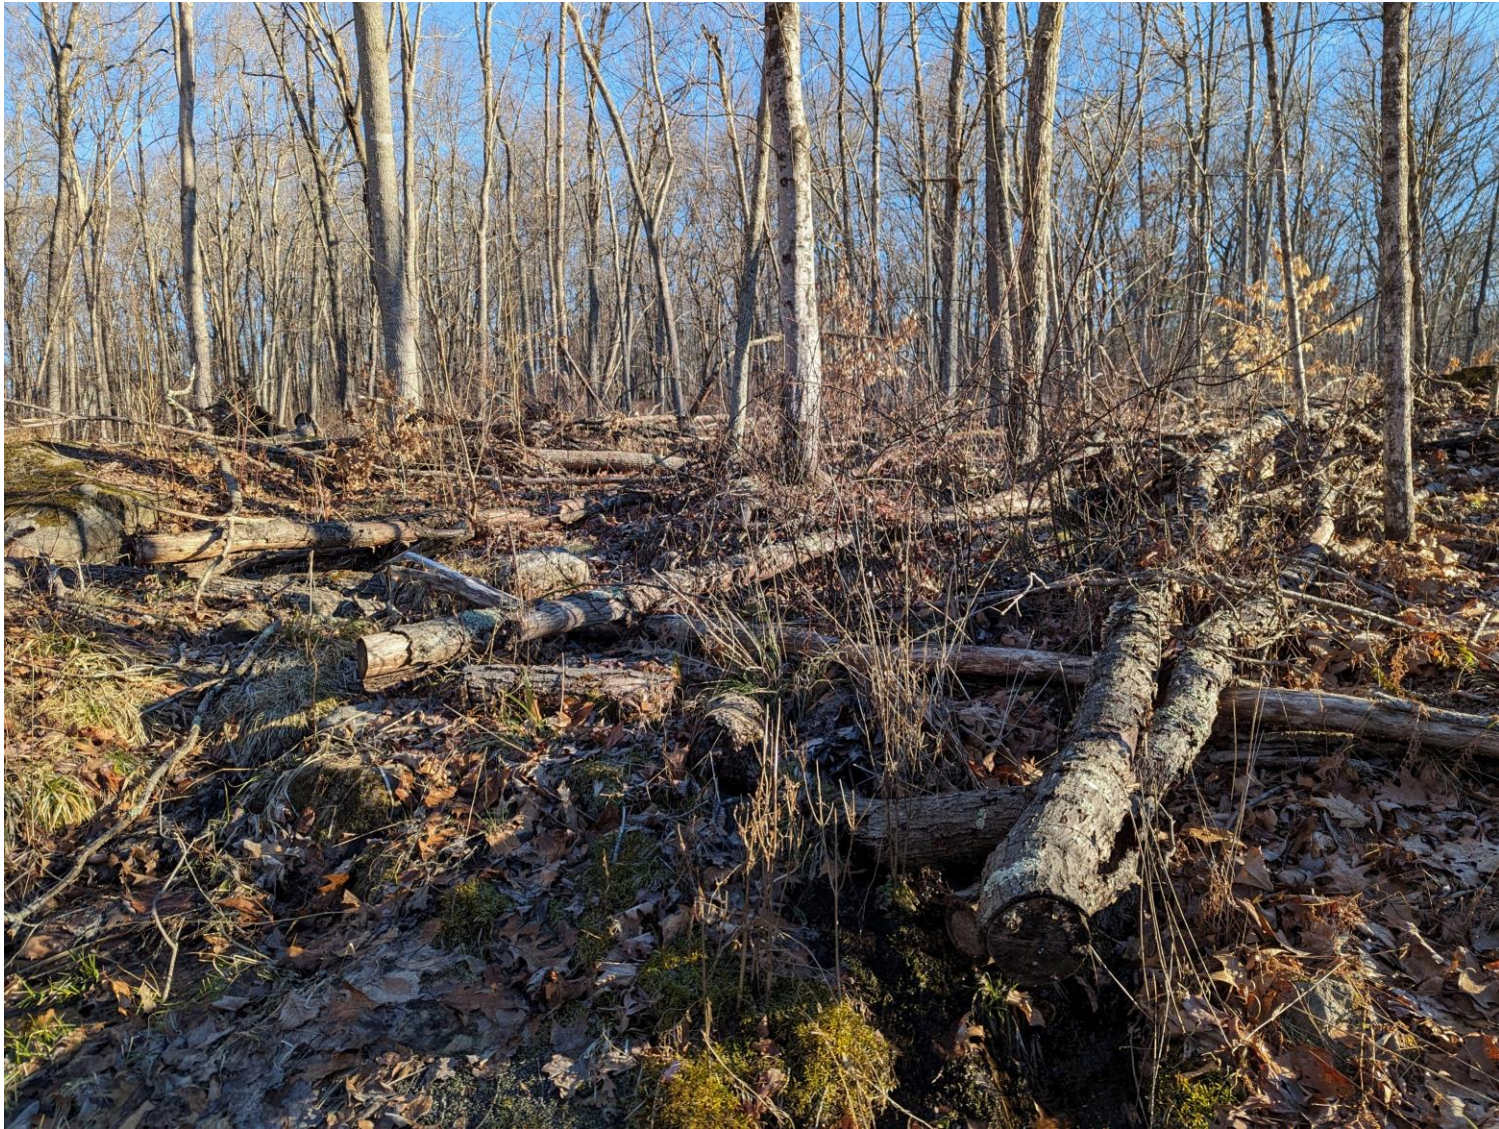
*8- View from northernmost wetlands crossing, which was unused in this harvest. Vernal pool is over the hill in this photo.*

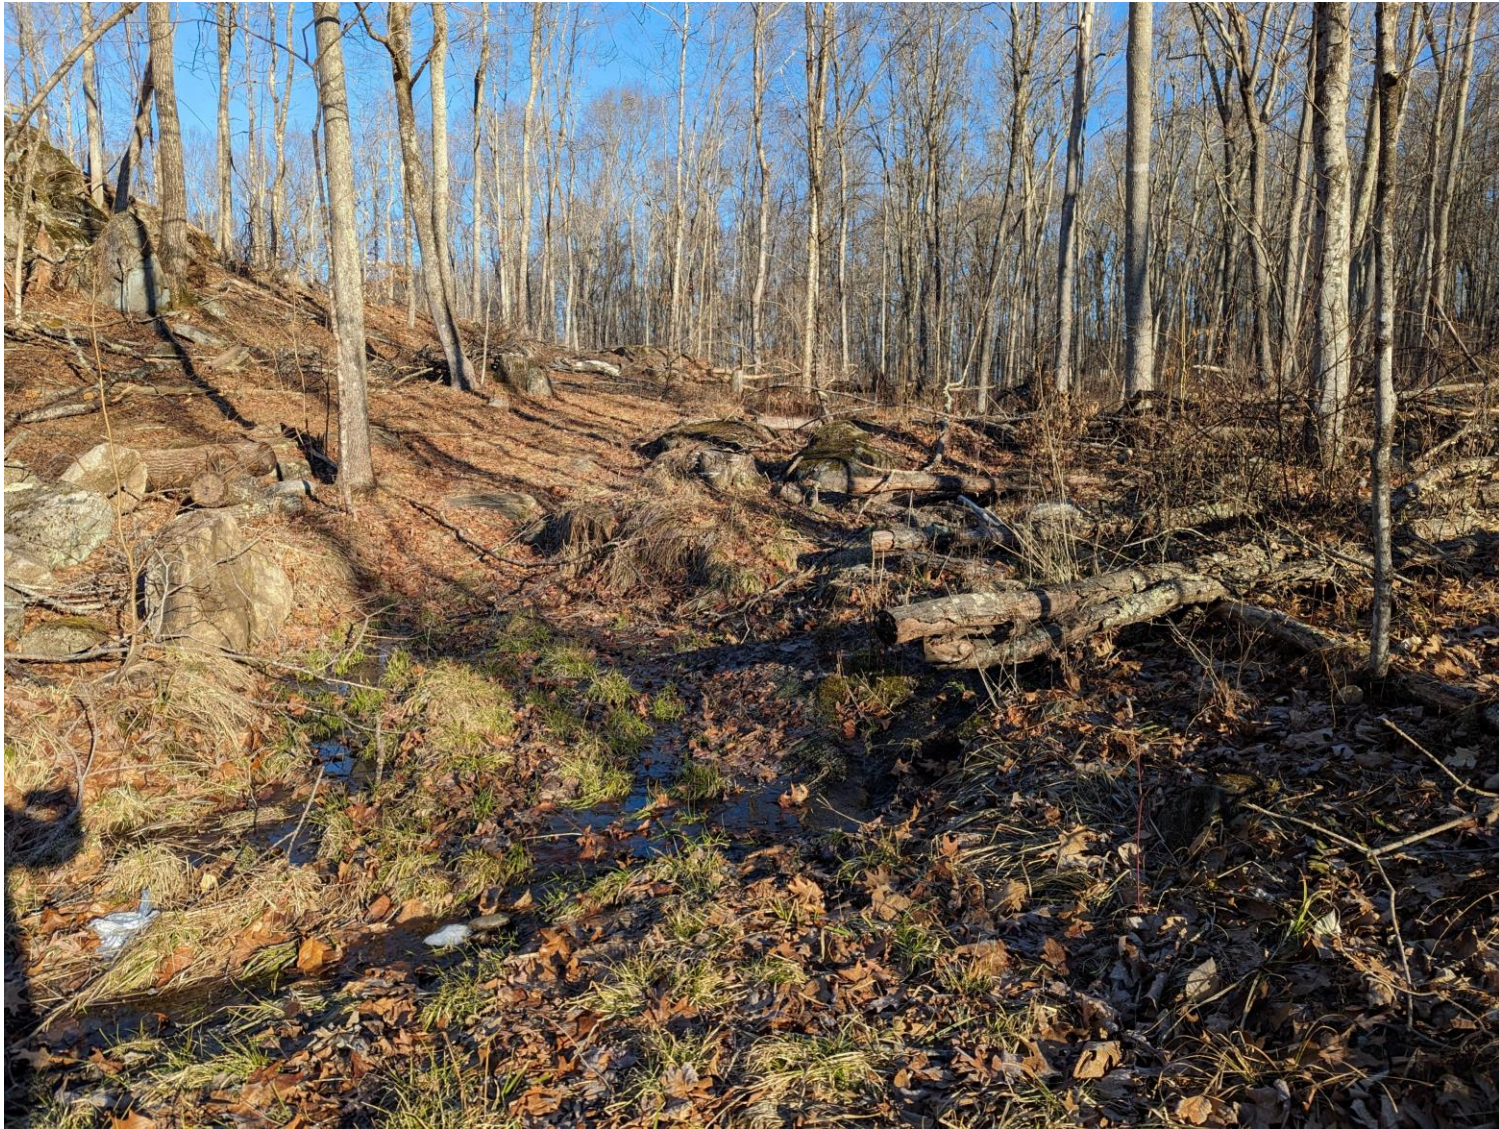
*9- View of northernmost wetlands crossing, which was unused in this harvest. The Vernal pool is to the right of the photo..*

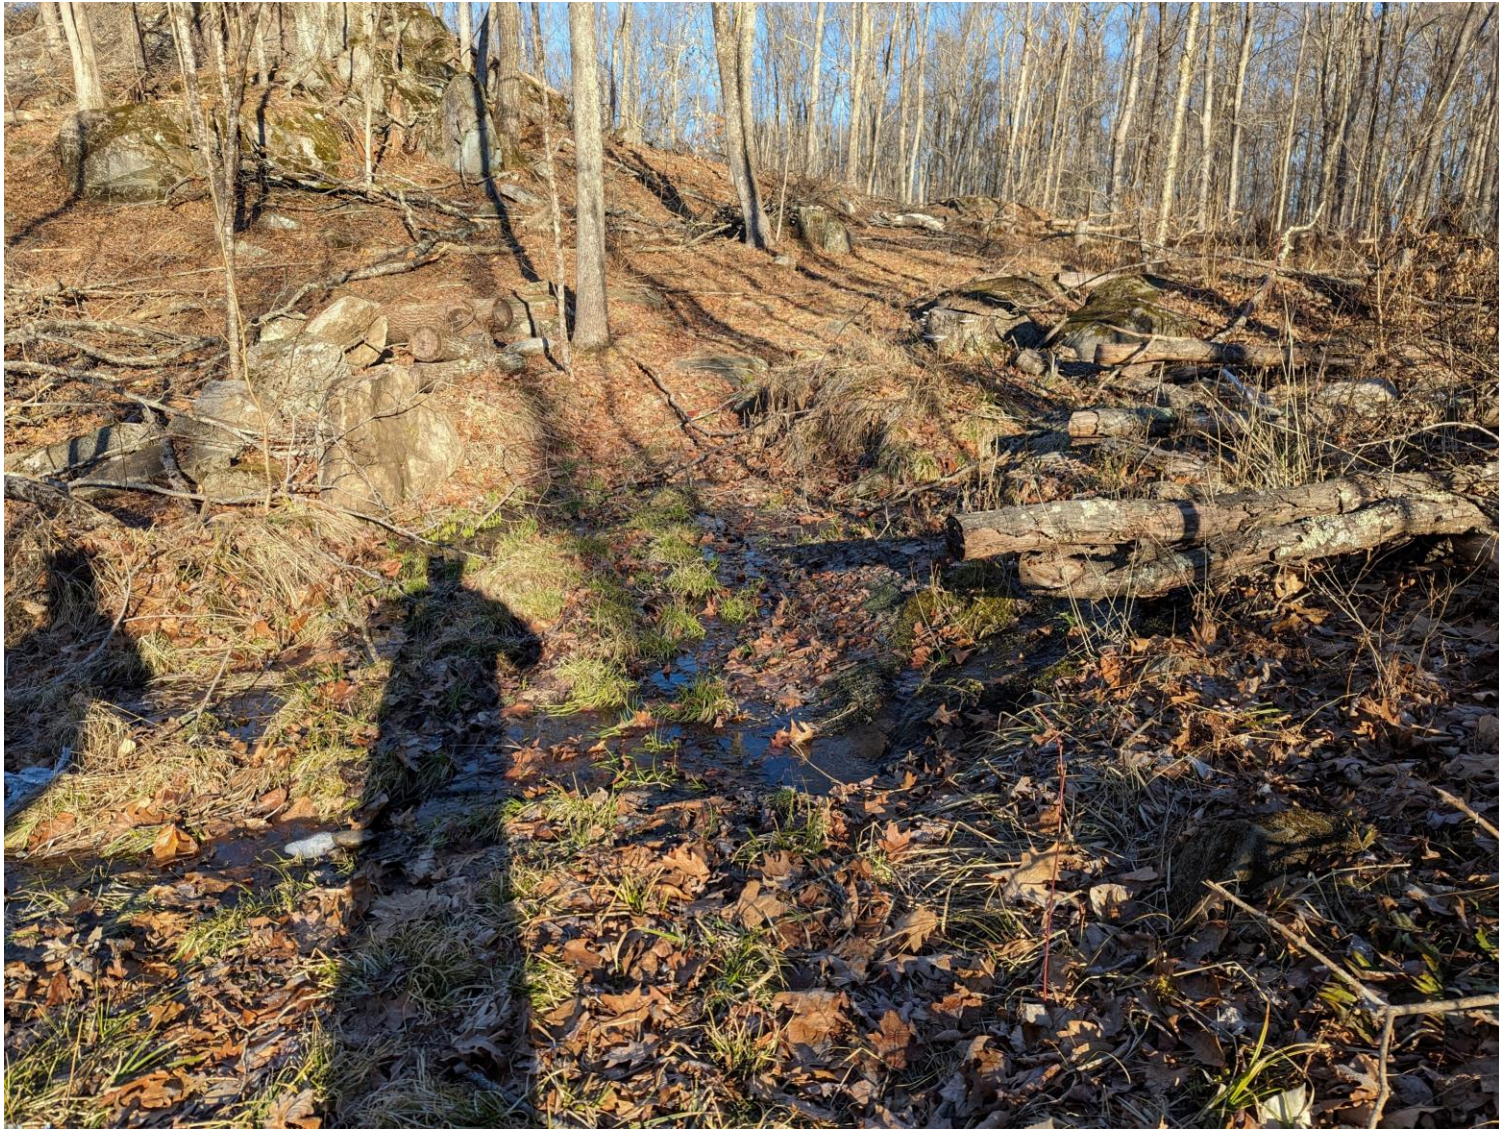
*10 - View of northernmost wetlands crossing, which was unused in this harvest. Access to the west was from one crossing to the north of the main (southern crossing).*

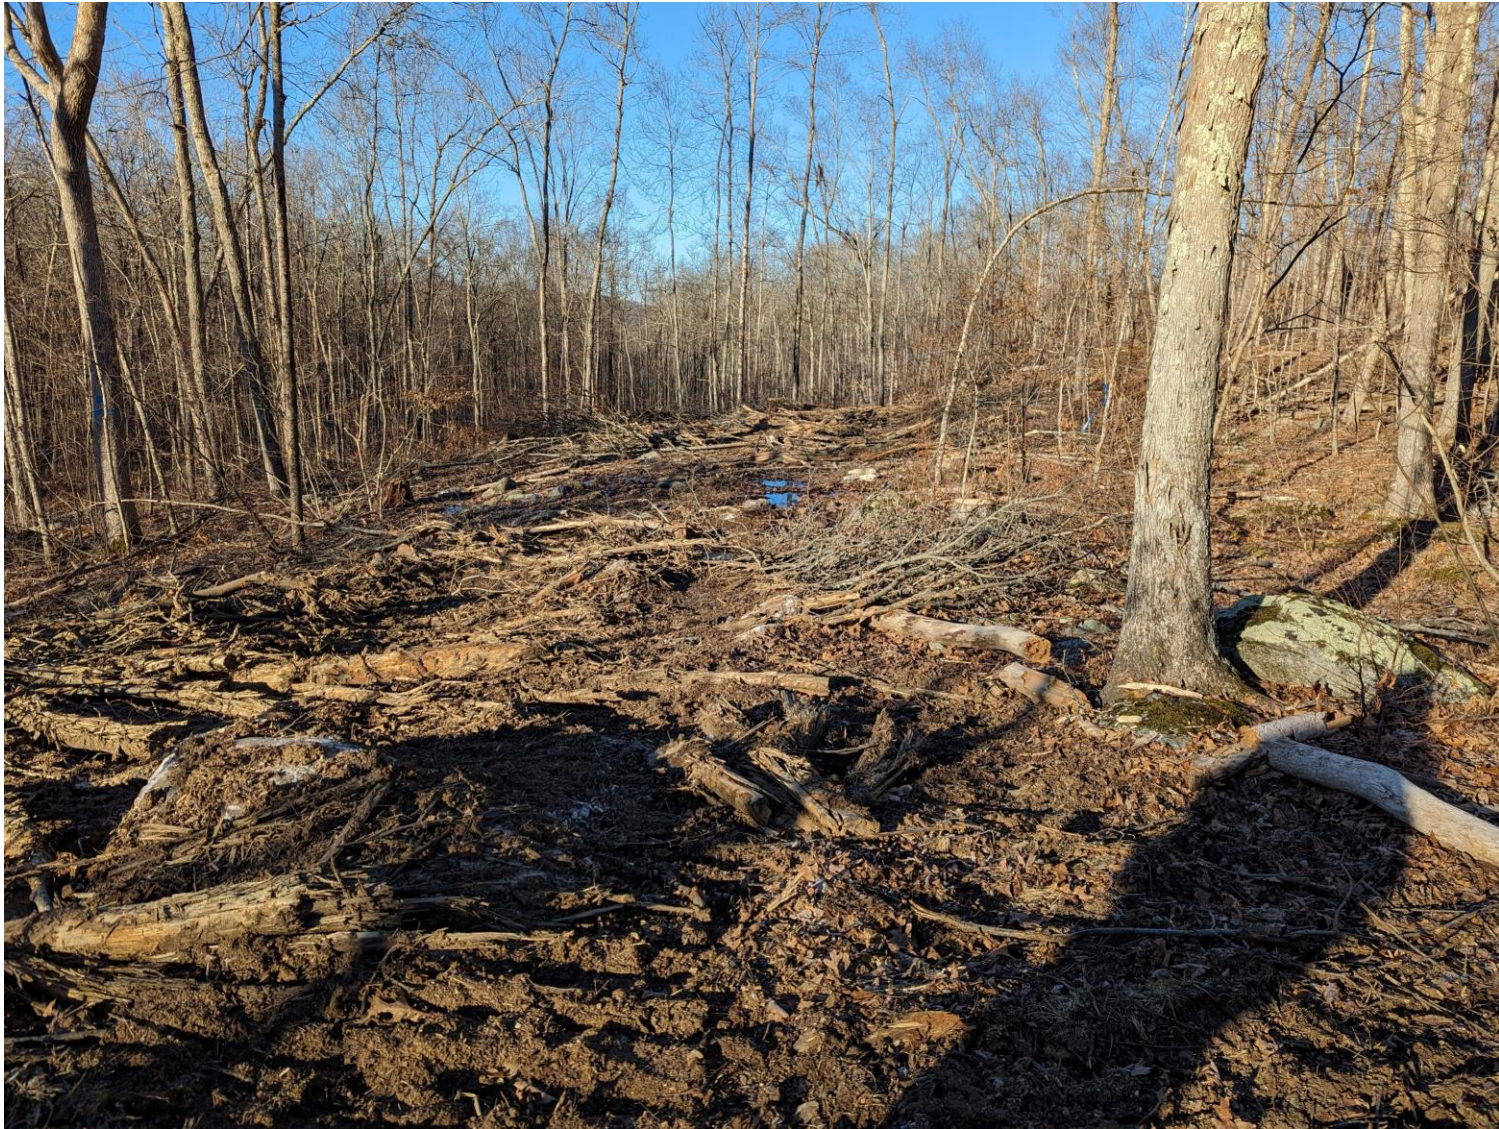
*11 - View of wetlands crossing (the second on the map, if counting from south to north). Crossing area and watercourse is in middle of photo.*

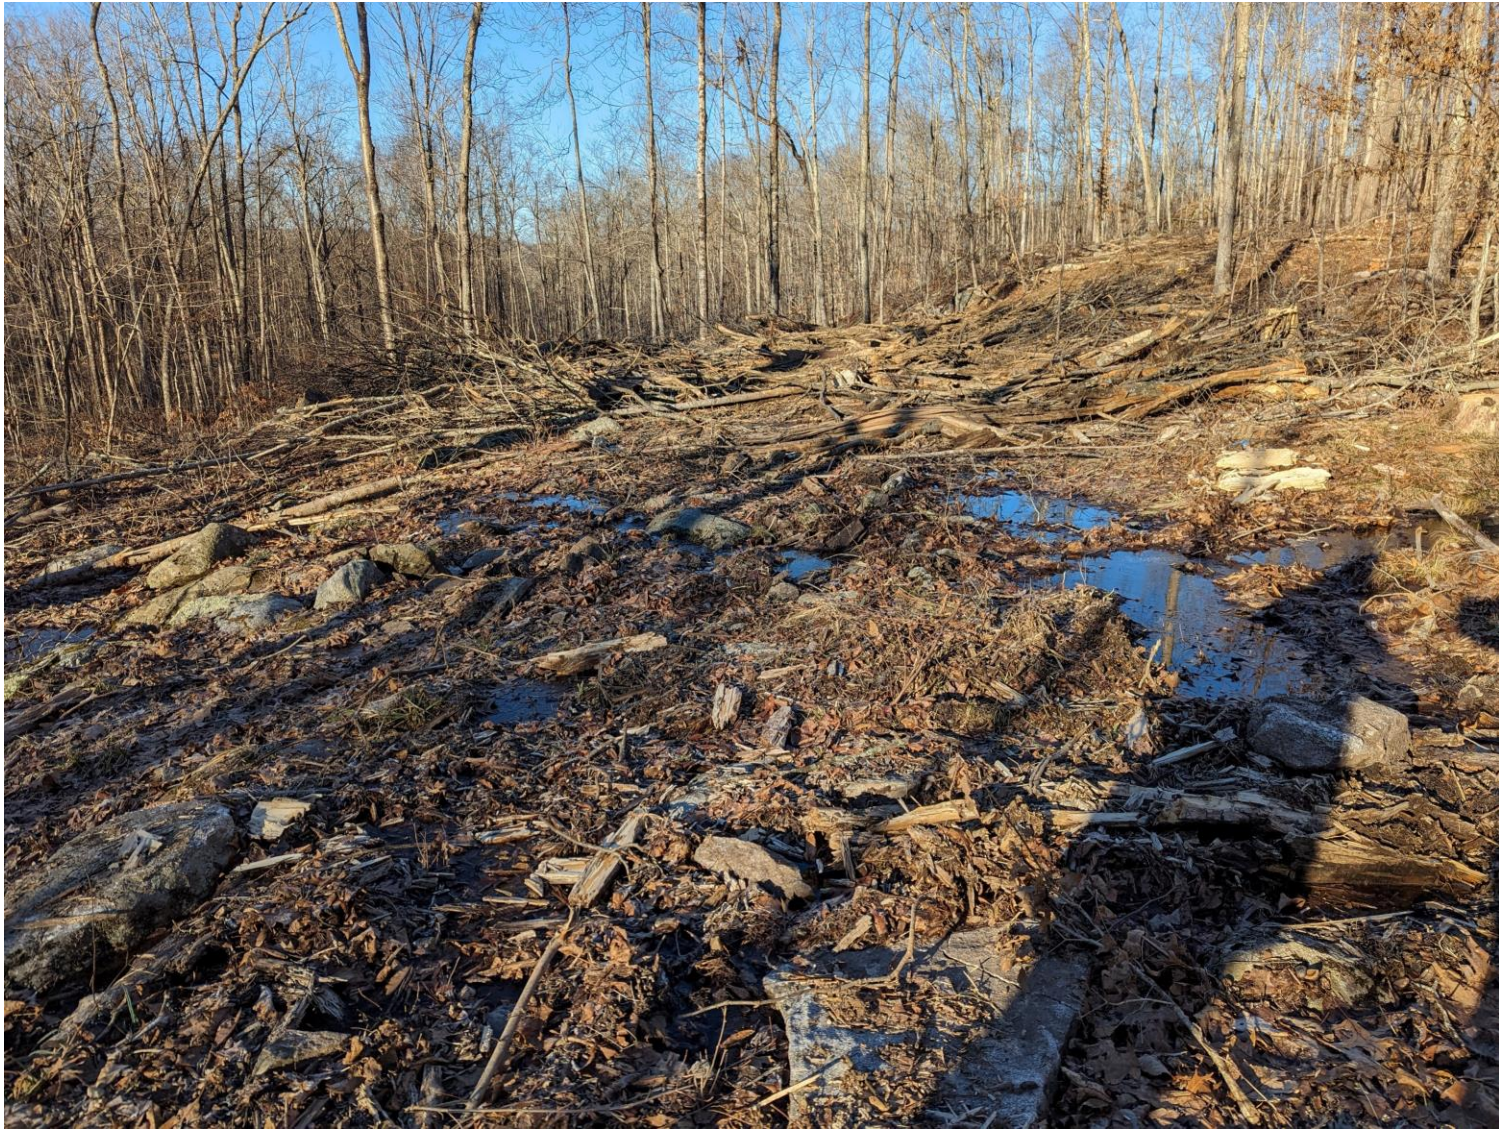
*12 - View of wetlands crossing (the second on the map, if counting from south to north). Stream channel was left intact with minimal disturbance from temporary bridge. Tree limbs seen in photo will be left in place to stabilize approaches to the crossing.*

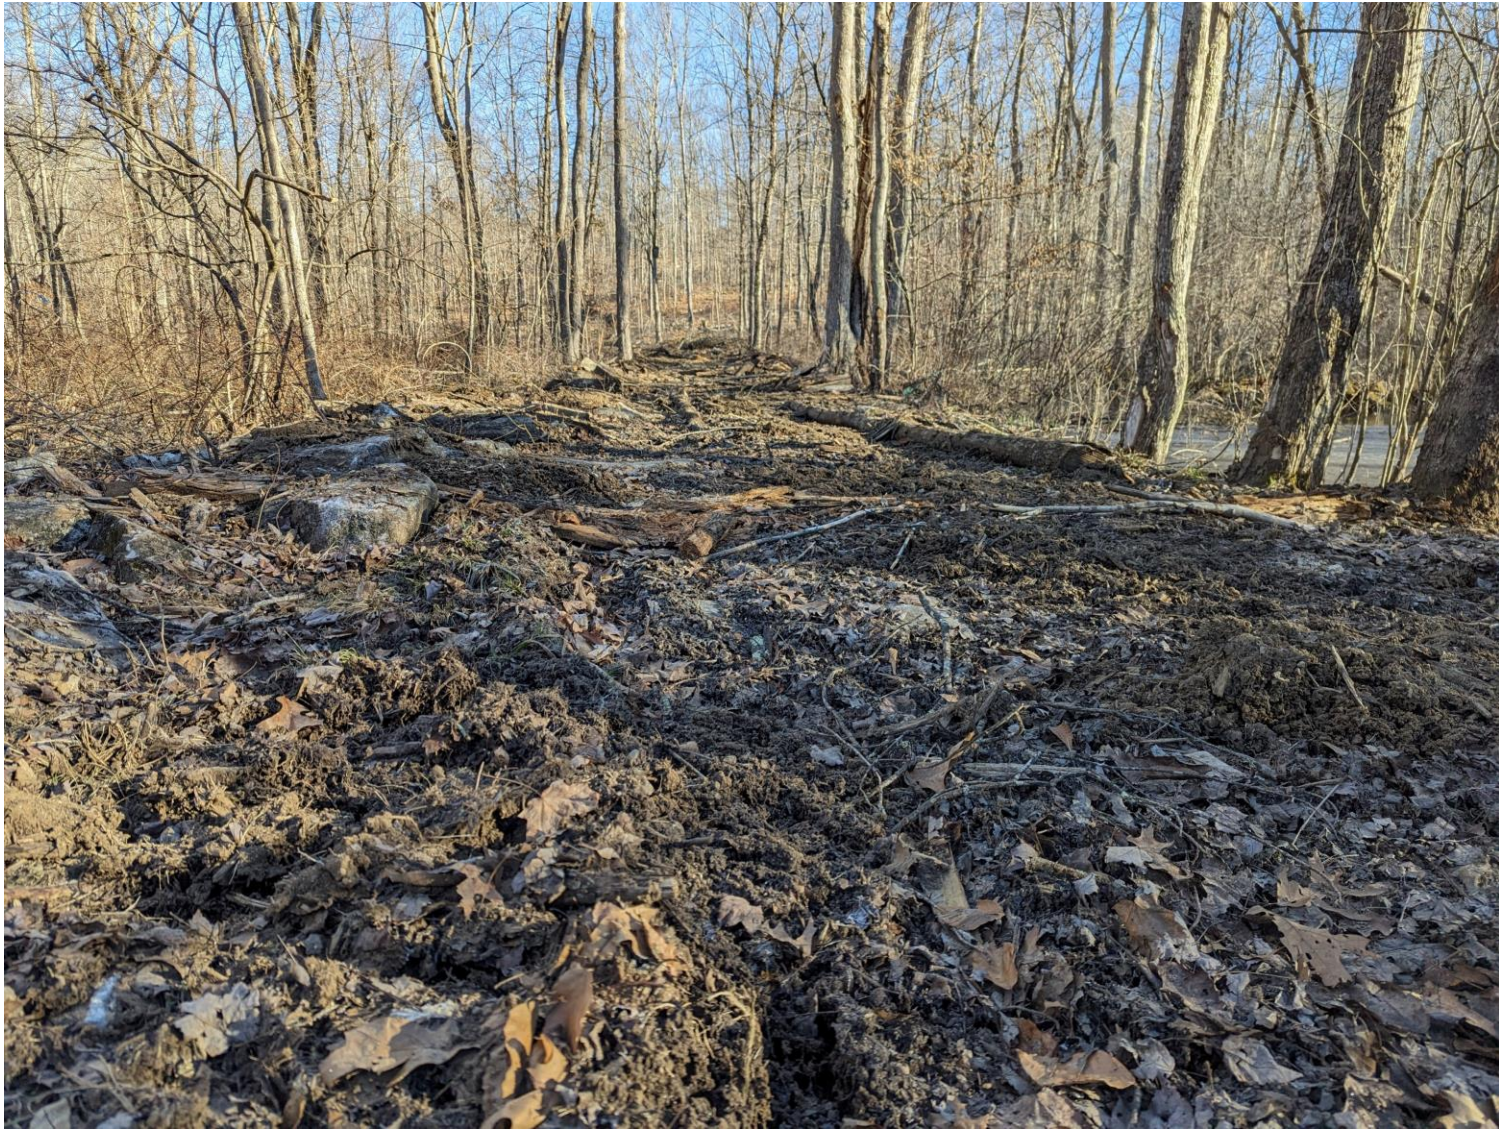
*13 - View of southern crossing area, looking north toward harvest area. Vernal pool is on the right in the photo.*
