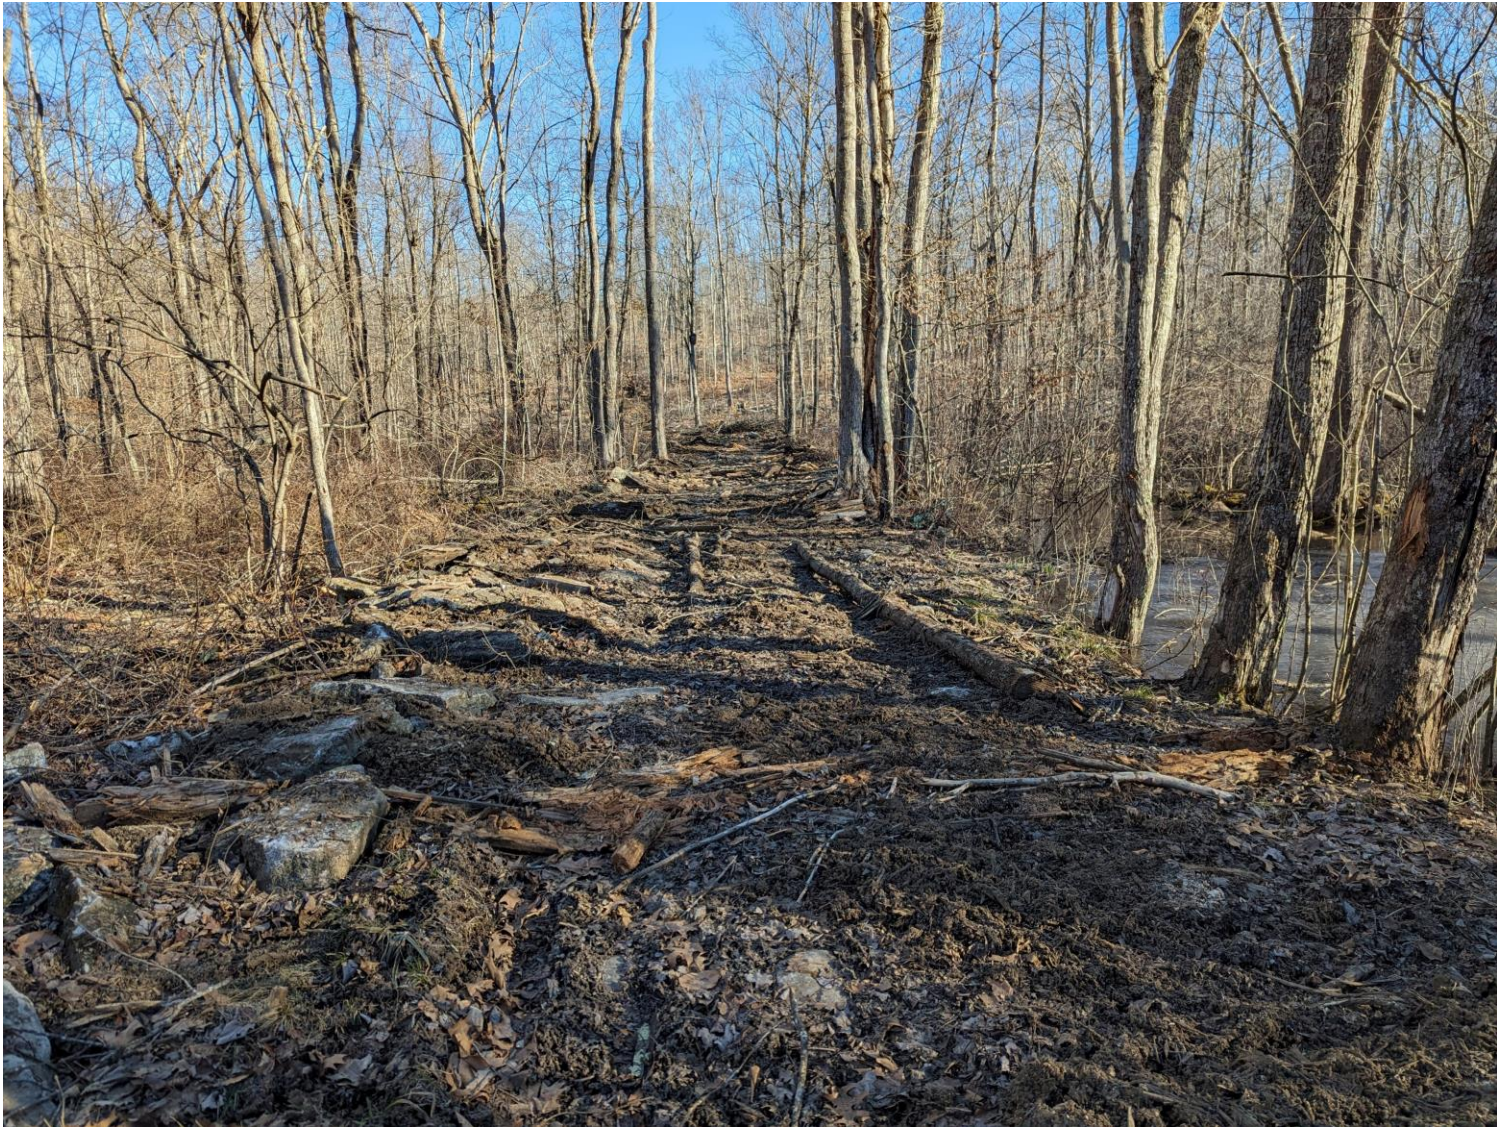
*14- View of southern crossing area, looking north. Vernal pool is to the right, and the main wetlands area is to the left.*
