101 Gilead Road – Pictures from Wetland Agent visit with Contractor. Taken 03.19.2024

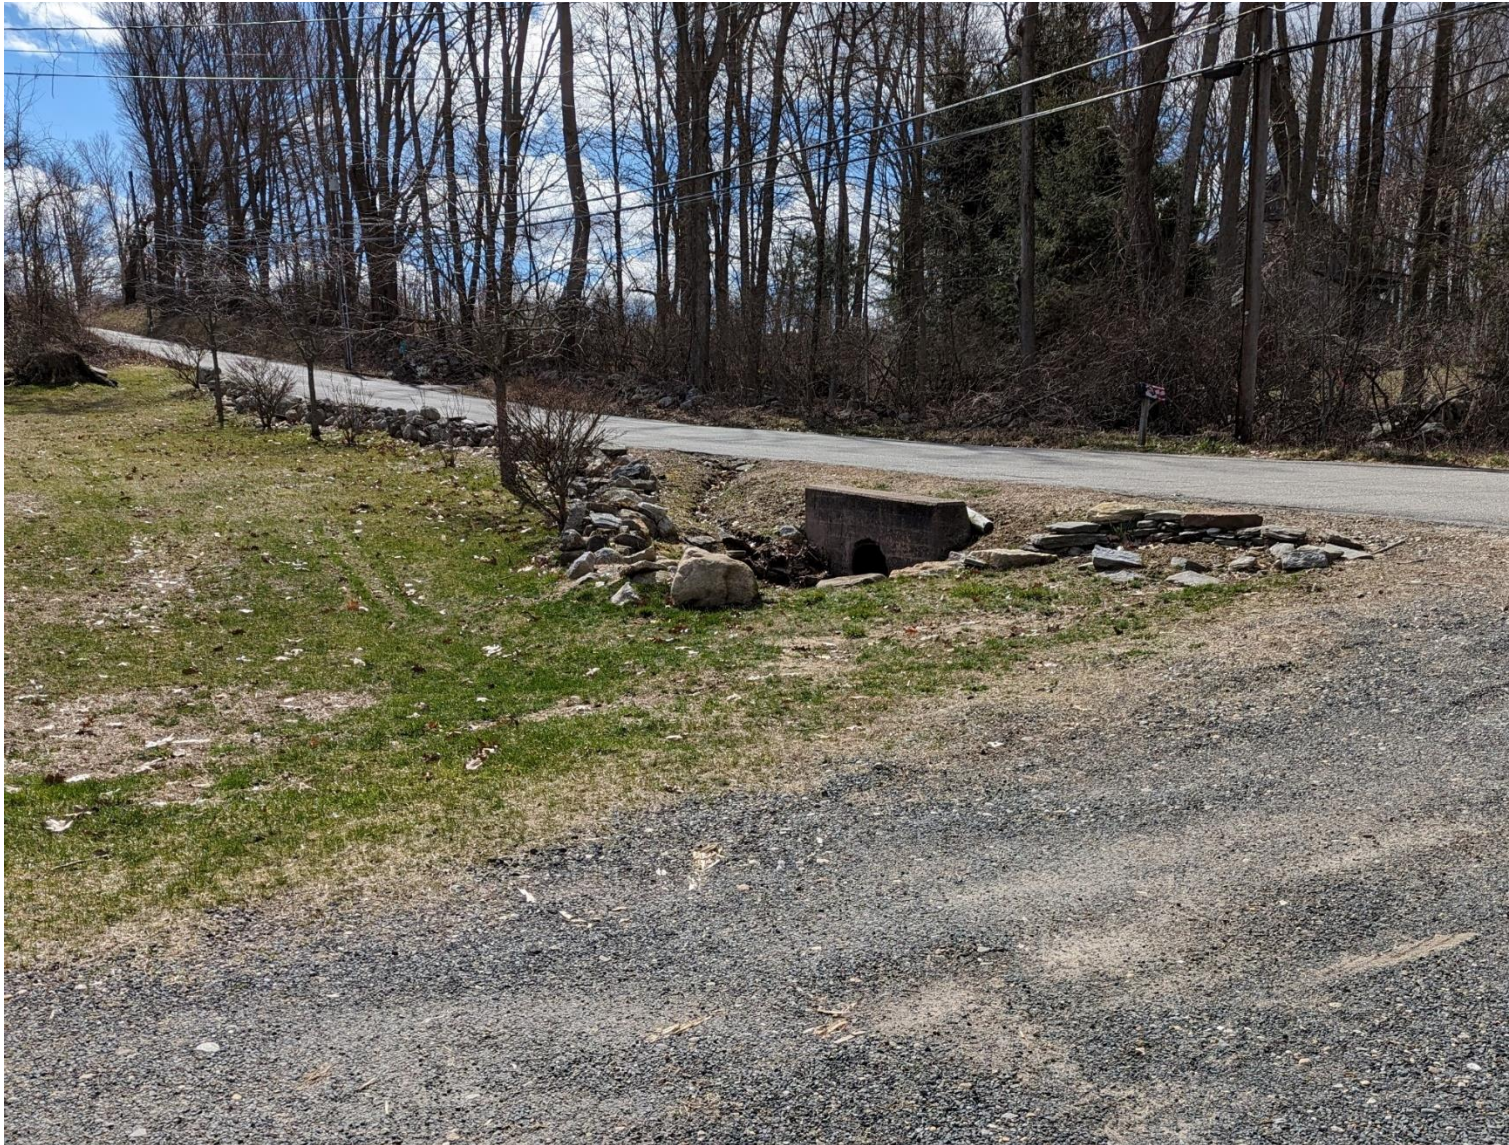
*1 - View of open drainage basin near Gilead Road. Photo was taken from the driveway at 101 Gilead, looking southwest. The plunge pool and pond are behind me.*

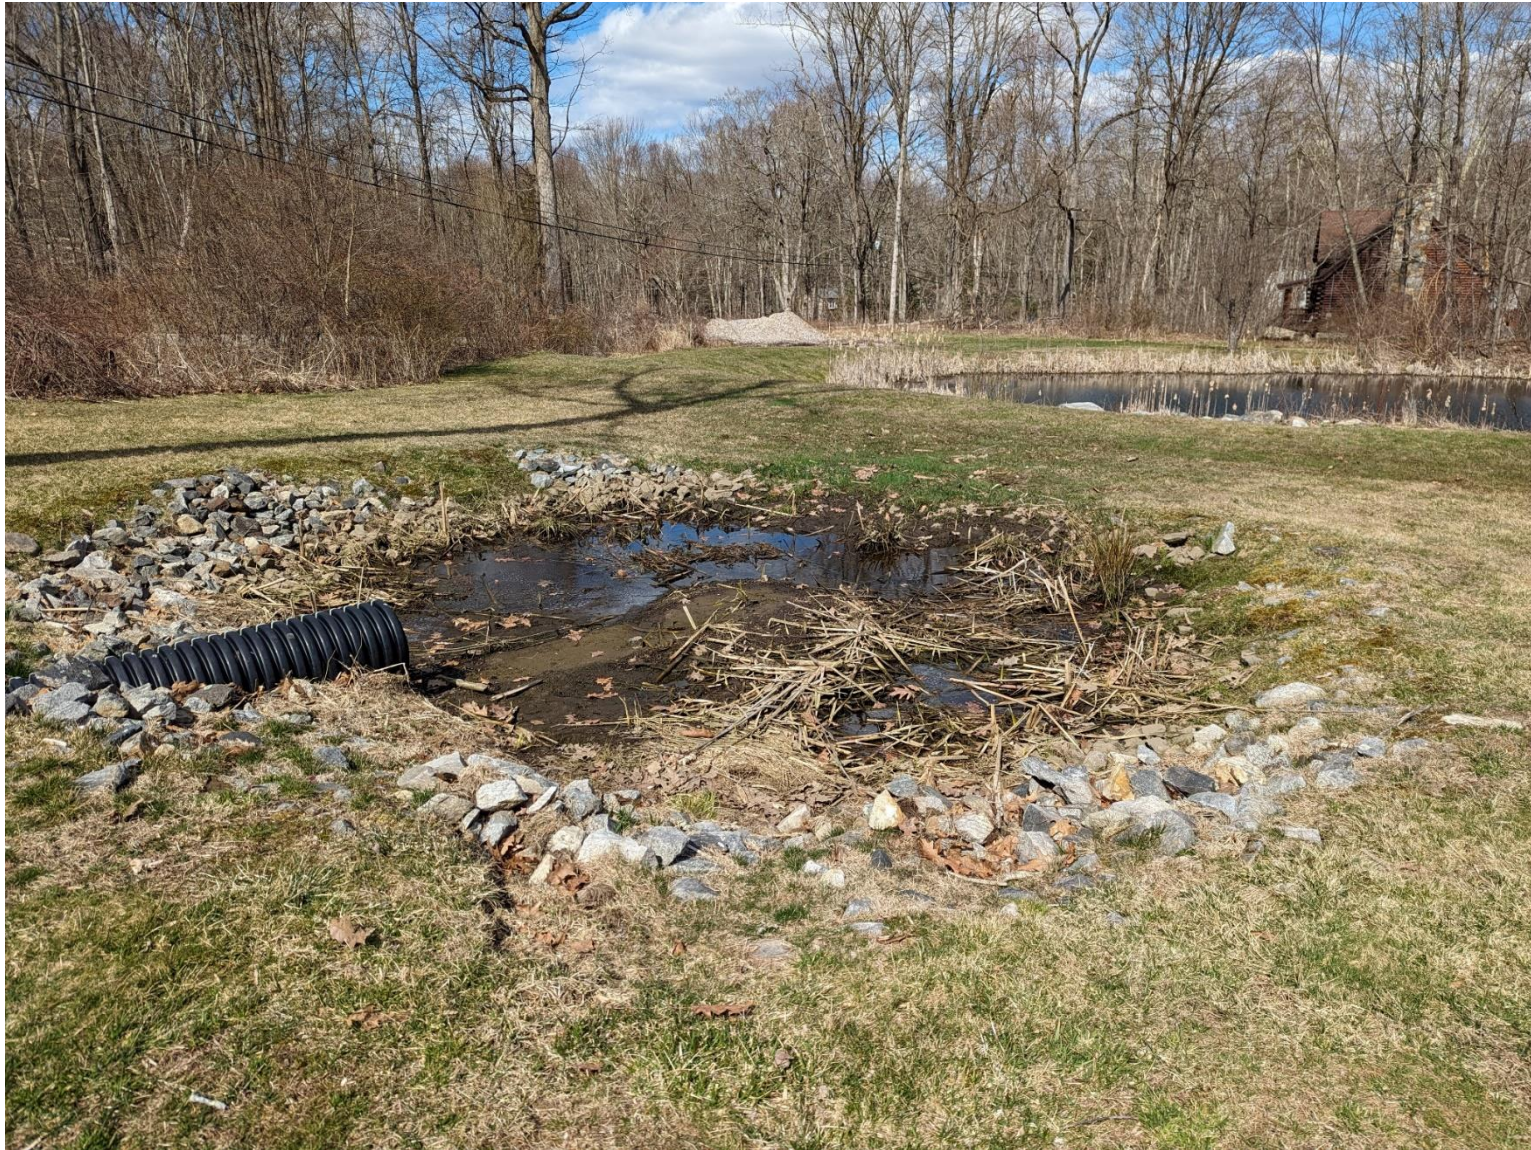
*2 - View of plunge pool. The man made pond is in the upper left corner. The pipe in the plunge pool is connected to the open basin near the road. Water flows from the road into this pipe, then under the driveway into this plunge pool.*

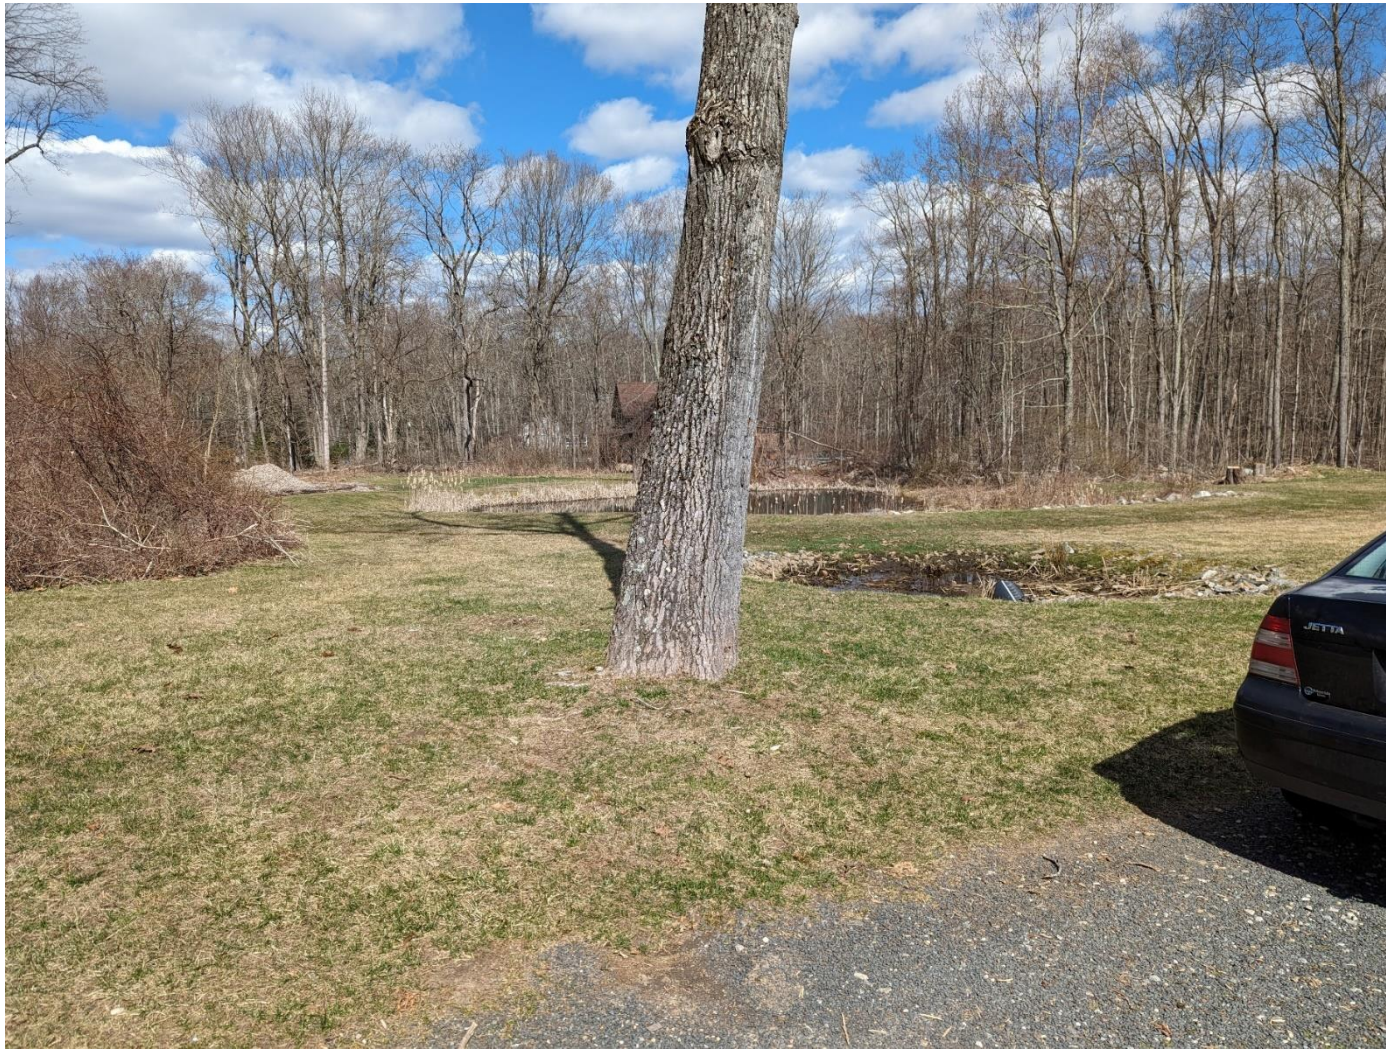
*3 - Looking north from driveway toward plunge pool and pond. The wetland area is behind and to the right of the pond. Any runoff from the plunge pool currently flows onto the lawn, then around the pond.*
