Andover Town Buildings and Properties 2020-21 CIP Report

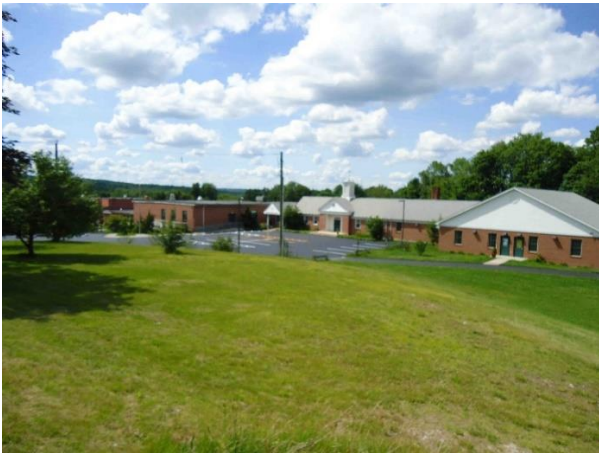
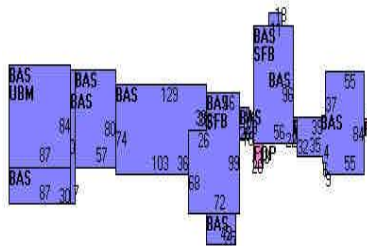
1. Andover Elementary School at 35 School Rd

- The original wing of AES was built in 1940's to replace a one-room schoolhouse that is no longer town property. The school was expanded in the 1956s, and again in 1967.

Current Condition = 9

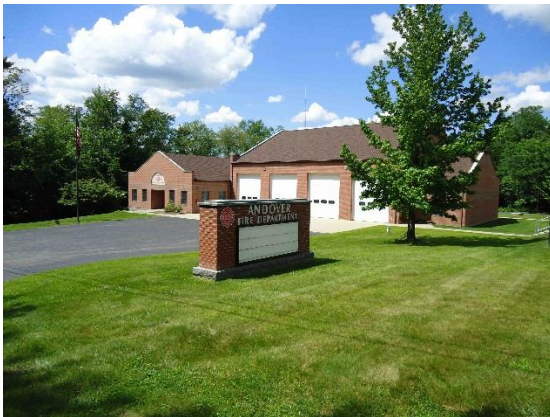
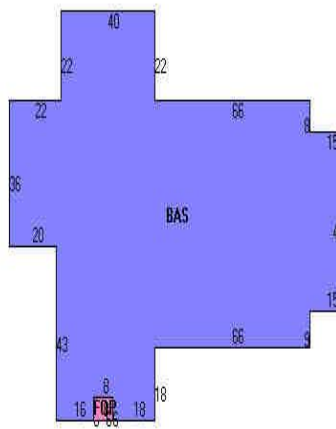
- Built in 1990 to replace old firehouse.
- 9,600 sf masonry construction asphalt shingled roof.
- Converted to Propane heat in 2020.
- Overall condition excellent.
- Appraised at 1.3 million dollars.

Current Condition = 9 *No current requirements

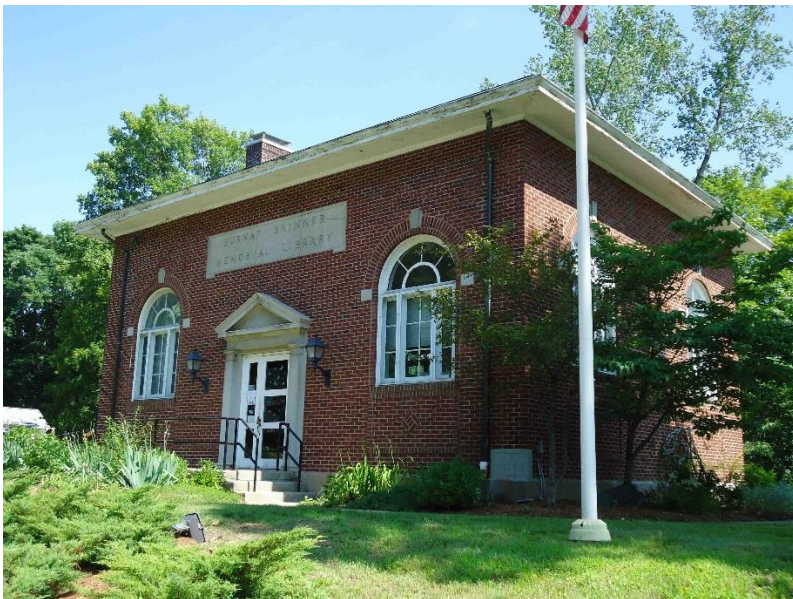
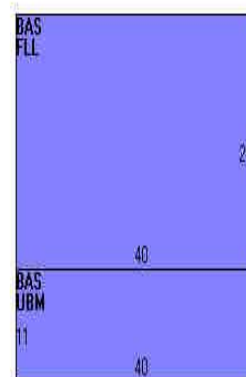
4. Andover Public Library at 355 Route 6

Current Condition = 8

- Walkway along Long Hill Rd to connect to new signalized exchange crosswalk to library and cross Route 6.
- Installation of a Bike Rack.
- Waiting on Connectivity Grant to fund improvements. As part of the Connectivity Grant, the front steps will be replaced and a handicapped ramp installed with new decorative railing and access pathway.
- Library Board of Directors recommends whole building surge suppressor, repointing chimney.

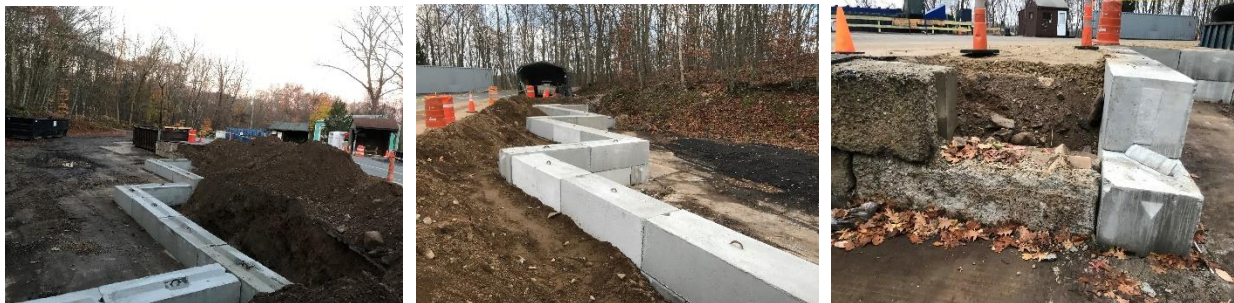
- The Andover Transfer Station has been in need of substantial rebuilding. This began in 2019 by replacing the walls on the side that has the open dumpsters for Bulky Waste. This project includes:
 - Complete rework of the electrical system at the transfer station including changing to a rotary phase converter located in the blue shed
 - Removal of old overhead electrical lines
 - Replacement of side walls on both sides
 - Repair and replacement of 4 concrete pads for the compactors
 - Concrete floor in the new building
 - Add a new double Catchbasin at the base of hill in front of recycling shed
 - Reclaim existing pavement, regrade and repave ~ 22,500 SF of surface area
 - Replacement of the operators shed with a new prefab building with a porch. Insulate and condition the space.
 - Summer 2020 work is well underway.

Current Condition = 9 when project complete

- CIP has allocated funds to repair the Transfer Station walls and to replace the shed with a prefab structure. This is in 2019-20 budget for a total of \$50,000. That budget has been exhausted and additional funds from Contingency spent on the project.
- The largest single item will be the cost of the Reclaim / Repaving. Based on initial estimates this will cost between \$60,000 and \$65,000. The Board of Selectman has approved applying for Locip funds to complete this project

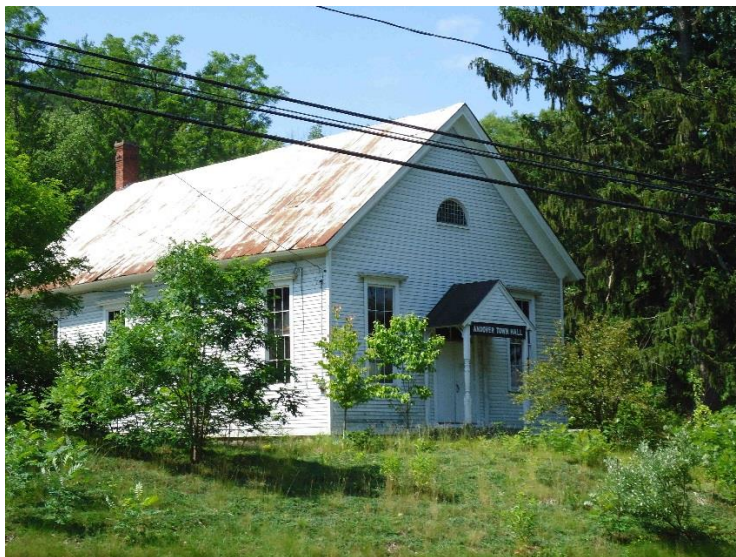
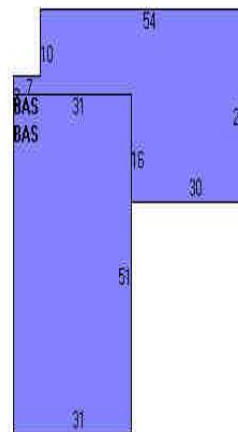
8. Museum of Andover History (Old Town Hall) at 1 Monument Lane

- Originally built in 1890's as Andover's Town Hall. Currently in use as a Museum of Andover History.
- Property is also used as a trailhead for the Rail Trail In the last few years.
- There has been tree removal as well as landscaping.
- The upper roof is asphalt shingle and was completed within the last 5 years. The lower roof was replaced this year with a low pitch EPDM.

Current Condition = 7

- The town is seeking a grant for siding replacement. The town is also looking into replacing the front door.
- There is a drilled well that has been made available for watering for landscaping purposes.
- This building has no septic system, and has a porta-potty . One alternative would be to add a Clivus Mulstrand composting toilet in an outside building as a long-term solution. This would also serve as a resource for the Hop River Rail Trail.
- The building also needs interior painting.
- Efforts should be made to evaluate the humidity control for the building, since it is used for historic preservation.
