ENGINEERING REPORT DRIVEWAY DRAINAGE CROSSING CORREIA / PINE RIDGE DRIVE / ANDOVER, CONNECTICUT

WATERSHED / CORREIA DRIVEWAY CROSSING / ANDOVER, CT

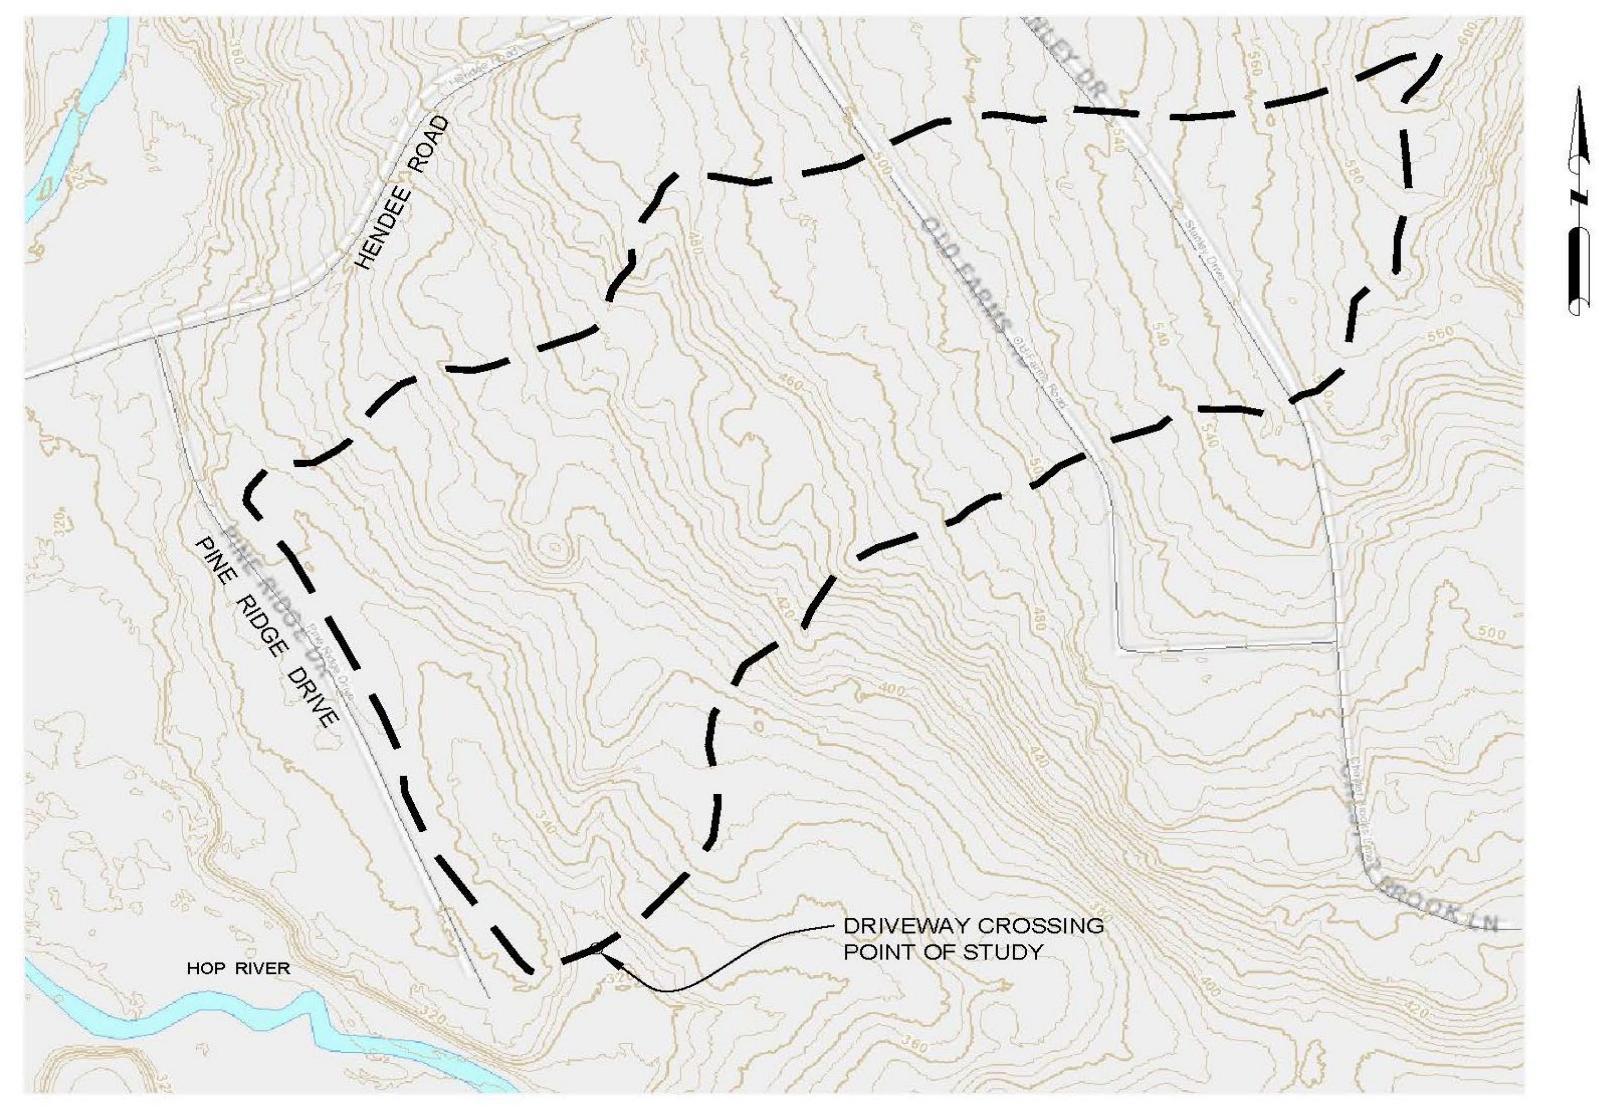
BASE MAP SOURCE: CT ECO/DEEP 2016 AERIAL

The driveway analyzed for the crossing of an unnamed stream is situated between properties at 68 and 74 Pine Ridge Drive at the cul-de-sac end of the road. Subsequent to its entrance from Pine Ridge Drive, the driveway crosses an intermittent and unnamed stream that runs in a generally southerly direction to join the Hop River and encompasses a watershed of 62.9 acres, or approximately 0.10 square mile. The area is largely covered with densely wooded slopes of approximately 10% grades, and soils that are overall moderately well drained (NRCS Hydrologic Soil Group "B").

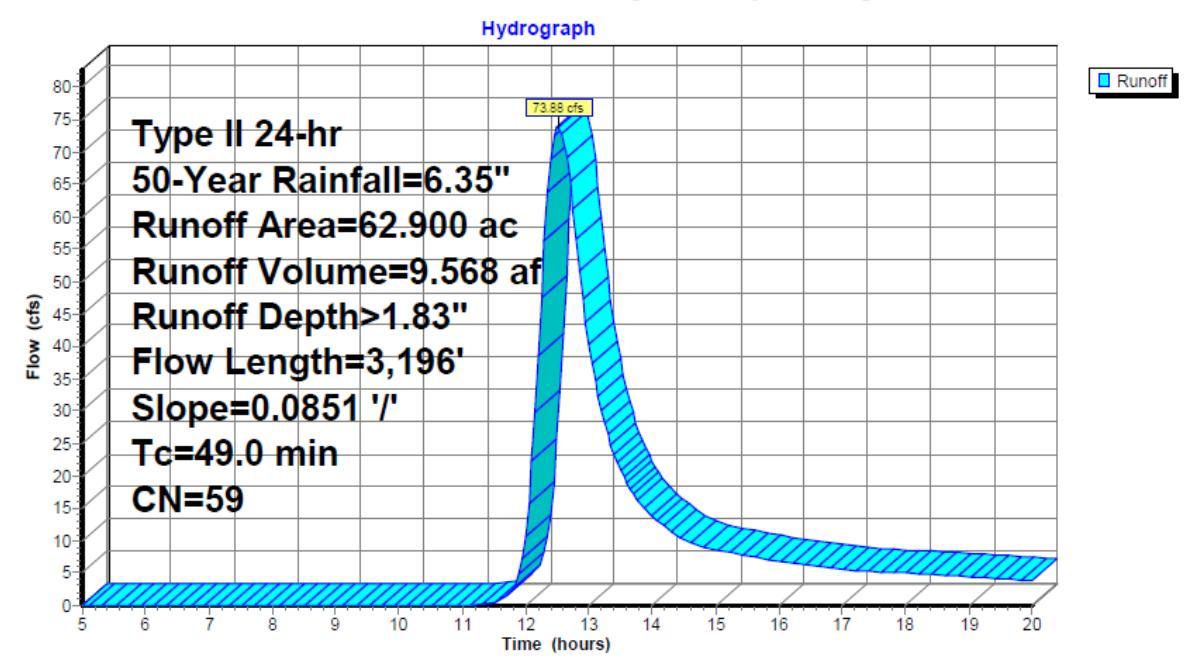
Summary for Subcatchment 1S: Pine Ridge Driveway Crossing

Runoff = 73.88 cfs @ 12.52 hrs, Volume= 9.568 af, Depth> 1.83"

Runoff by SCS TR-20 method, UH=SCS, Time Span= 5.00-20.00 hrs, dt= 0.05 hrs Type II 24-hr 50-Year Rainfall=6.35"

Area	(ac)	CN	Desc	ription		
*	62.	900	59	Woo	ded		
	62.	900	100.00% Pervious Area				
	Тс	Length	ı	Slope	Velocity	Capacity	Description
	(min)	(feet)	(ft/ft)	(ft/sec)	(cfs)	
	49.0	3,196	6 0	.0851	1.09		Lag/CN Method, Pine Ridge Watershed

50-YEAR STORM EVENT

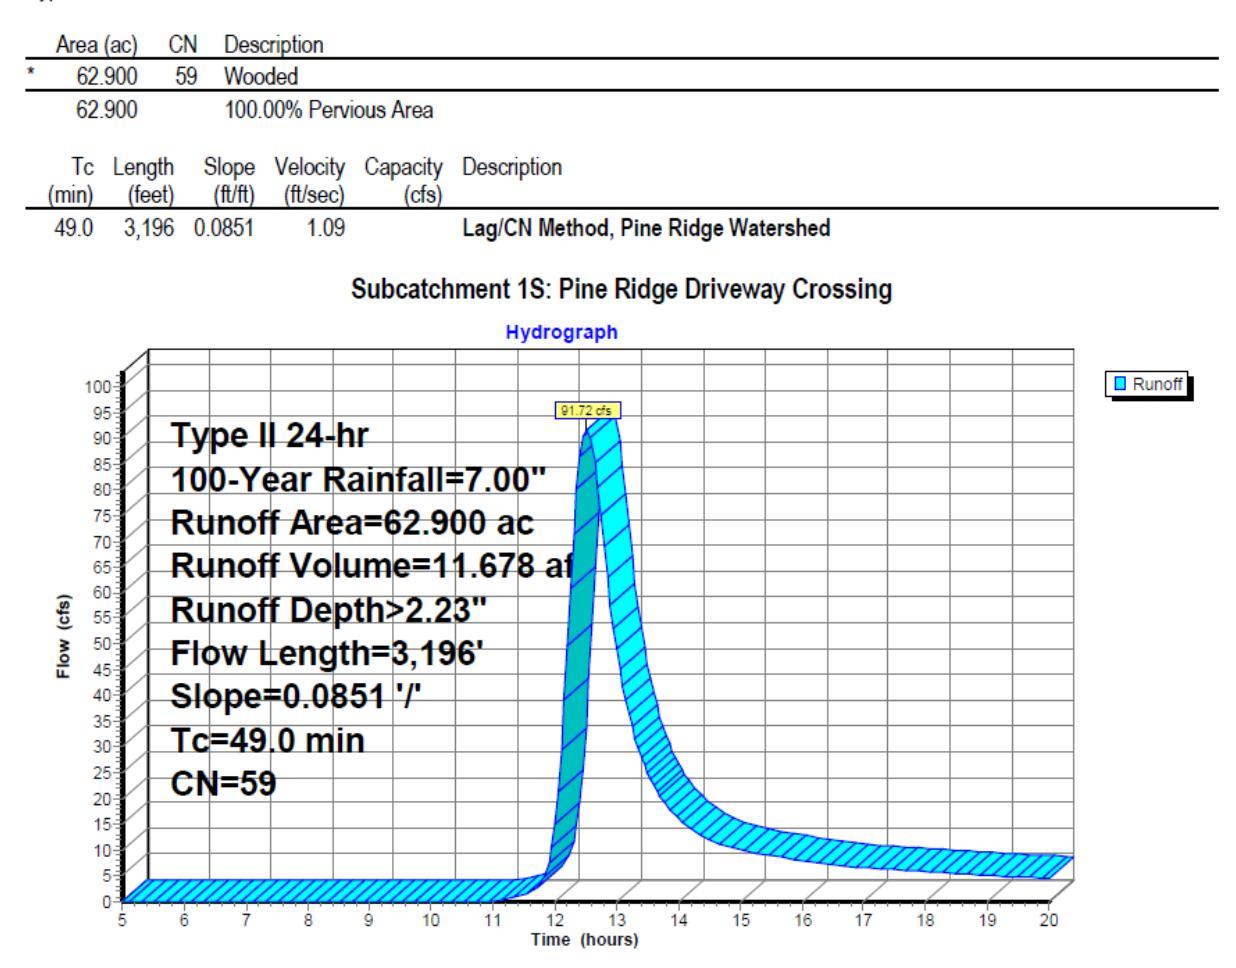
Summary for Subcatchment 1S: Pine Ridge Driveway Crossing

Runoff = 91.72 cfs @ 12.51 hrs, Volume= 11.678 af, Depth> 2.23"

Runoff by SCS TR-20 method, UH=SCS, Time Span= 5.00-20.00 hrs, dt= 0.05 hrs Type II 24-hr 100-Year Rainfall=7.00"

100-YEAR STORM EVENT

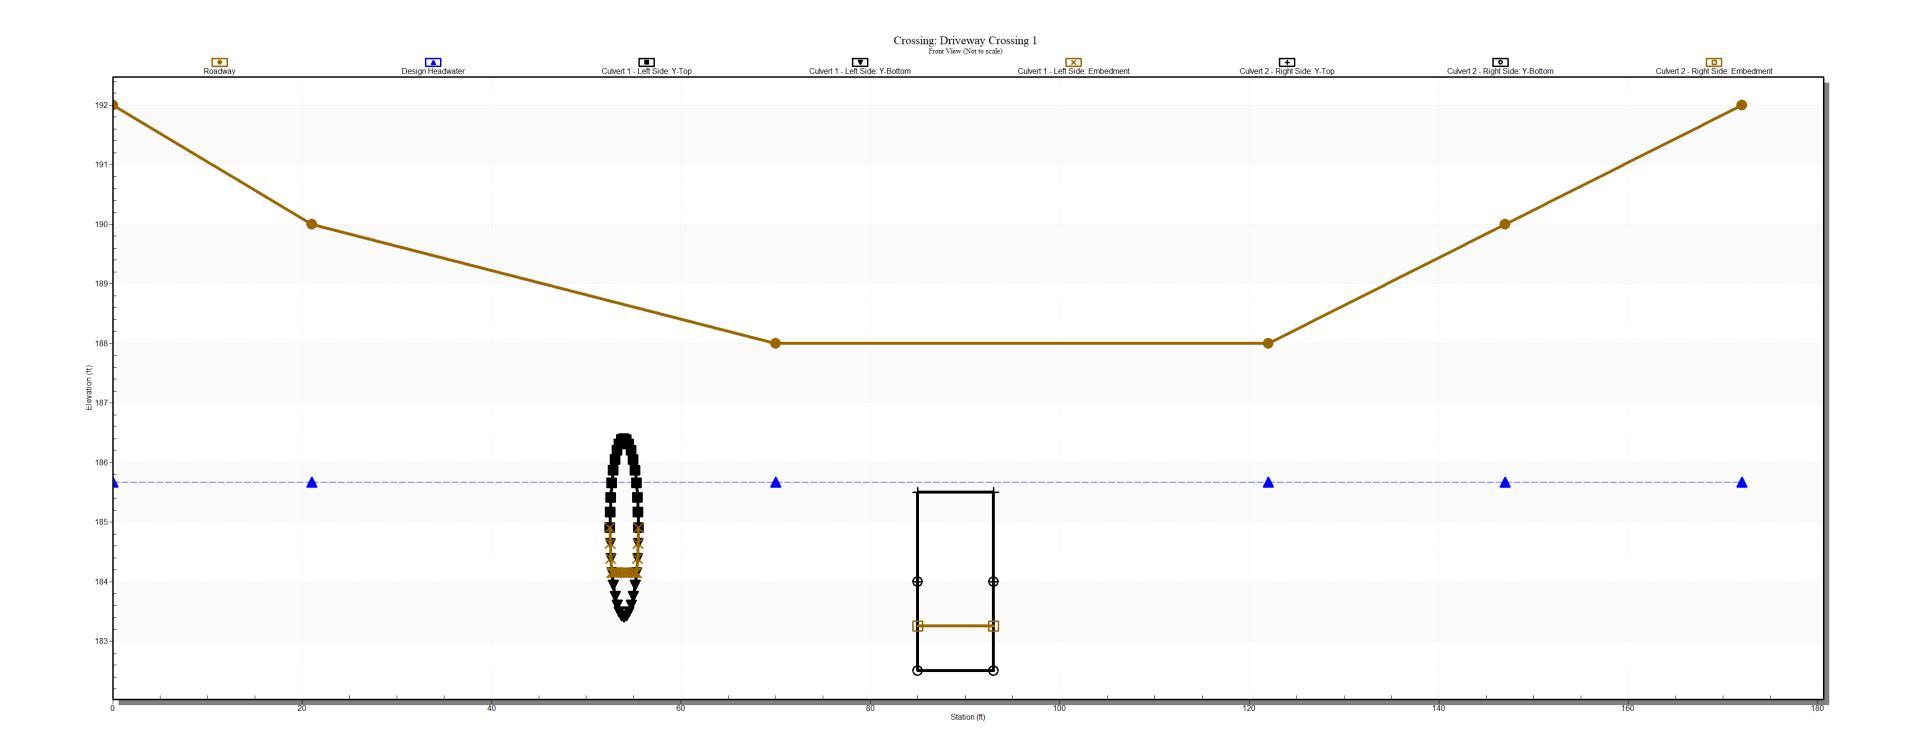
DRIVEWAY CROSSING SECTION / LOOKING DOWNSTREAM FHWA / HY-8 CULVERT ANALYSIS / 100-YEAR EVENT

Drainage Area:	0.10 sq. mi.
NRCS Runoff Curve No. (RCN):	59
50-Year Flow at Crossing:	74 cfs
100-Year Flow at Crossing:	92 cfs
Proposed:	
(1) Pipe:	36" Dia. HDPE (Smooth Interior)
(2) Box Culvert	3' H x 8' W (Concrete Box Culvert)
	[Note: Each culvert will be filled to a 9-inch depth inside
	its base with natural stream materials.]
Total Flow Capacity (Both Culverts):	192 cfs (at top of driveway level)
100-Year Freeboard: ¹	2.3 ft. (below top of driveway)

¹ The freeboard, as noted here for the 100-year event, is measured from the upstream flood water level surface to the lowest crest point of the driveway crossing.
